Appendix E2 - Stormwater Restoration (Restoration Inspections)

MEMORANDUM

Date: December 3, 2024
To: Danielle Hankins – Harford County Department of Public Works
From: Heaven Aziz – RK&K
CC: Andrew Bodt – Harford County Department of Public Works
Kate Gordon – RK&K
Re: Harford County Fall 2024 Gunpowder Valley Conservancy Tree Planting Site Inspections

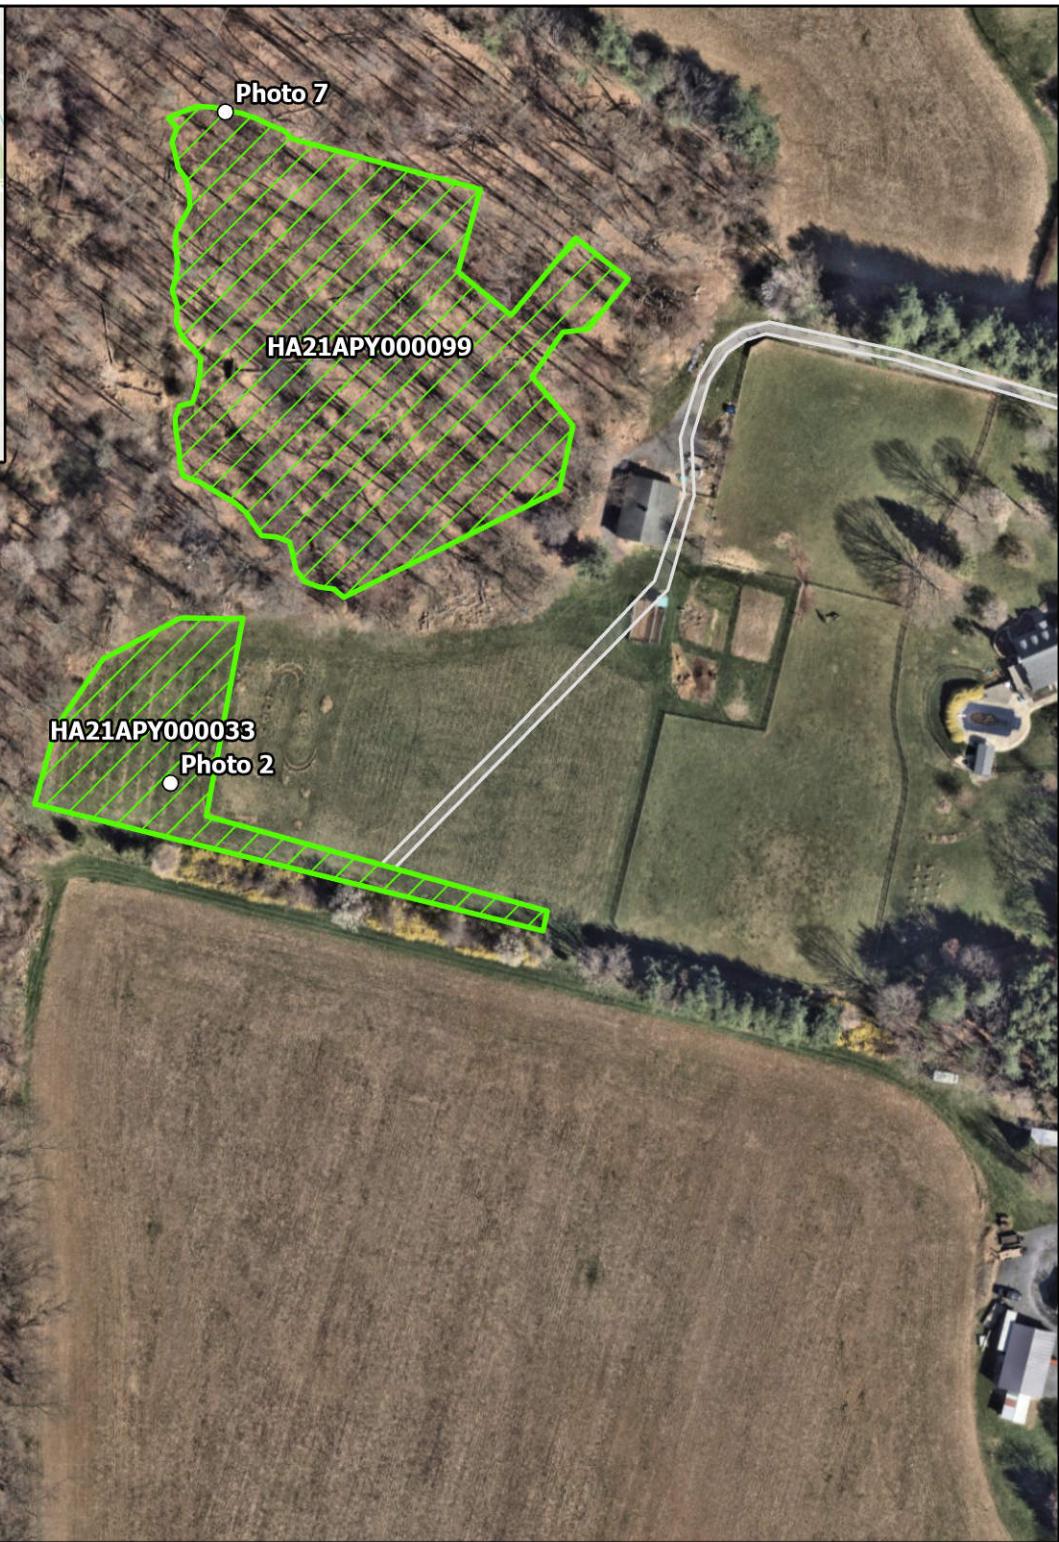
BMP Type: Forest Planting
Total Trees: 126
Trees per Acre: 227
Planted Acres: 0.56
Total IA Credit: 0.61
Site Condition: Functioning
Inspection Method: Total Site Count
Understory: Maintained Turf
General Comments: Site doing well overall. Some small gaps in survival but trees are generally 6-15' tall. Site is actively maintained and mowed. Landowner interested in additional planting.
Maintenance Comments: Re-stake and re-shelter.
Owner Type: Homeowner

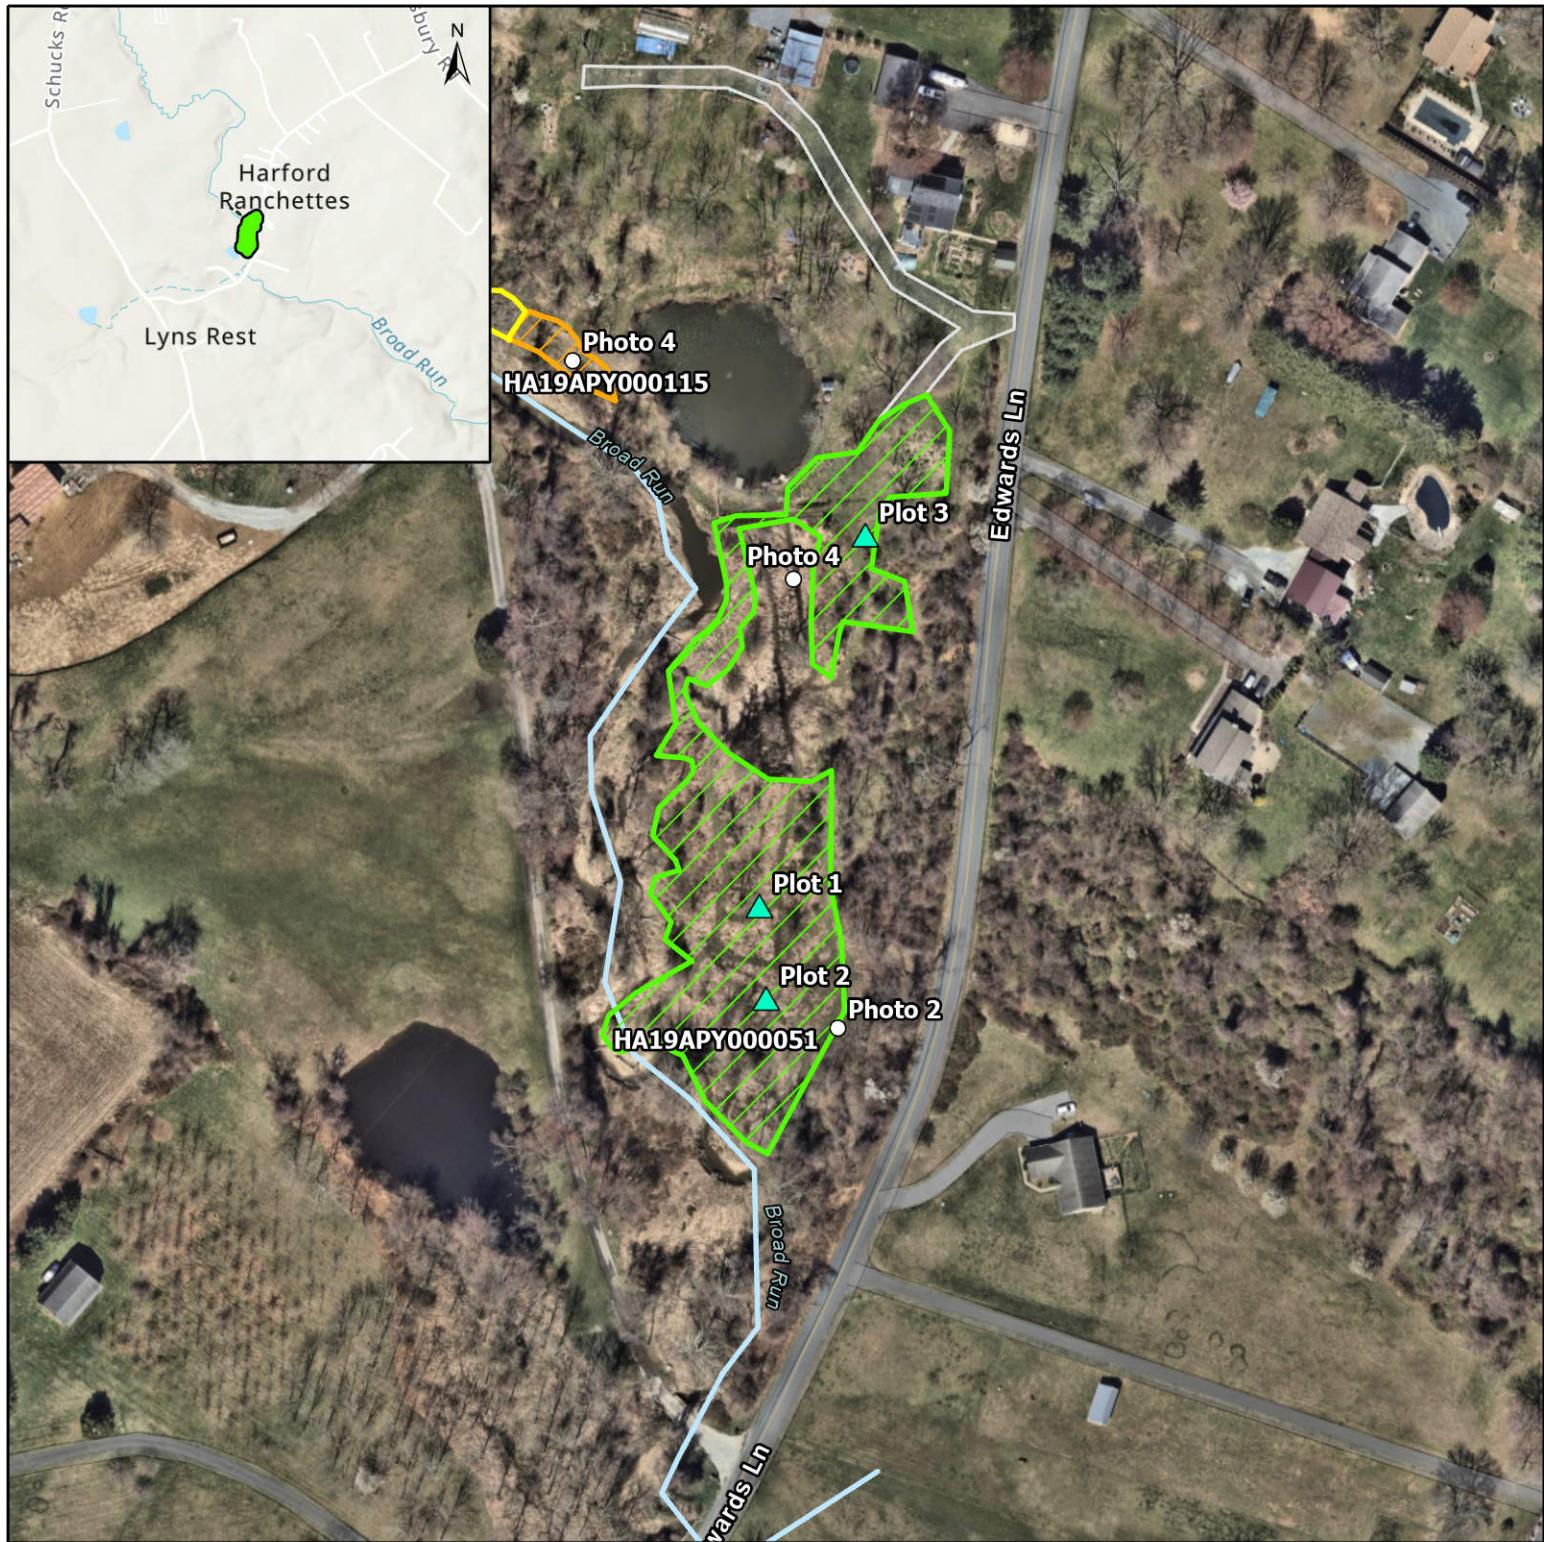
BMP Type: Forest Planting
Total Trees: 3
Trees per Acre: 60
Planted Acres: 1.24
Total IA Credit: 1.37
Site Condition: Not Functioning
Inspection Method: 0.05 Acre Plots
Understory: Unmanaged
General Comments: Active floodplain with wetland conditions beginning at toe of slope. Appears to be maintained due to lack of invasive woody species. Entire site could use infill with wetland species like sycamore, river birch, black willow, willow oak, and swamp white oak.
Maintenance Comments: Conduct infill planting throughout. Clear plant debris as needed for access.
Owner Type: Homeowner

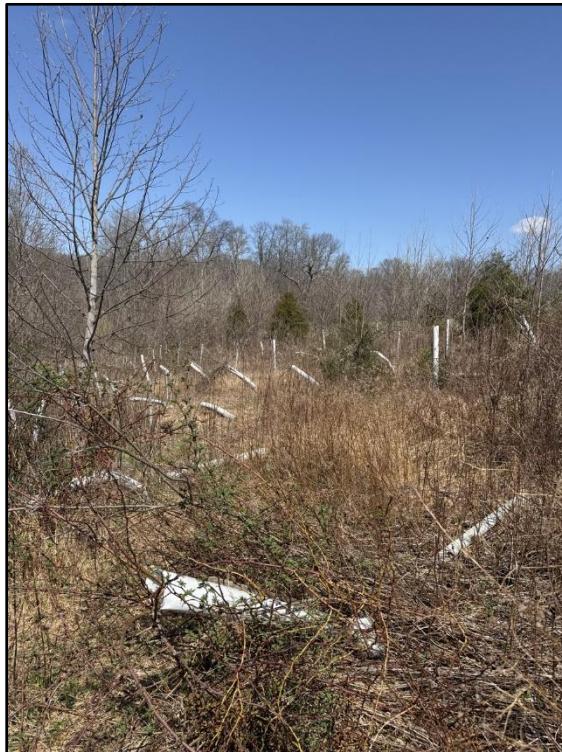
Special Concern Photo 1: Windthrow damage.

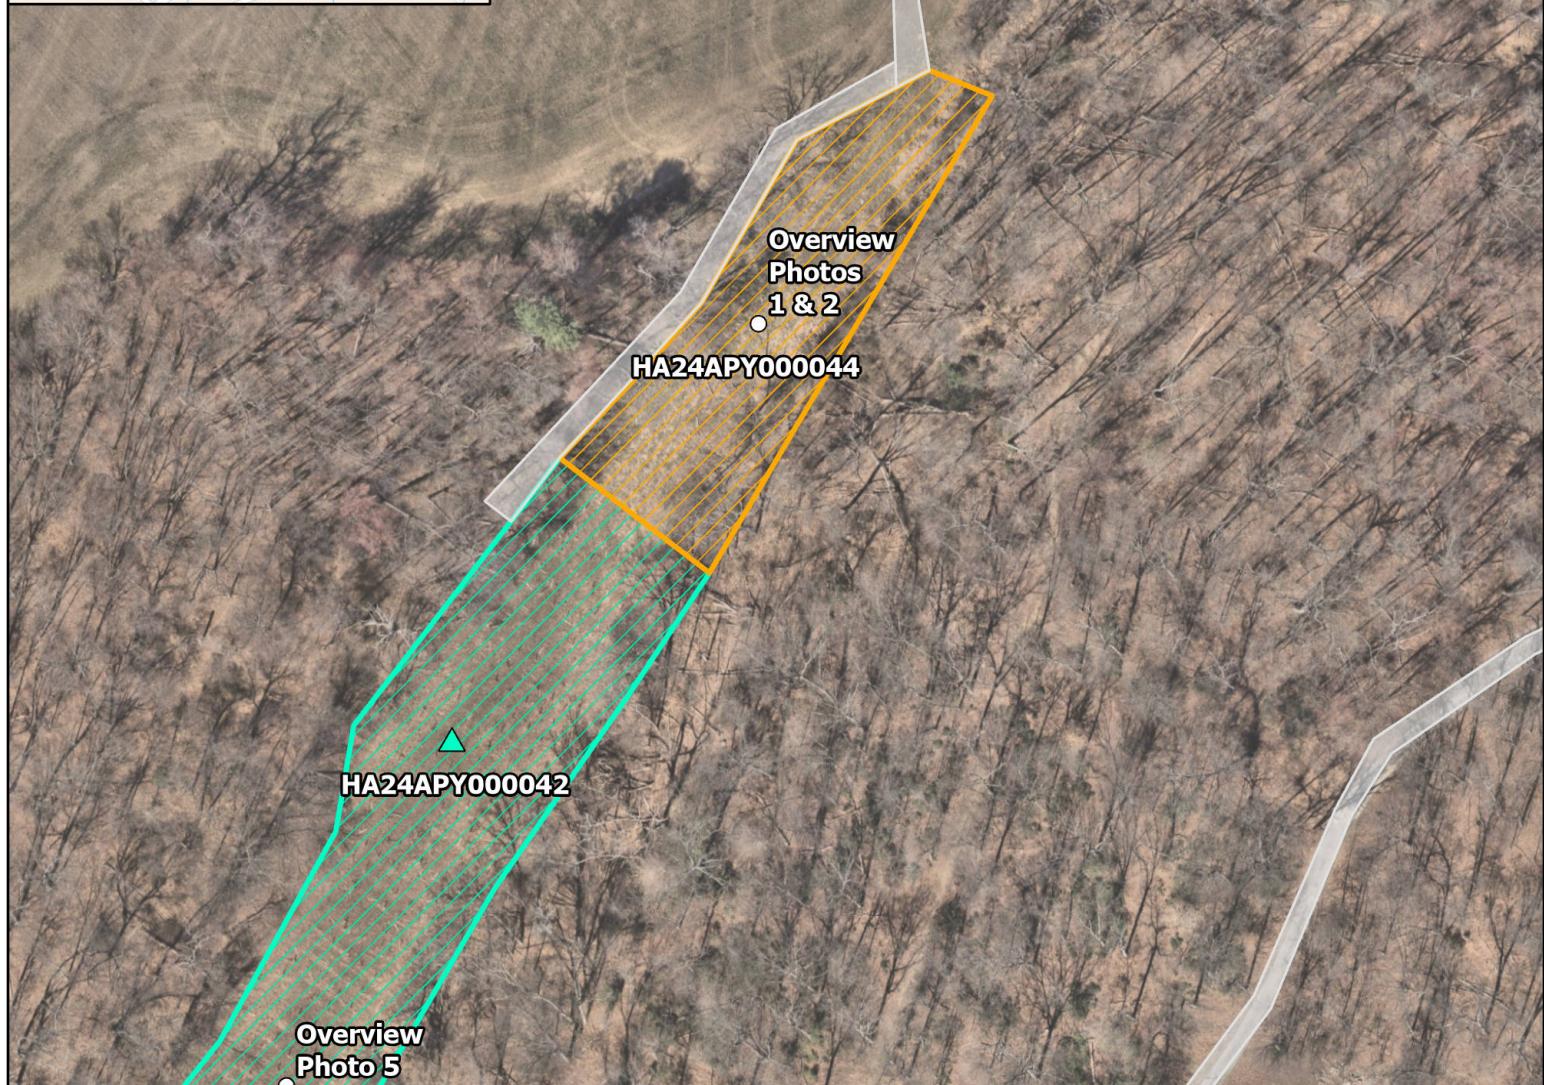
BMP Type: Urban Tree Canopy
Total Trees: 6
Trees per Acre: 12
Planted Acres: 0.48
Total IA Credit: 0.13
Site Condition: Not Functioning
Inspection Method: Total Site Count
Understory: Maintained Turf
General Comments: Site has largely failed, complete replanting needed. Landowner mentioned that the forestry board oversaw the initial plantings.
Maintenance Requested: Yes
Maintenance Comments: Removal of invasive honeysuckle needed, followed by replanting/infill of entire site.
Owner Type: Homeowner

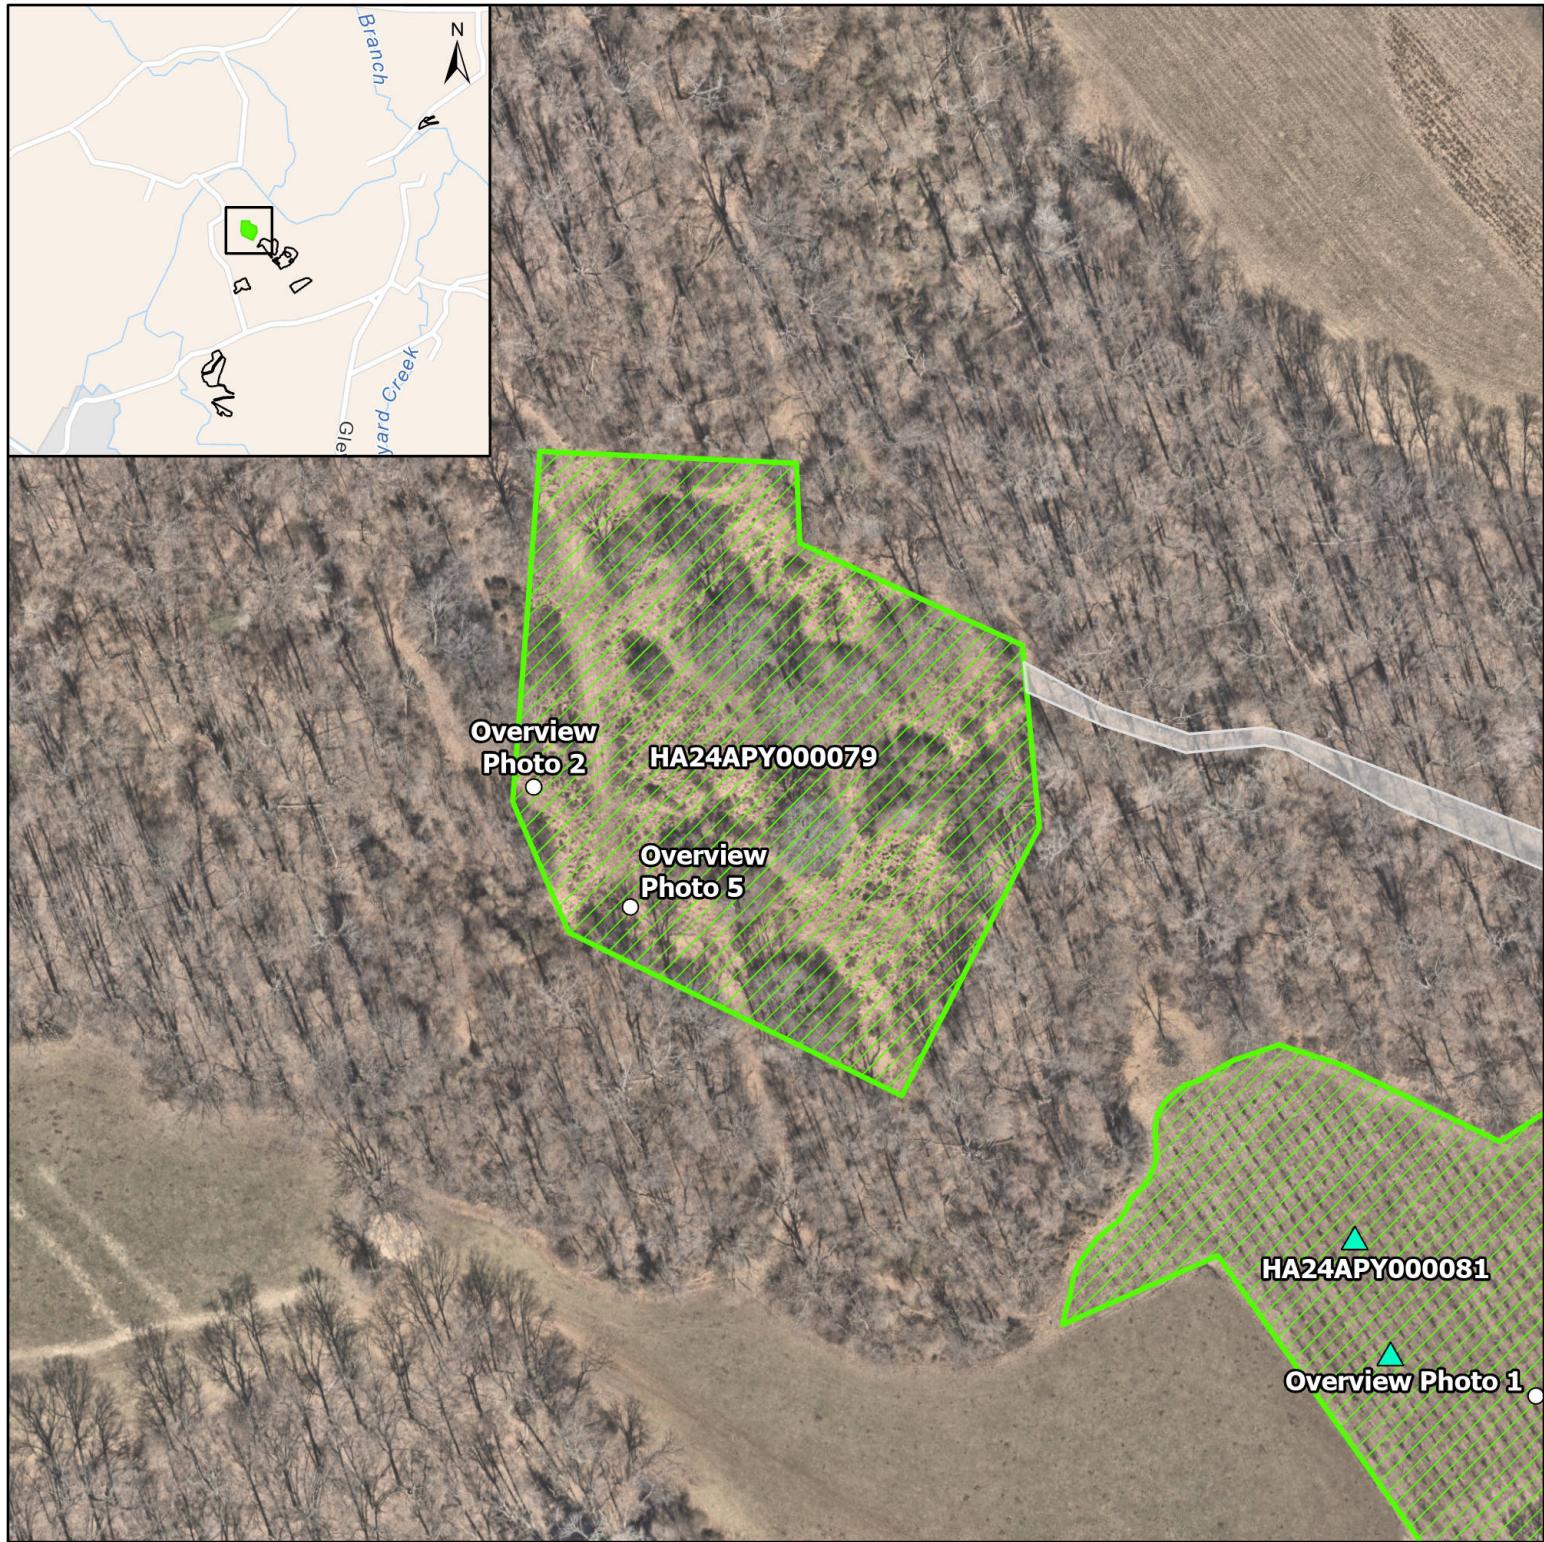
BMP Type: Forest Planting
Total Trees: 0
Trees per Acre:
Planted Acres: 3.33
Total IA Credit: 0.00
Site Condition: Does Not Exist
Inspection Method: 0.1 Acre Plots
Understory: Unmanaged
General Comments: Scrub shrub site that was never planted. Could be planted after heavy site clearing and prep. Steep slopes present, likely old ag field with poor soils. Some large mature trees with understory around them. Heavy invasive presence. The Alliance may have plans to plant.
Maintenance Requested: Yes
Maintenance Comments: Full site clearing and heavy herbicide use. Brush hogs, hand tools, tank sprayer and backpacks
Owner Type: Homeowner

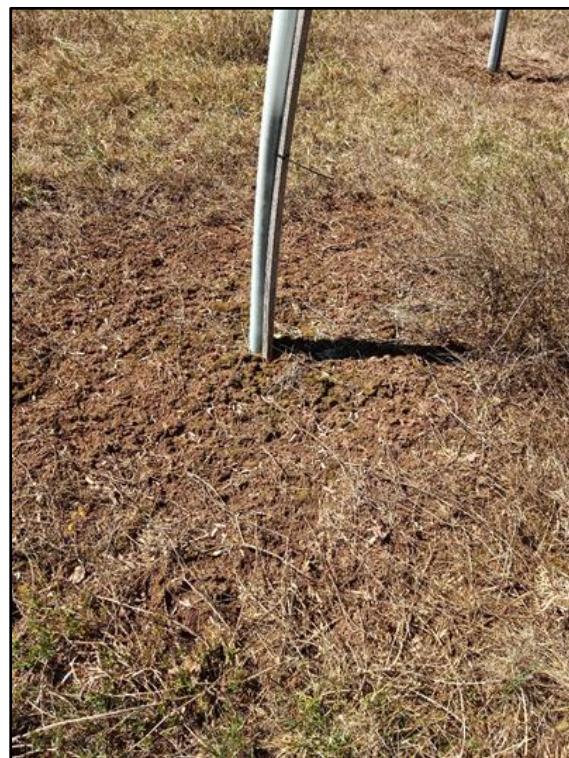
Special Concern Photo 1: Herbicide burn circle.
