Appendix E3 - Stormwater Restoration (Restoration Monitoring)

C. Milton Wright High School Stream Restoration Post Construction

Annual Monitoring Report – Year 3

Harford County, Maryland

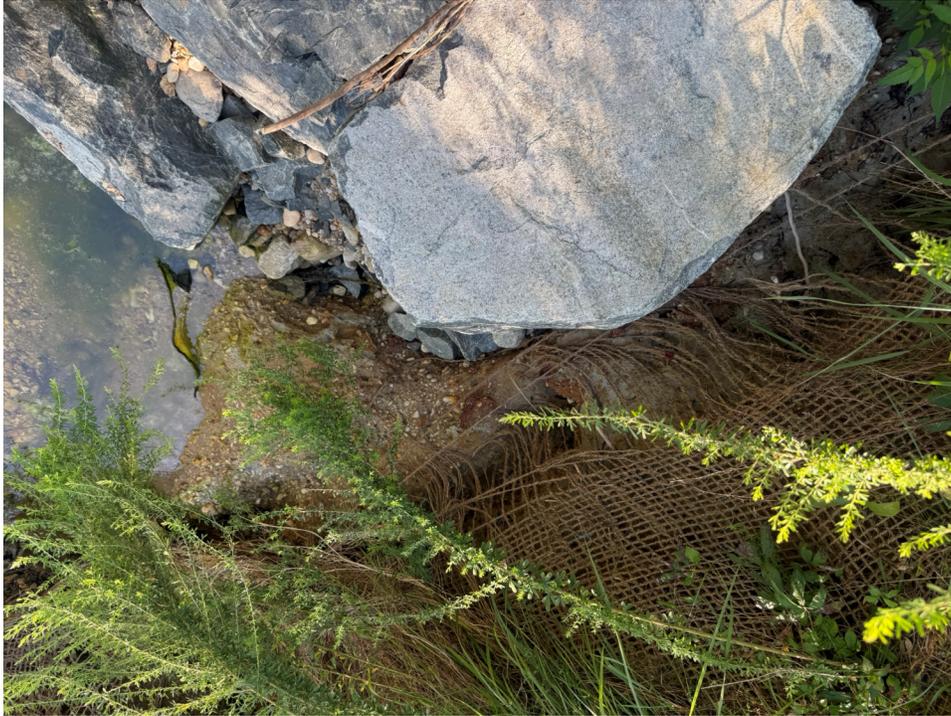
At the step pools SP-06 and SP-07, there was observed structural erosion called out in year 1 monitoring. The erosion appears to have worsened in year 2 with new erosion observed at SP-08 as well (Figures 5 and 6). End around erosion was observed around the step structures and undercutting of the banks. One structure on the left bank had a cavity of about 2 feet deep and 1 foot wide from the edge of the boulder tie-in to the exposed bank (Figure 5). There was little to no base flow at the time of monitoring, indicating that erosion likely occurs during flashy storm events. Remedial action is recommended to fill the voids and re-stabilize the structures and re-establish vegetated banks.

Figure 5: End around erosion around step boulder

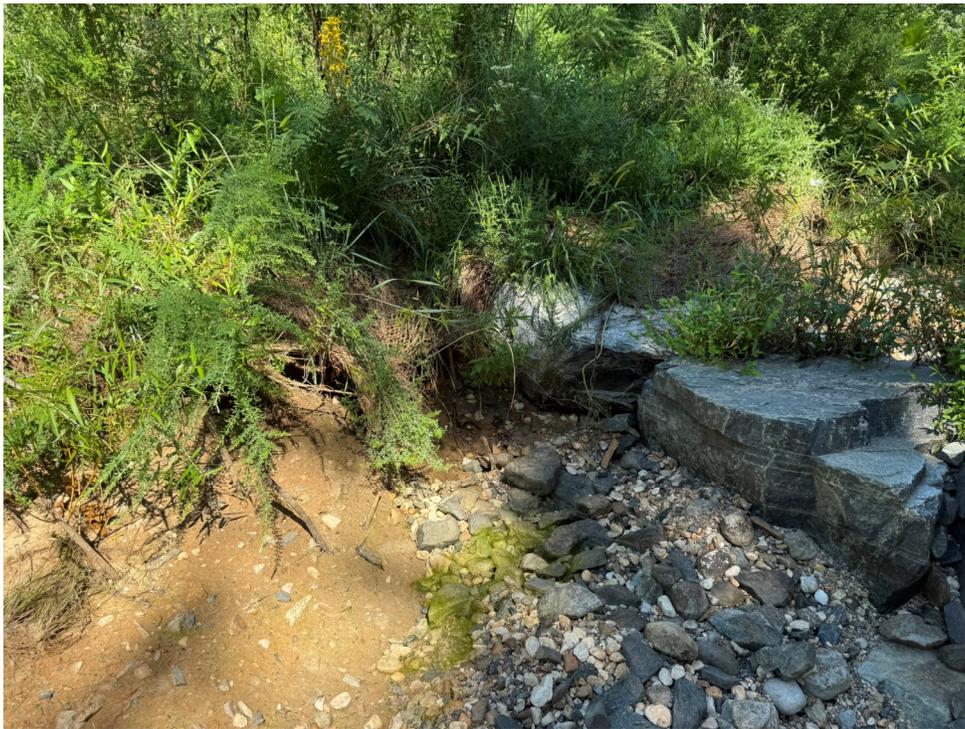
Figure 6: Erosion by step pool structures

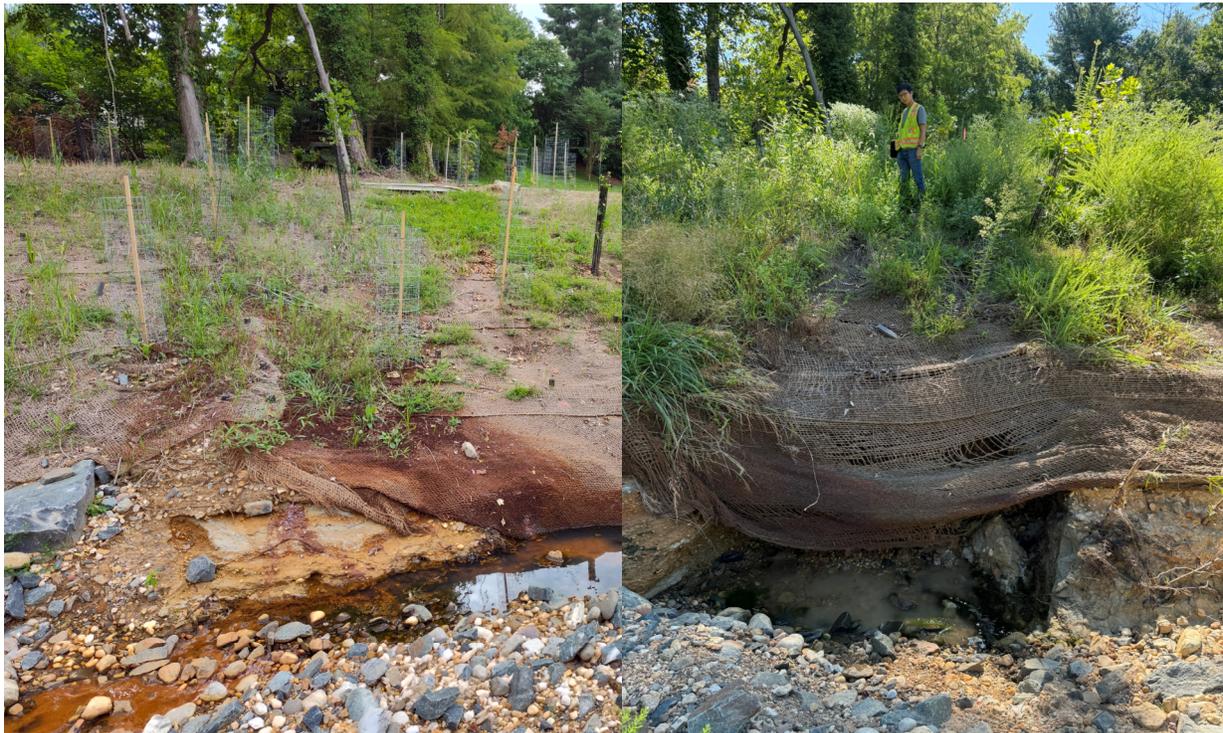
There is upland outfall drainage (labeled as 18" RCP on as-builts) or a hillside seep near STA 15+25 causing severe erosion on the left bank. Noted in year 1, conditions have visibly deteriorated in the past year. While the source of the water needs to be confirmed, it is eroding the soil beneath the coir fiber matting on the left bank - currently up to 3 feet from eroded surface to approximated original bank surface. Remedial action is recommended to confirm the cause of erosion, stabilize the bank, and prevent future erosion.

Figure 2: Severe bank erosion from hillside seep. 2024 conditions on left, 2025 conditions on right. Biohabitats team member standing near uphill extent of erosion.

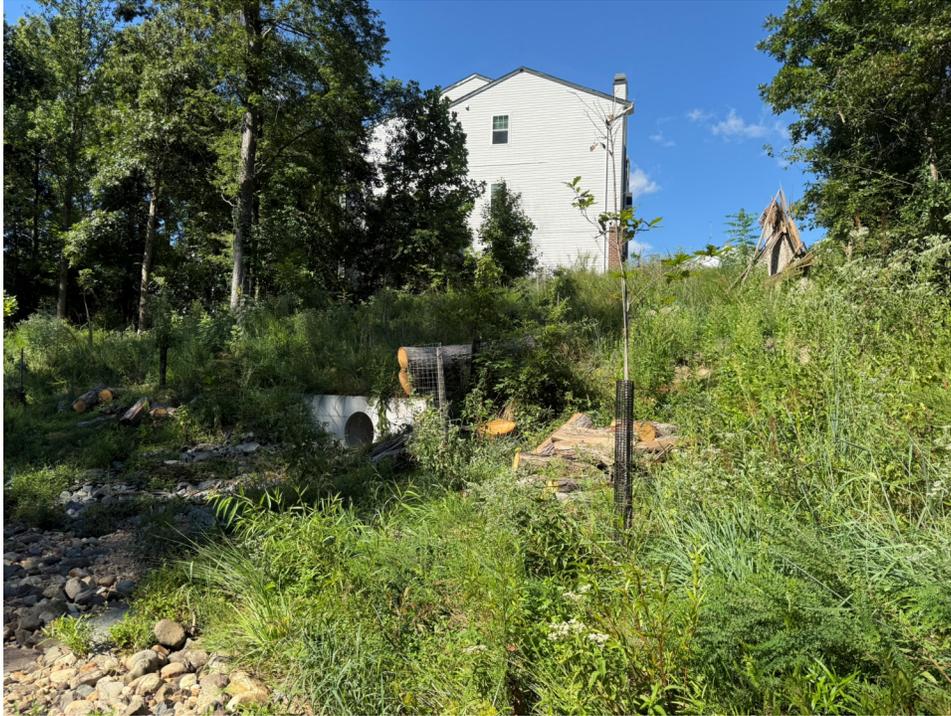
A recently fallen tree was observed at the outfall near as-built STA 16+75. Maintenance had occurred to cut the tree, but the logs remain scattered around either bank. See Figures 9 and 10 for photos. No impact to the stream or plantings were observed. No remedial action is recommended, although cleanup of the debris can be undertaken if desired by the County.

Figure 3: Downed tree and remains on left bank

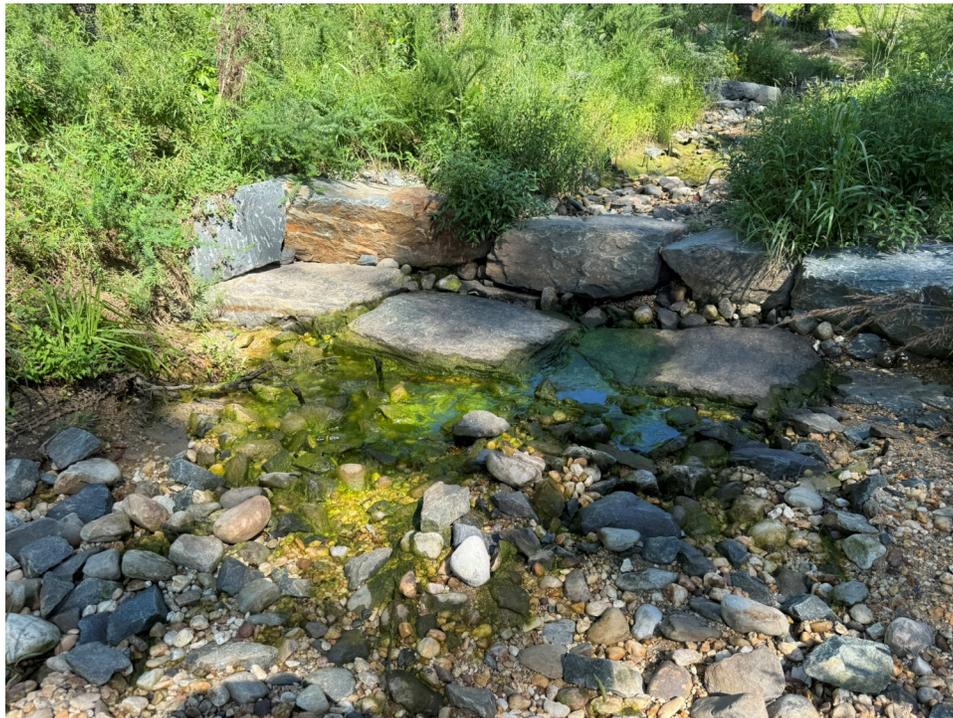
Stream baseflow was low during year 2 monitoring. However, this is one site visit during the summer occurred following approximately two weeks without rain. One section in Reach 4 from around STA 13+75 to STA 17+80 had no baseflow. Iron flocculate and algal growth was observed in the stream and pools, indicative of the low flow rate (Figures 11 and 12). Although unsightly, the iron floc is likely due to natural occurrence of dissolved iron in the system. Its persistence however means that it is not naturally broken up or washed away by stream flow. This suggests that the stream regularly has a low flow rate.

Figure 5: Green algae in dry downstream pool

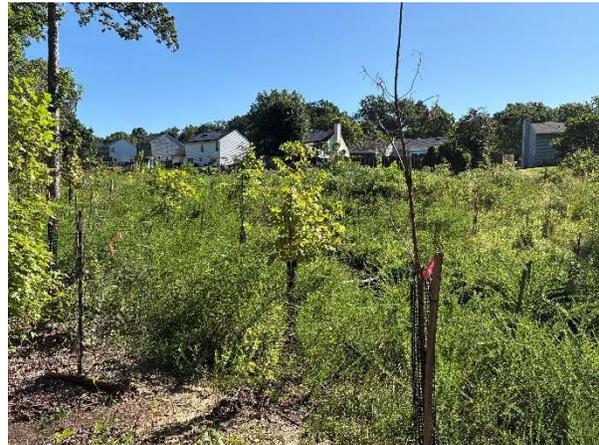
Photo Station 06 (2025): From top of right bank looking at stream, slightly upstream. Drainage channel still present on right of photo on the left bank that remains repaired and vegetated. Planted tree in forefront now dead. Houses on Declaration Circle in the background.

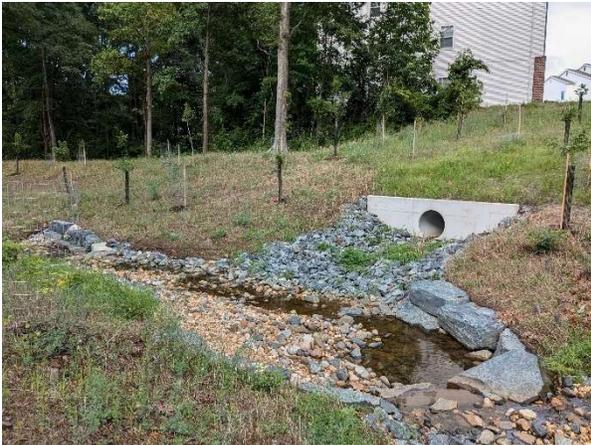
Photo Station 08 (2024): From left bank looking at stabilized banks and repaired right bank stormwater outfall. Gravel sediment bar in middle of channel is common across the stream.

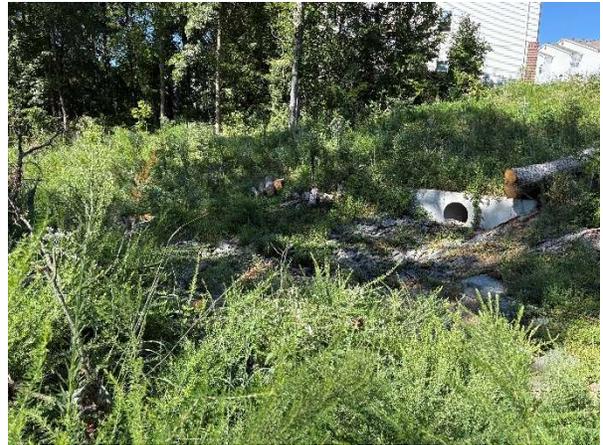
Photo Station 08 (2025): From left bank looking at stabilized banks and repaired right bank stormwater outfall. Instream bars now vegetated and common across stream. Large tree fall at outfall, but has been cut. Debris remains in pile on both banks.

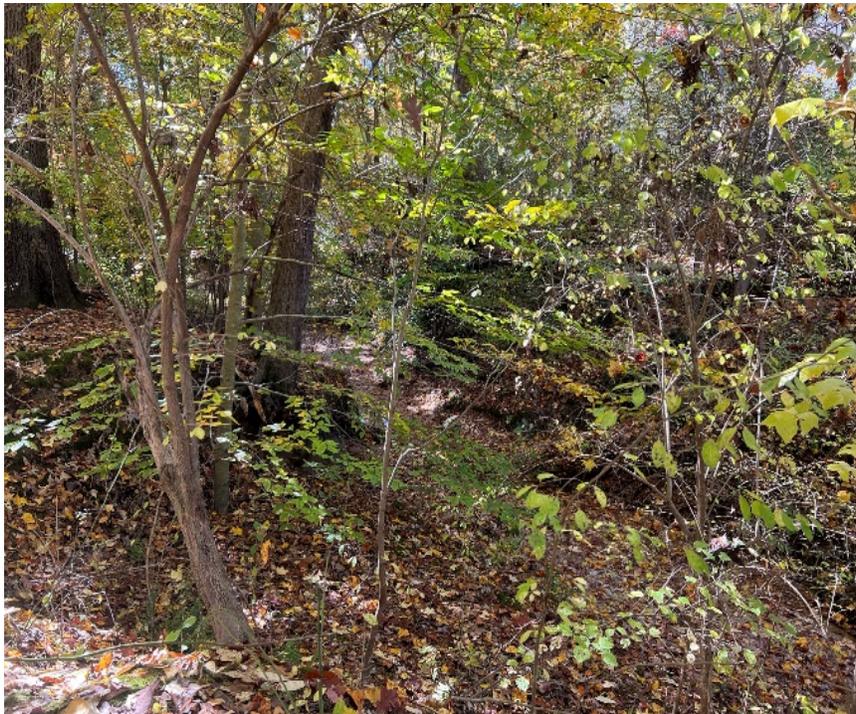
08_Overview Photo: Deeply incised and eroded intermittent channel. Damaged stormwater outfall with actively eroding channel entering right bank. Channel top width is approximately 42 feet and bottom width is approximately 12 feet. Stream banks are often vertical, exceeding 10 feet in height.

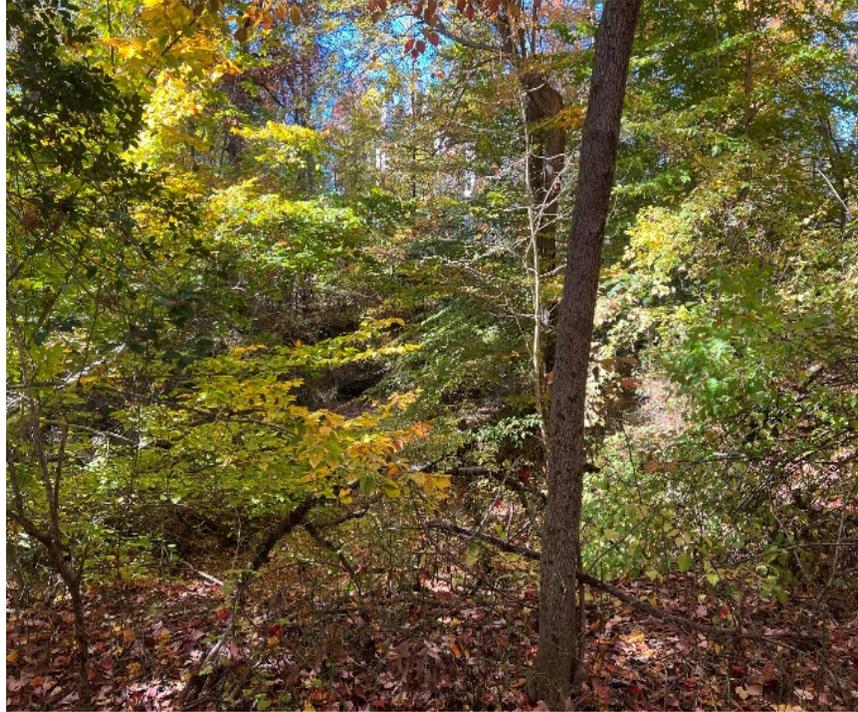
09_Overview Photo: Deeply incised and eroded intermittent channel at two meander bends. Channel has widened and deposition is occurring along the margins of the channel. Channel top width is approximately 42 feet and bottom width is approximately 12 feet. Stream banks are often vertical, exceeding 10 feet in height.
