HARFORD COUNTY

# HISTORIC PRESERVATION DESIGN GUIDELINES

## 2022 EDITION

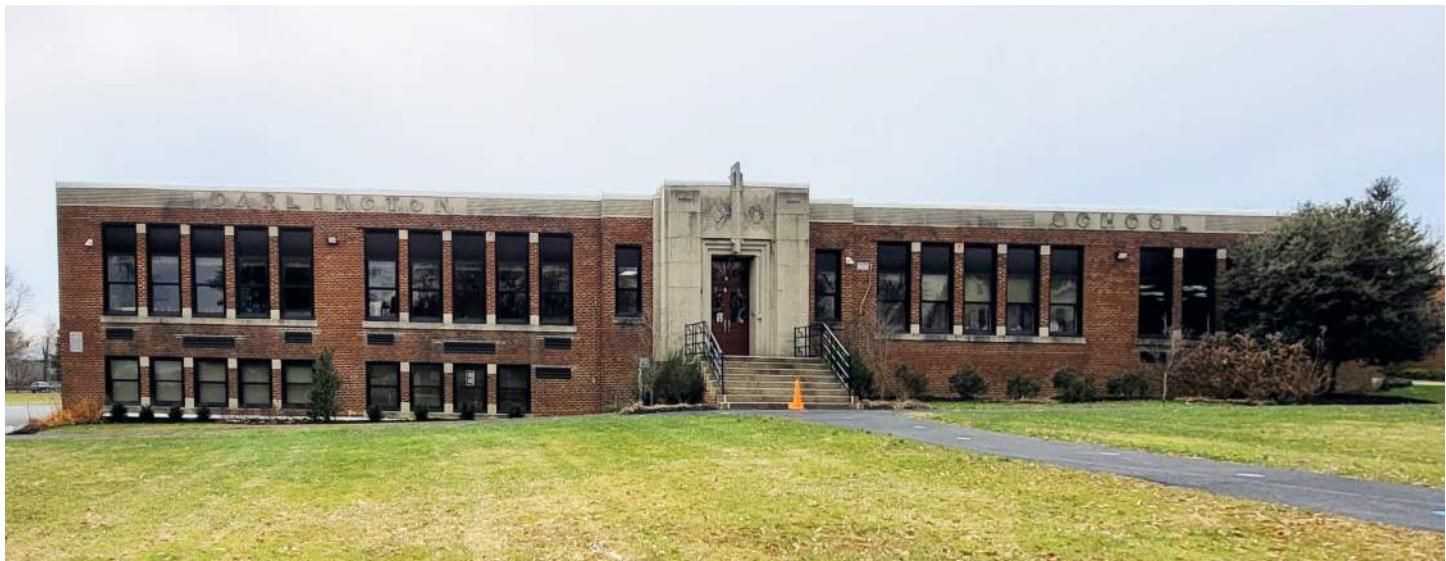
*Darlington Elementary School, 1938 (HA-2179), Darlington. An example of window repetition and spacing used to produce a regular rhythm along the primary elevation.*

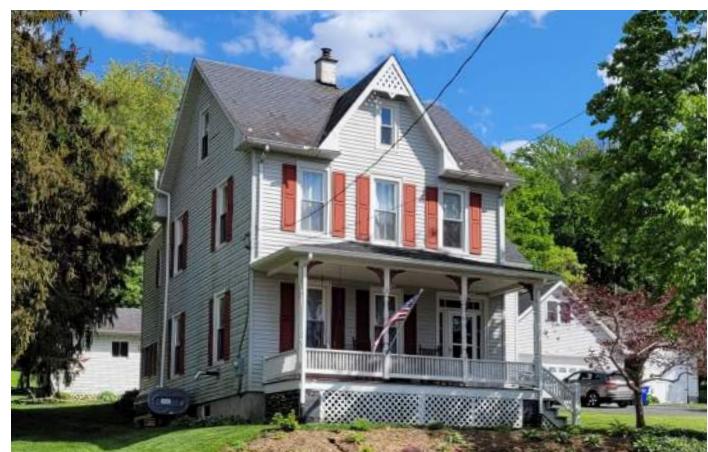
*The cross gable centered over the two-story William M. Williams House, c. 1895 (HA-1922), Cardiff gives the impression of great mass overlooking the street.*

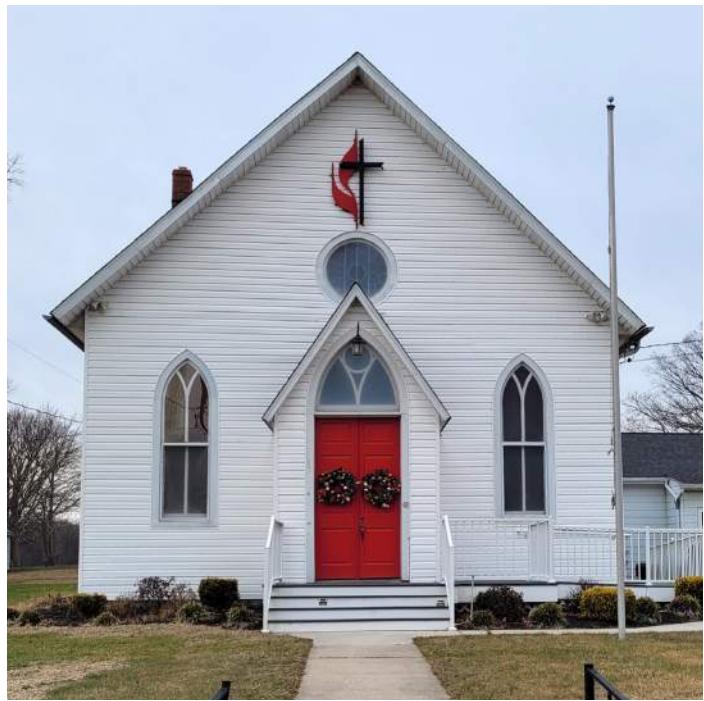
*Cranberry United Methodist Church, c. 1888 (HA-1665), Perryman has a front entrance door and flanking windows that are sized proportionately to the overall front elevation.*

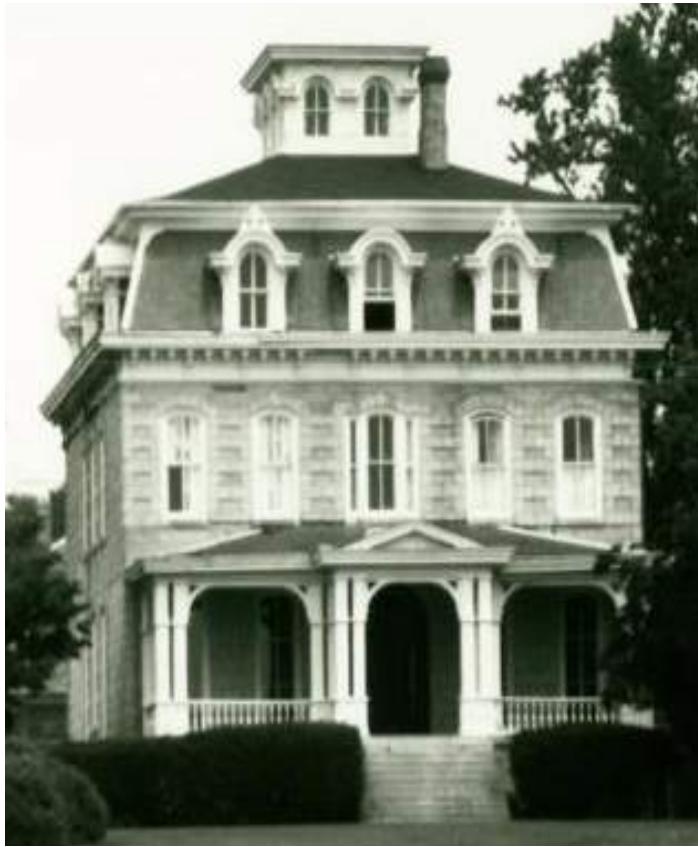
The mansard roof of Fair Meadows, 1868 (HA-1067), Creswell (no longer extant) includes dormers with rounded tops and a cupola at the top. HCG File Photo.

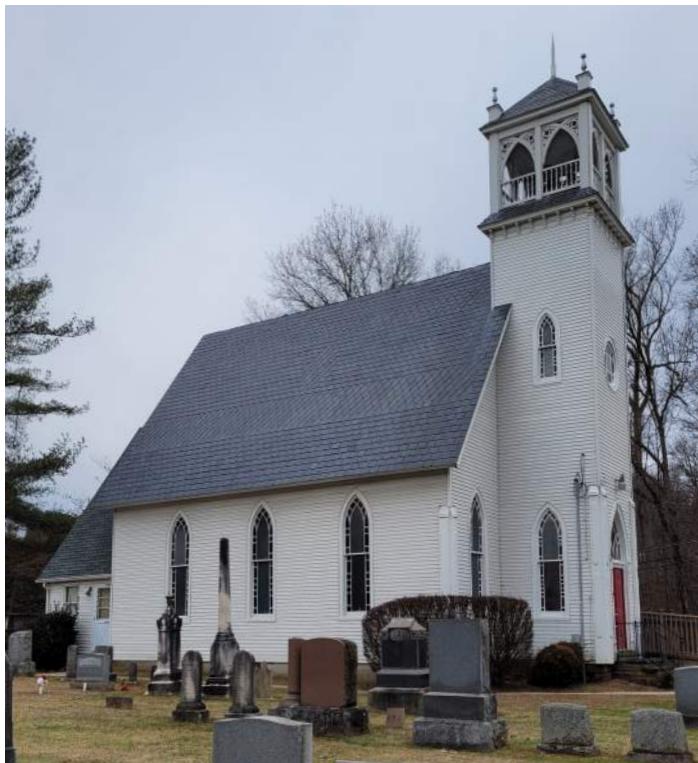
Ayres Chapel, 1896 (HA-461), Norrisville has a steeply sloped slate roof and unique belfry over the entrance.

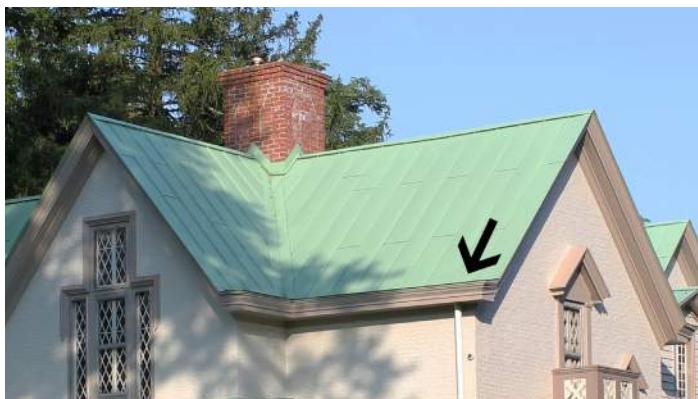
*Tudor Hall, 1847 (HA-117), Bel Air has a built-in gutter system. HCG File Photo.*

Original built-in gutters that are failing should be repaired or rebuilt; replacing built-in gutters with an exposed edge-mounted type of gutter should not be done.

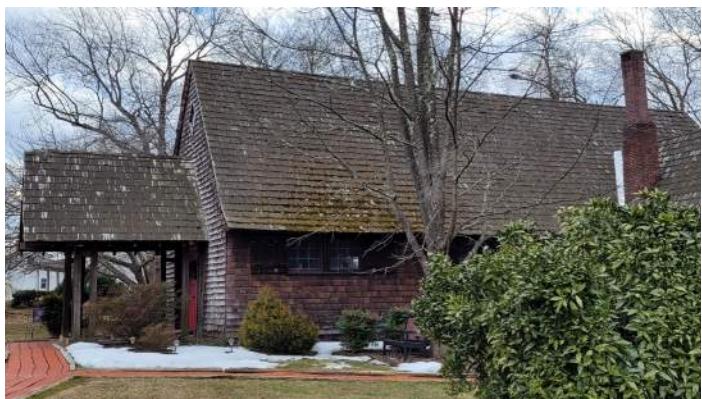
*Church of the Prince of Peace, 1908 (HA-617), Fallston has a chestnut shingle roof.*

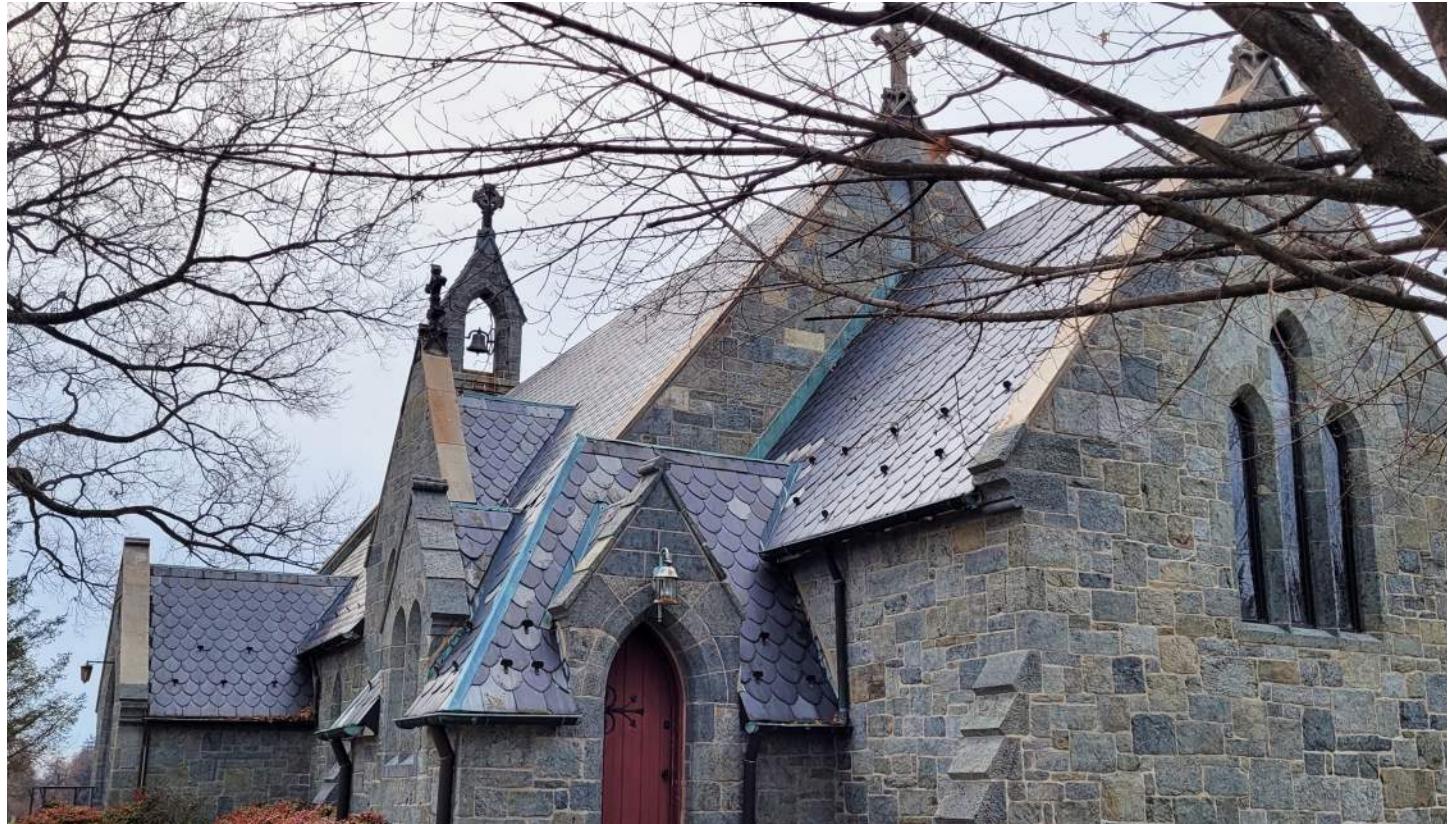
Grace Memorial Episcopal Church, 1876 (HA-78), Darlington has slate tile roofing.

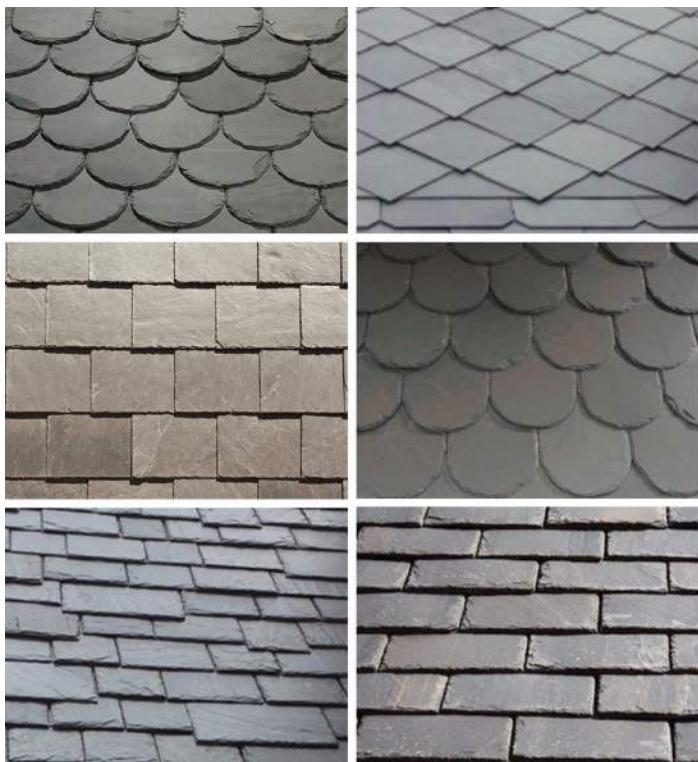
Examples of various slate roof tile shapes.

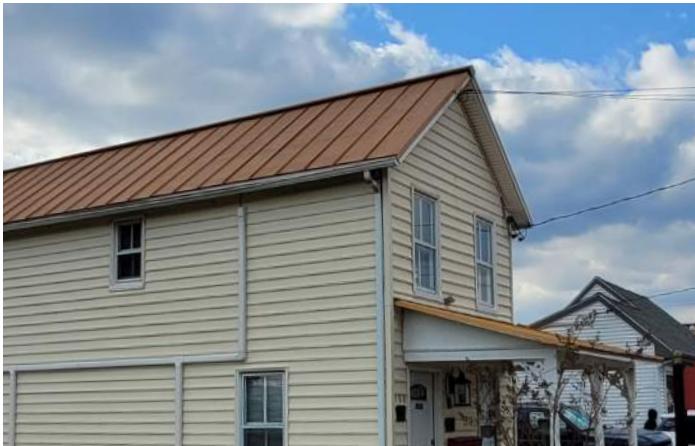
*James-Kennedy House, 1914 (HA-1349), Bel Air has a standing seam metal roof.*

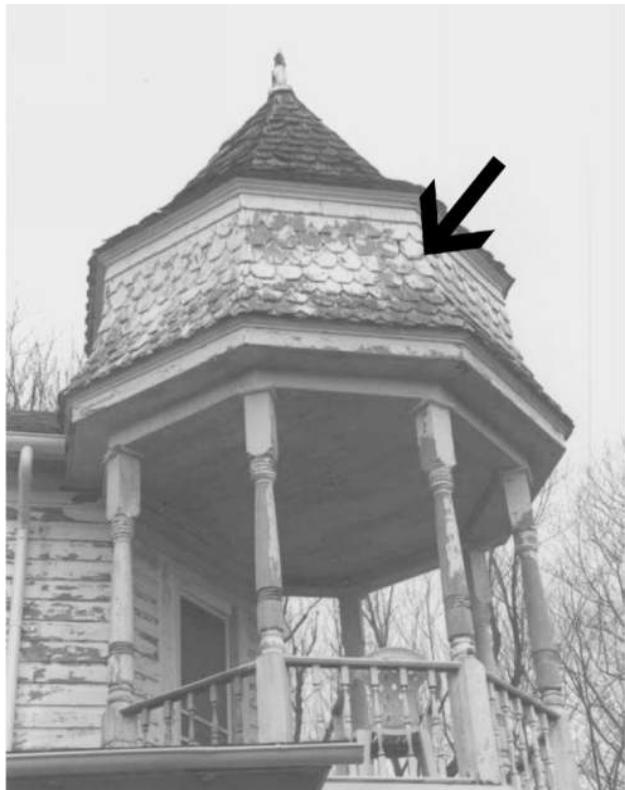
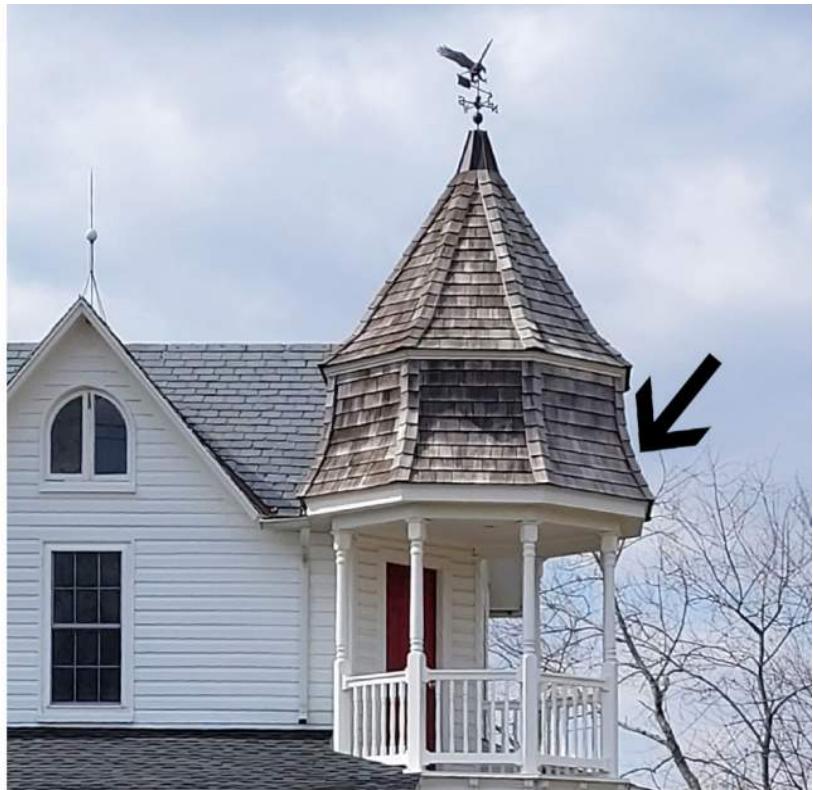
Edward L. Wilkinson Farm, late 19th century (HA-1569), Level (left image courtesy of Maryland Historical Trust). The roofing on the lower portion of the tower has been replaced with wood shingles matching the upper portion.

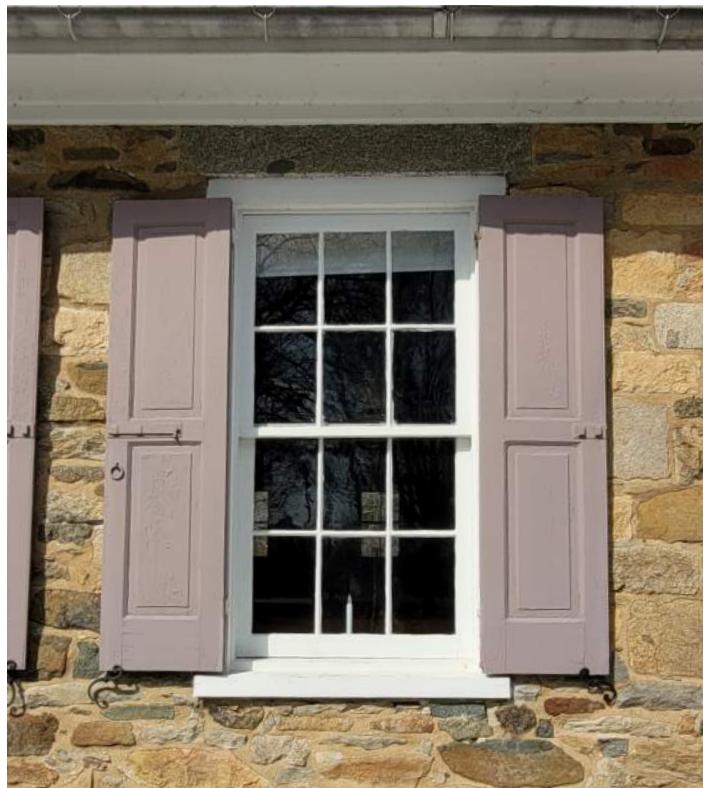
Deer Creek Friends Meeting House, 1784 (HA-12), Darlington has six-over-six double-hung wood sash windows.

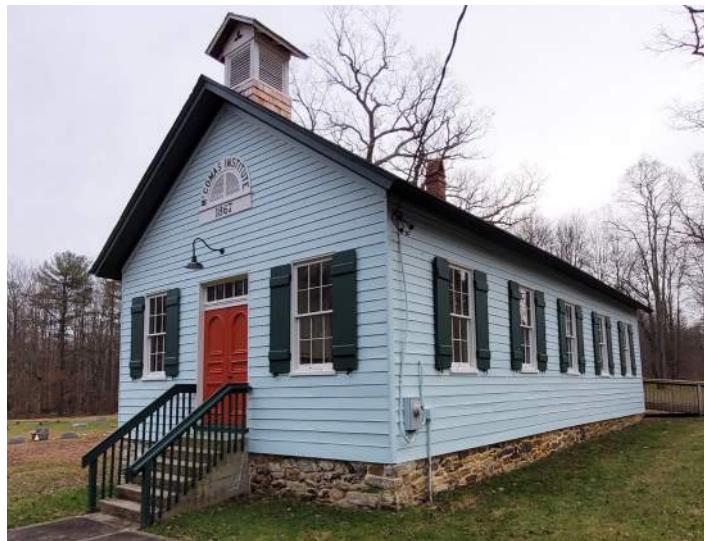
McComas Institute, 1867 (HA-307), Joppa has wood lap siding.

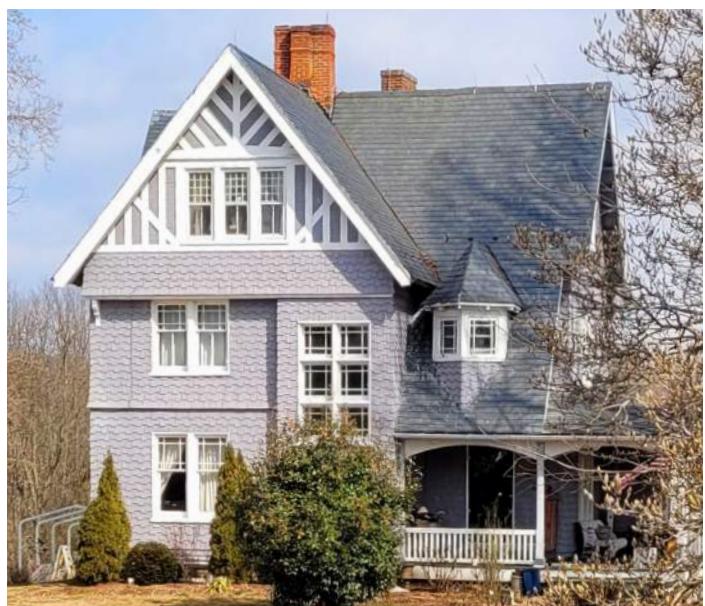
Gray Gables, c. 1885 (HA-310), Darlington has wood shingle siding and half-timbering decoration at the gables.

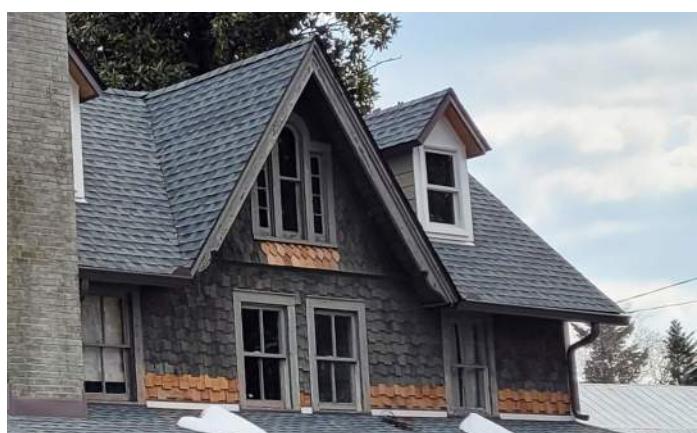
Wood shingle repairs to the Millstone Farm (HA-1693), Darlington.

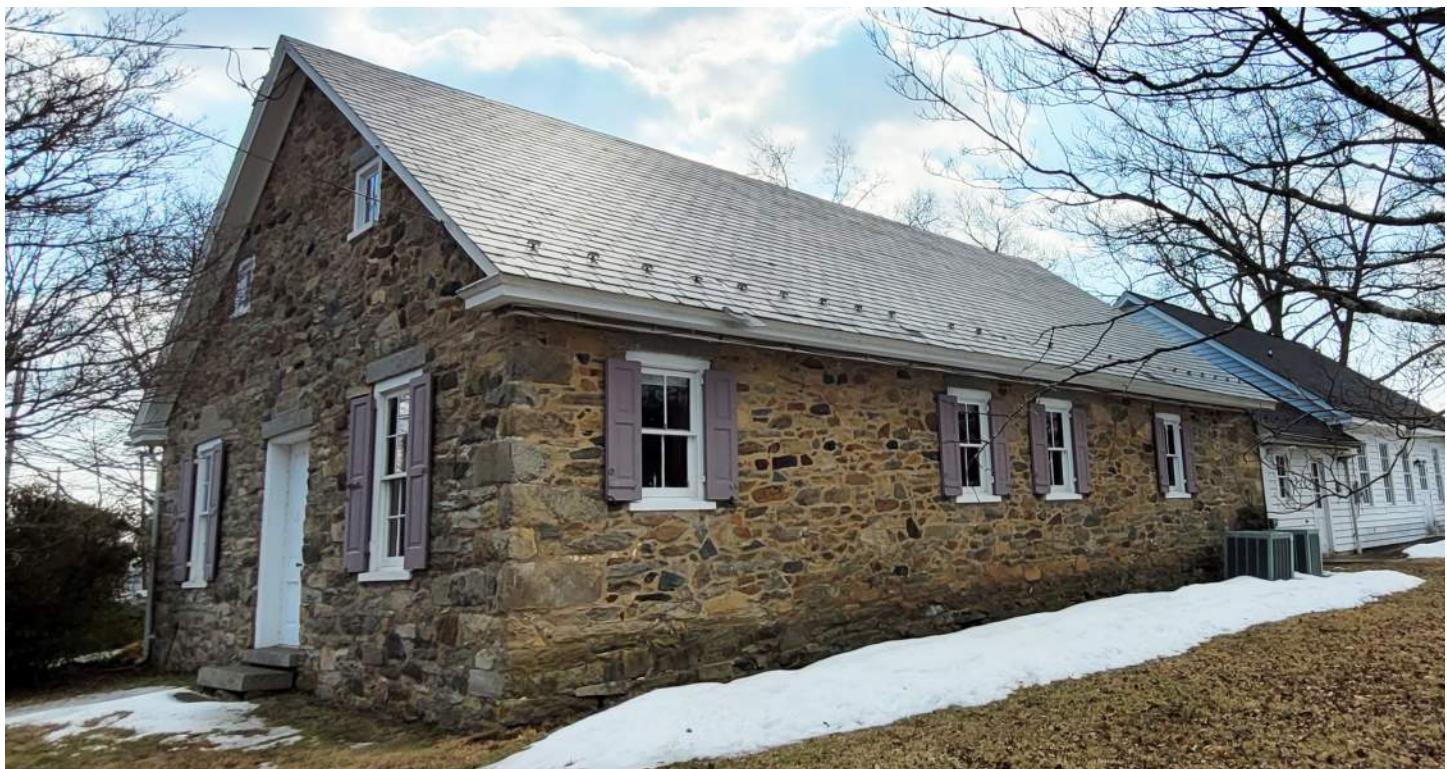
Deer Creek Friends Meeting House, 1784 (HA-12), Darlington has fieldstone walls.

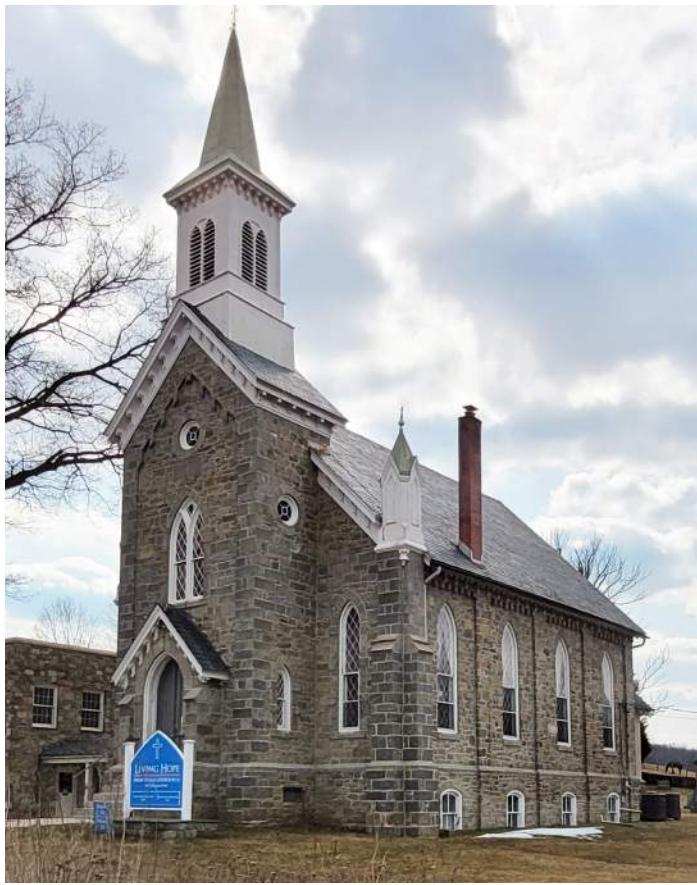
Deer Creek Harmony Presbyterian Church, 1867 (HA-165), Darlington has walls made of granite from the neighboring Susquehanna hills.

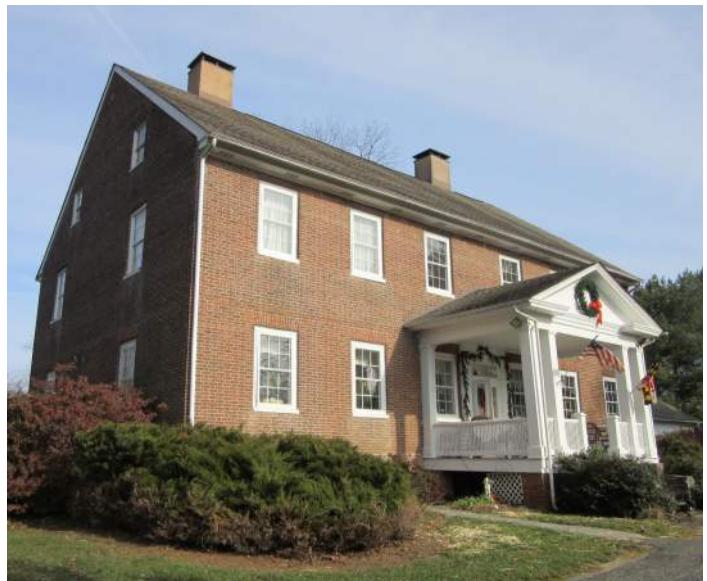
Sophia's Dairy, 1768 (HA-5), Belcamp is constructed of Flemish bond brick walls. HCG File Photo.

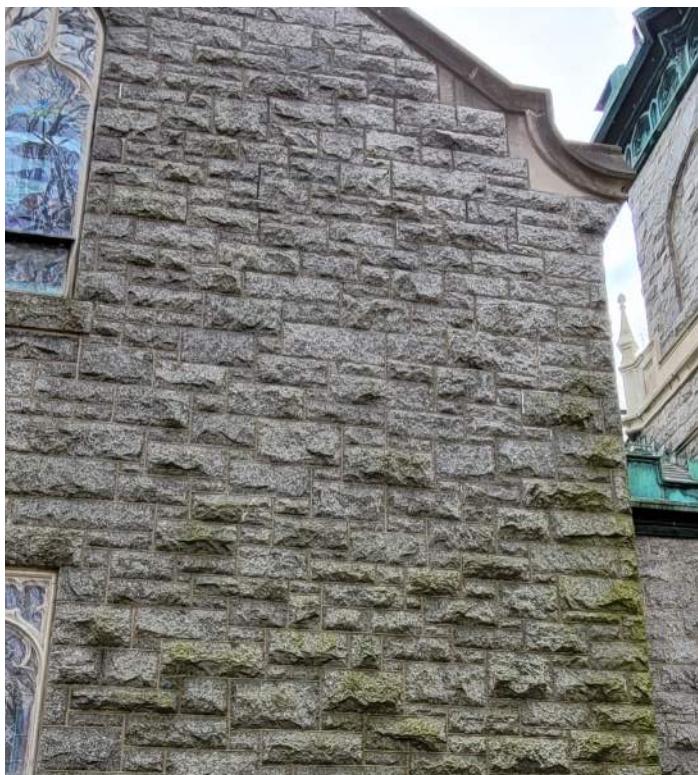
*Havre de Grace United Methodist Church, 1902 (HA-1125),  
Havre de Grace has rock-faced ashlar walls made of Port  
Deposit granite.*

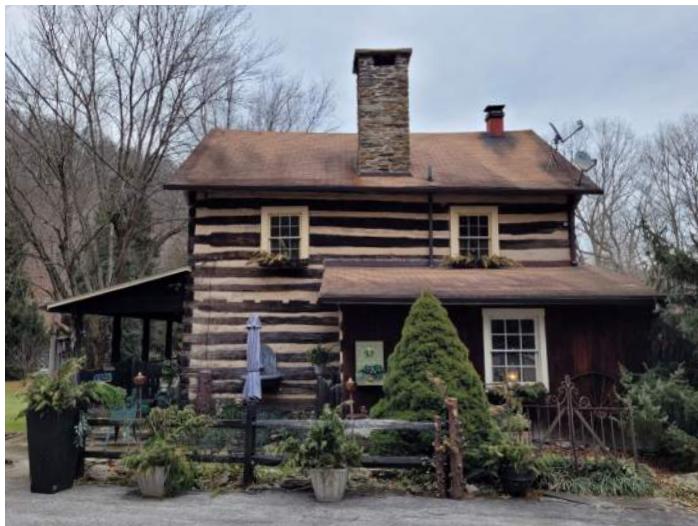
*Jolly Acres Old Mill, c. 1800 (HA-458), Norrisville is a two-story log building.*

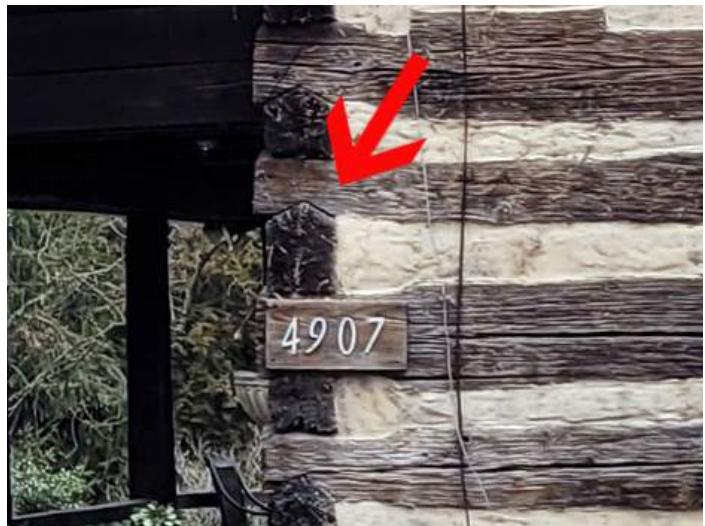
*The Jolly Acres Old Mill in Norrisville is constructed using "V" notching.*

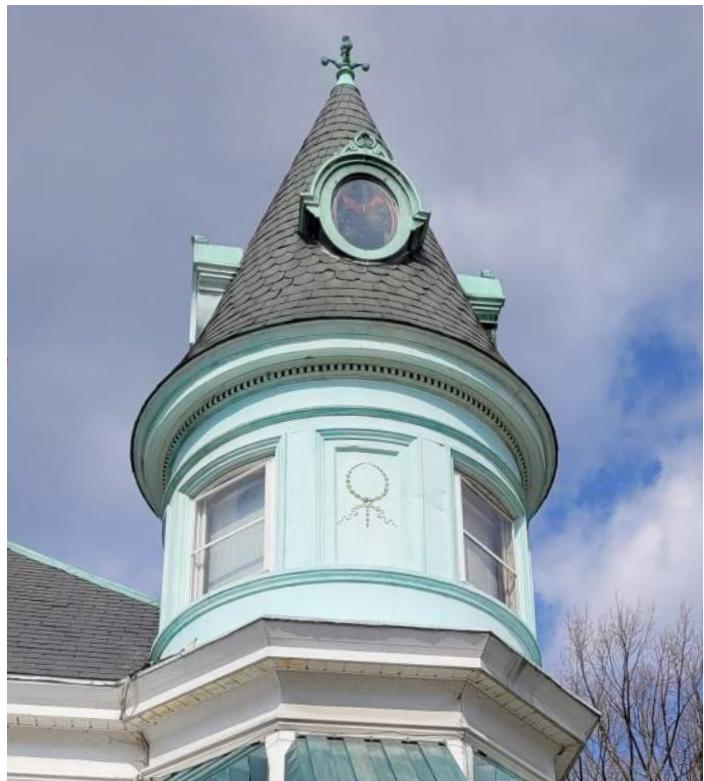
*Seneca Mansion, c. 1885 (HA-815), Havre de Grace has copper covered turrets and other decorative metal elements.*

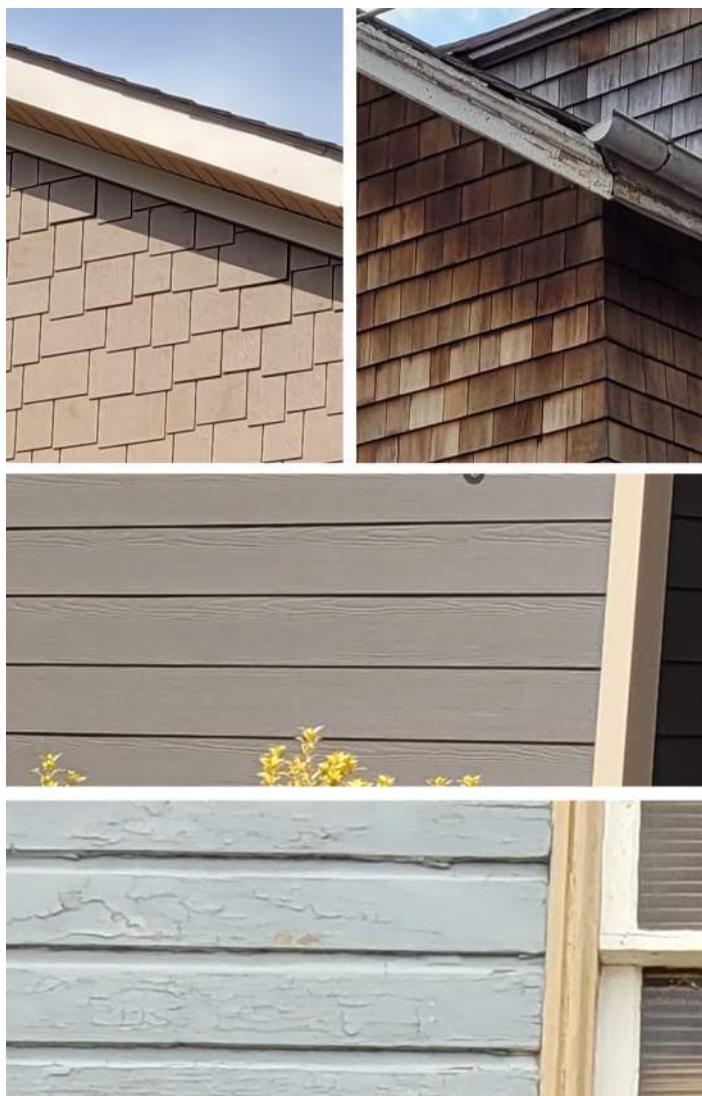
*Modern synthetic materials (upper left and middle) do not typically have the same texture and thickness as traditional materials.*

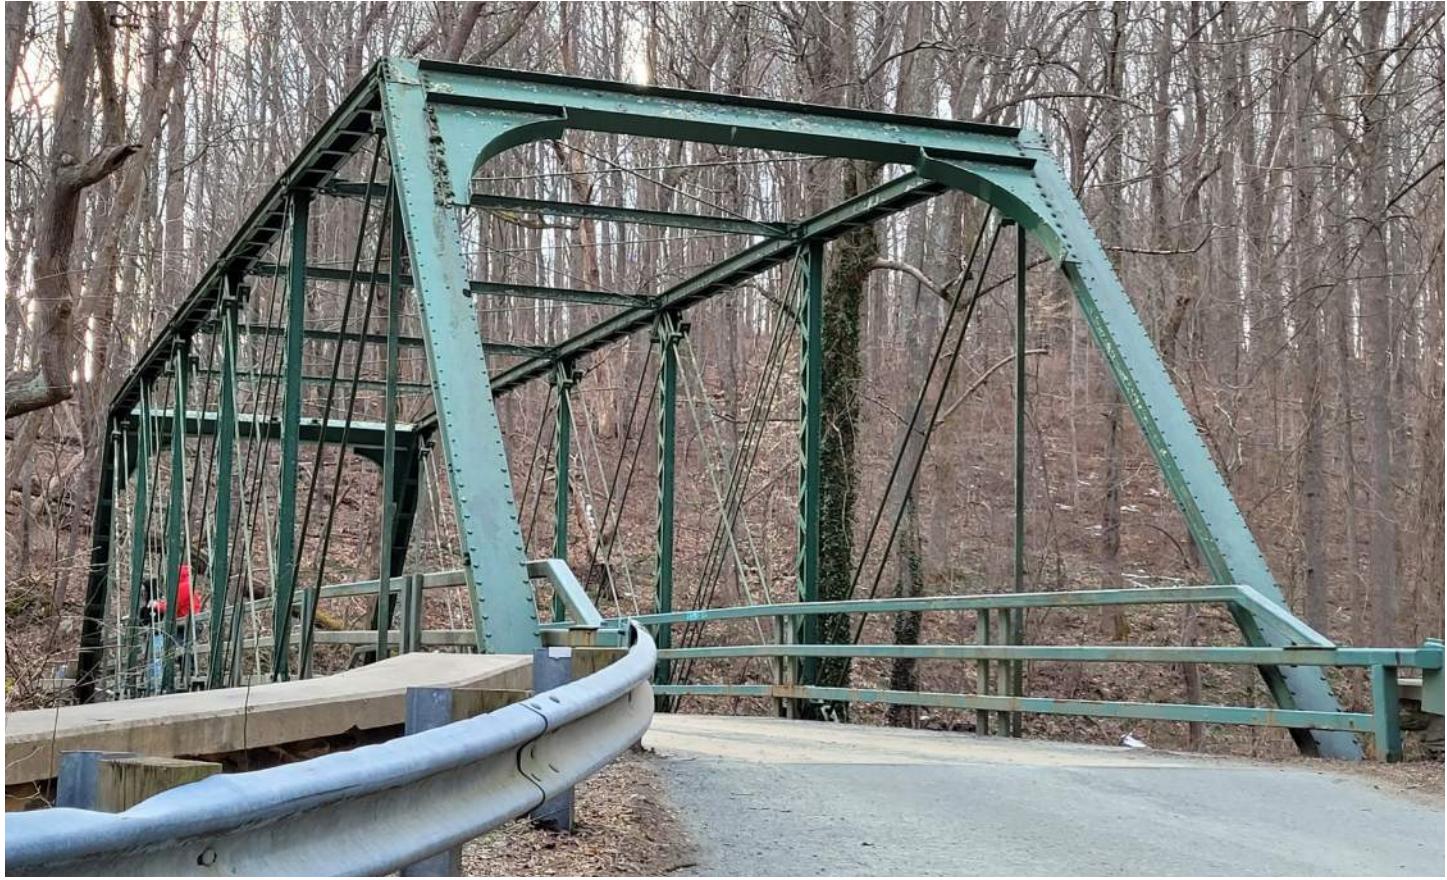
*Bottom Road Iron Bridge, 1886 (BA-961), Fallston is a wrought iron Pratt through truss.*

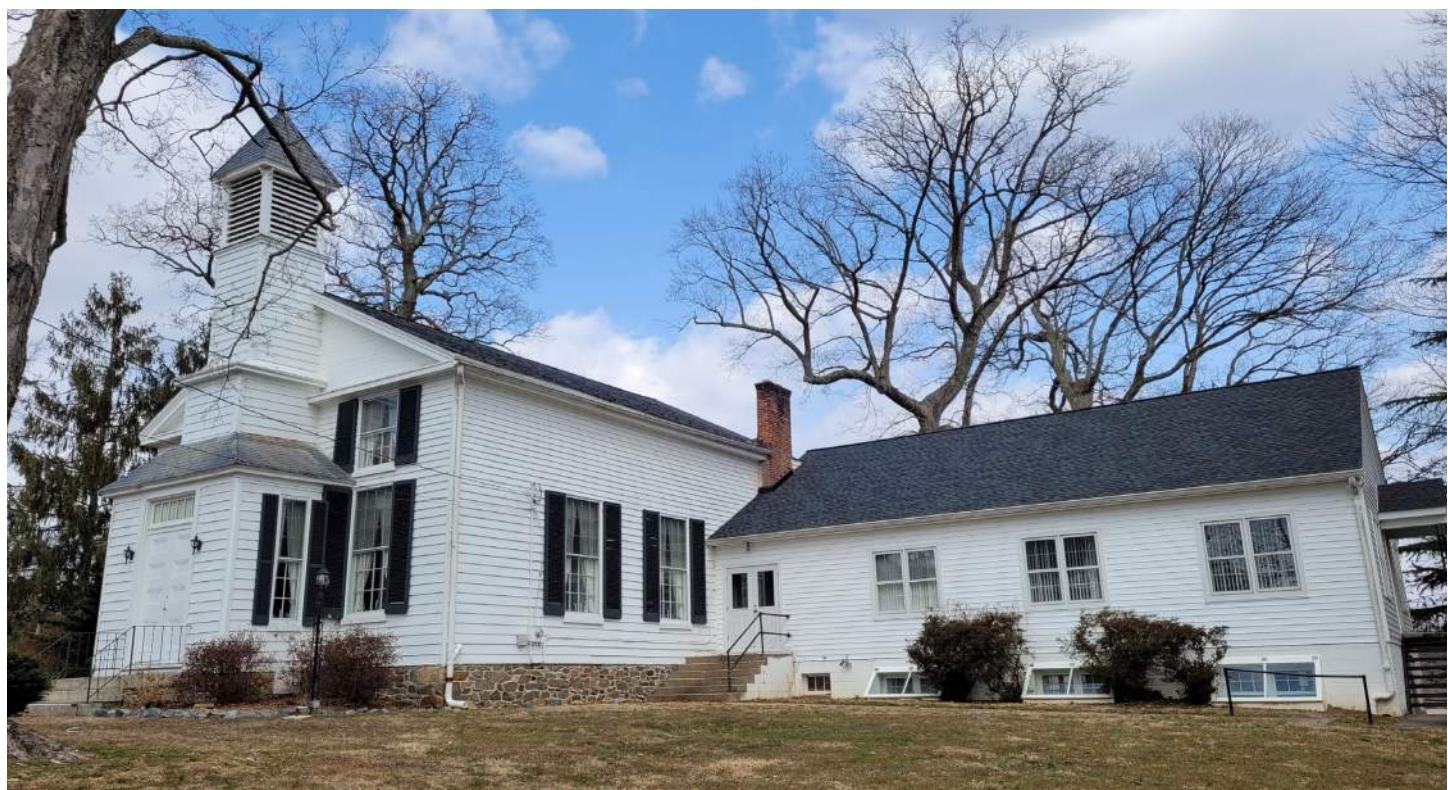
*The addition (right) to the Darlington United Methodist Church, 1852 (HA-24), Darlington is in keeping with the historic materials, but is distinguishable from the original building.*

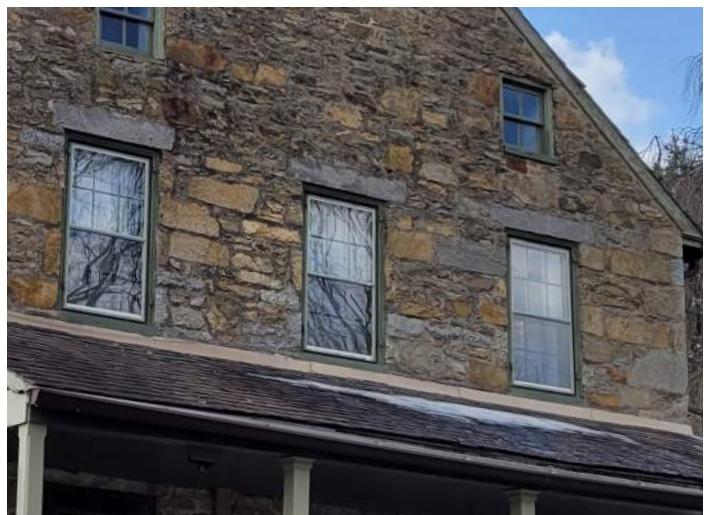
*Storm windows used at the Dr. Kirk House, c. 1745 (HA-21), Darlington do not obscure the windows within.*

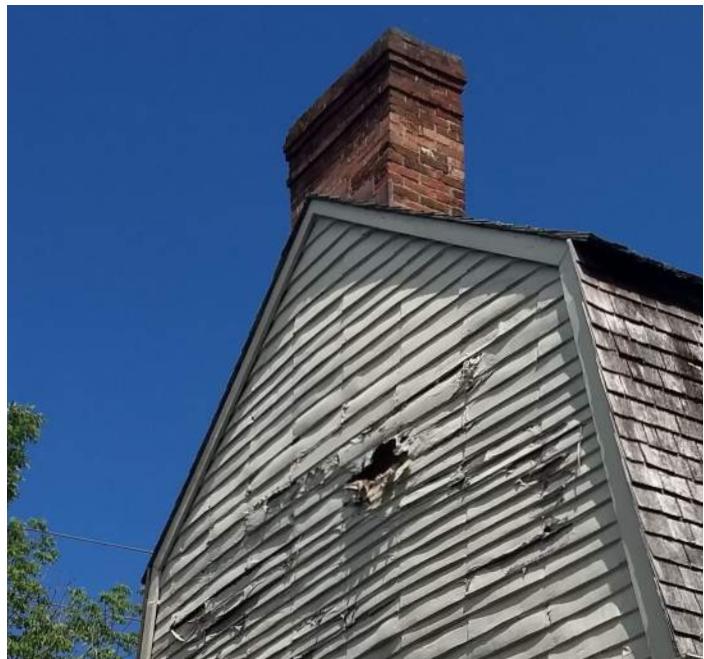
*Adding insulation to the wall cavity can potentially cause harm to the historic fabric if moisture becomes trapped in the walls.*  
HCG File Photo.

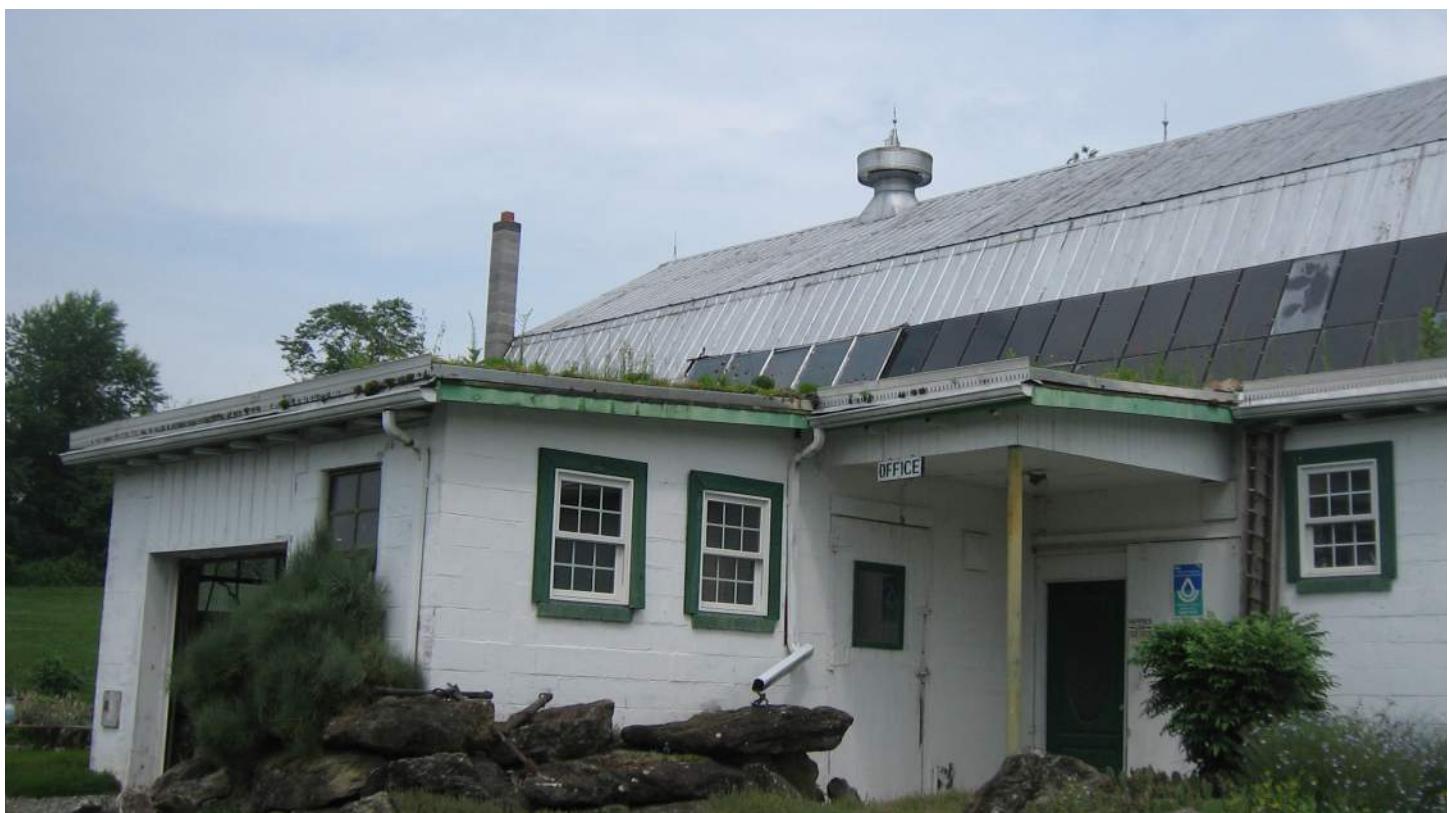
*Natural vegetation is used on this flat area of green roof at the mid-twentieth century dairy barn at Emory Knoll Farm. Photovoltaic panels are also used at the lower edge of the gambrel roof. Image courtesy of Jen Wilson.*

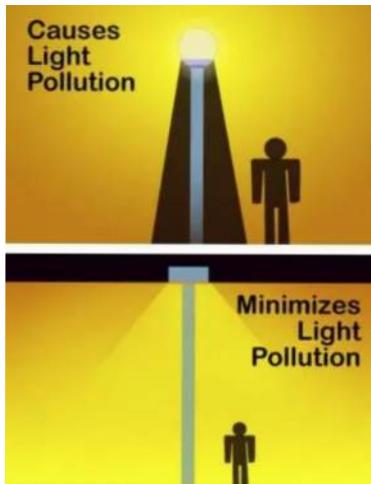
*Different types of exterior lighting fixtures can either cause or minimize light pollution. Graphic by Larry Wilson, National Park Service (Public Domain).*
