## Appendix G1 - Assessment of Controls (BMP Effectiveness Monitoring)

**WHEEL CREEK  
WATER CHEMISTRY MONITORING  
YEAR 13 REPORT**

Harford County  
Department of Public Works  
Watershed Protection and Restoration  
212 South Bond Street  
Bel Air, Maryland 21014

Final, December 12, 2023

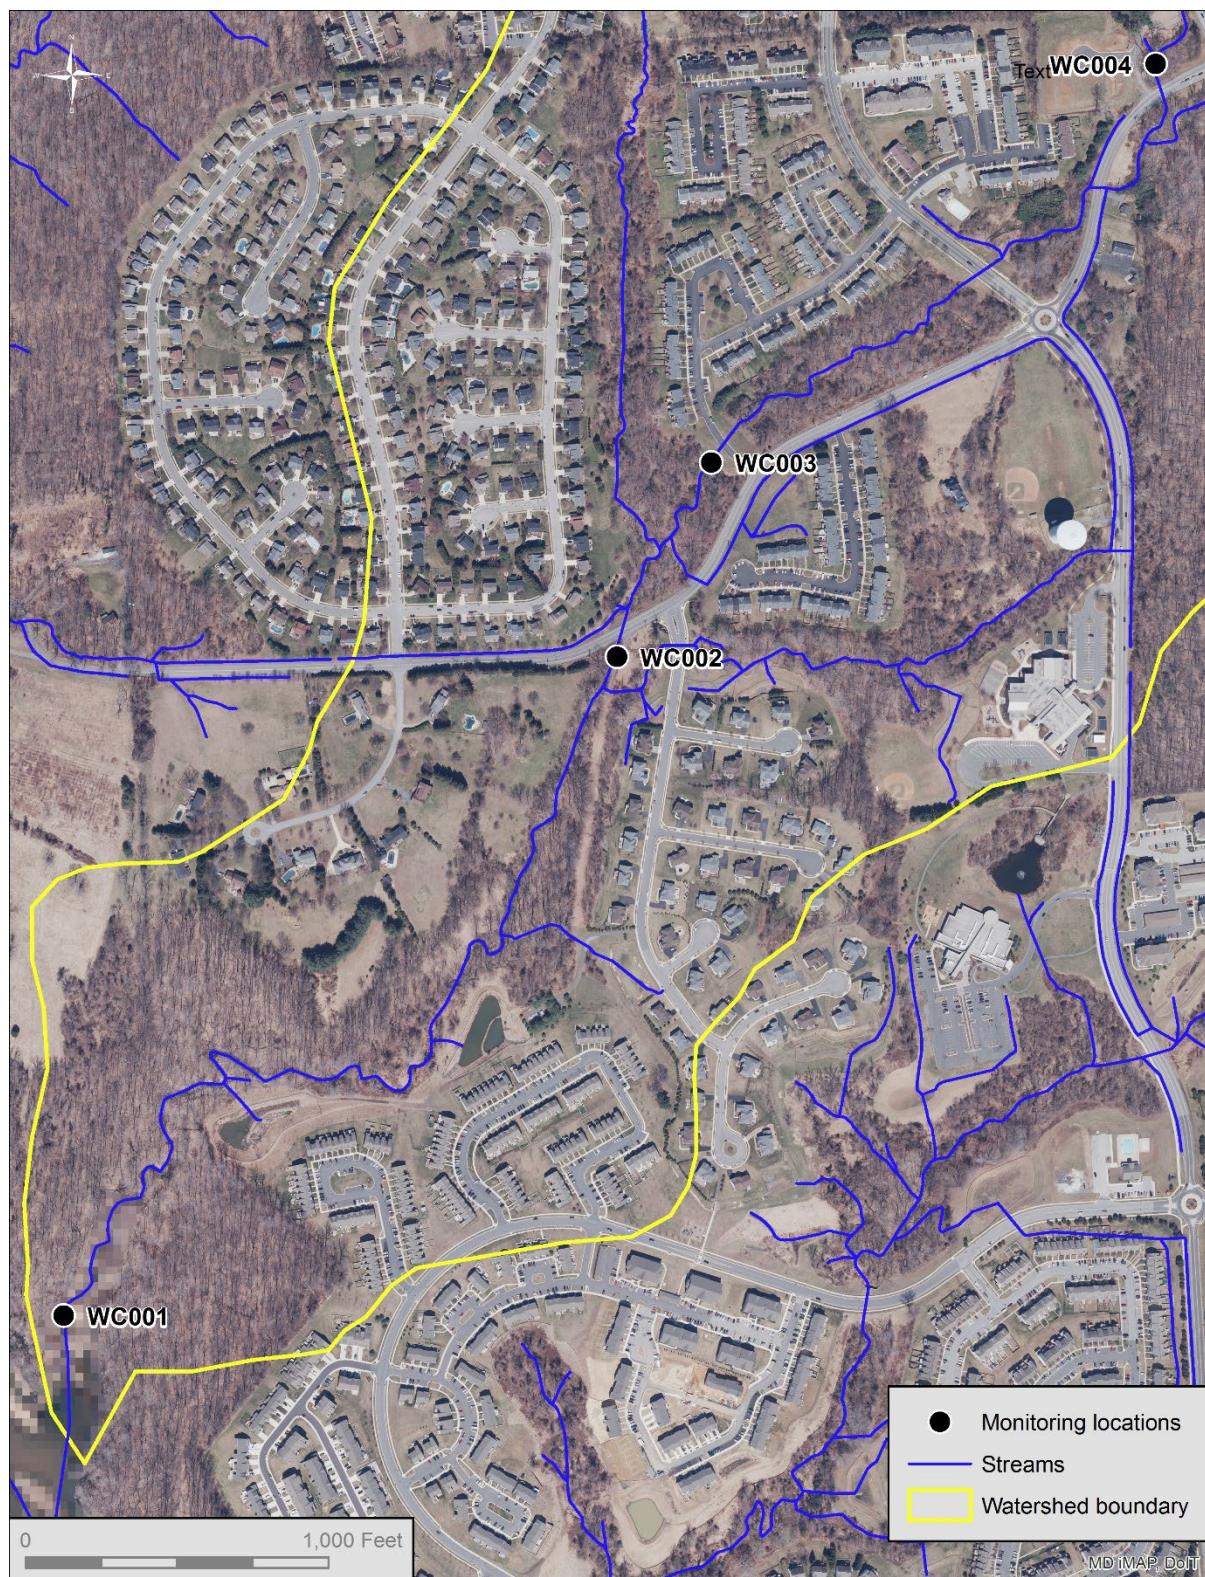
Figure 2-1. Wheel Creek Watershed long-term water chemistry monitoring stations

Three long-term automated water chemistry sampling and flow logging stations were established at Stations WC002, WC003, and WC004 (Figure 2-1). Station WC004 is located on the middle branch, immediately downstream of the stormwater retrofit at Festival Shopping Center (Point C; Figure 2-2). Stations WC003 and WC004 bracket completed stormwater retrofits at Pond D and Pond E along the middle branch (Figure 2-2). Station WC002 is located on the mainstem and water chemistry data collected there will provide an overall assessment of the benefits of retrofit and restoration projects in upstream tributaries (Figure 2-2). Baseflow monitoring took place at three stations along the Wheel Creek mainstem and tributaries (WC002, WC003, and WC004).

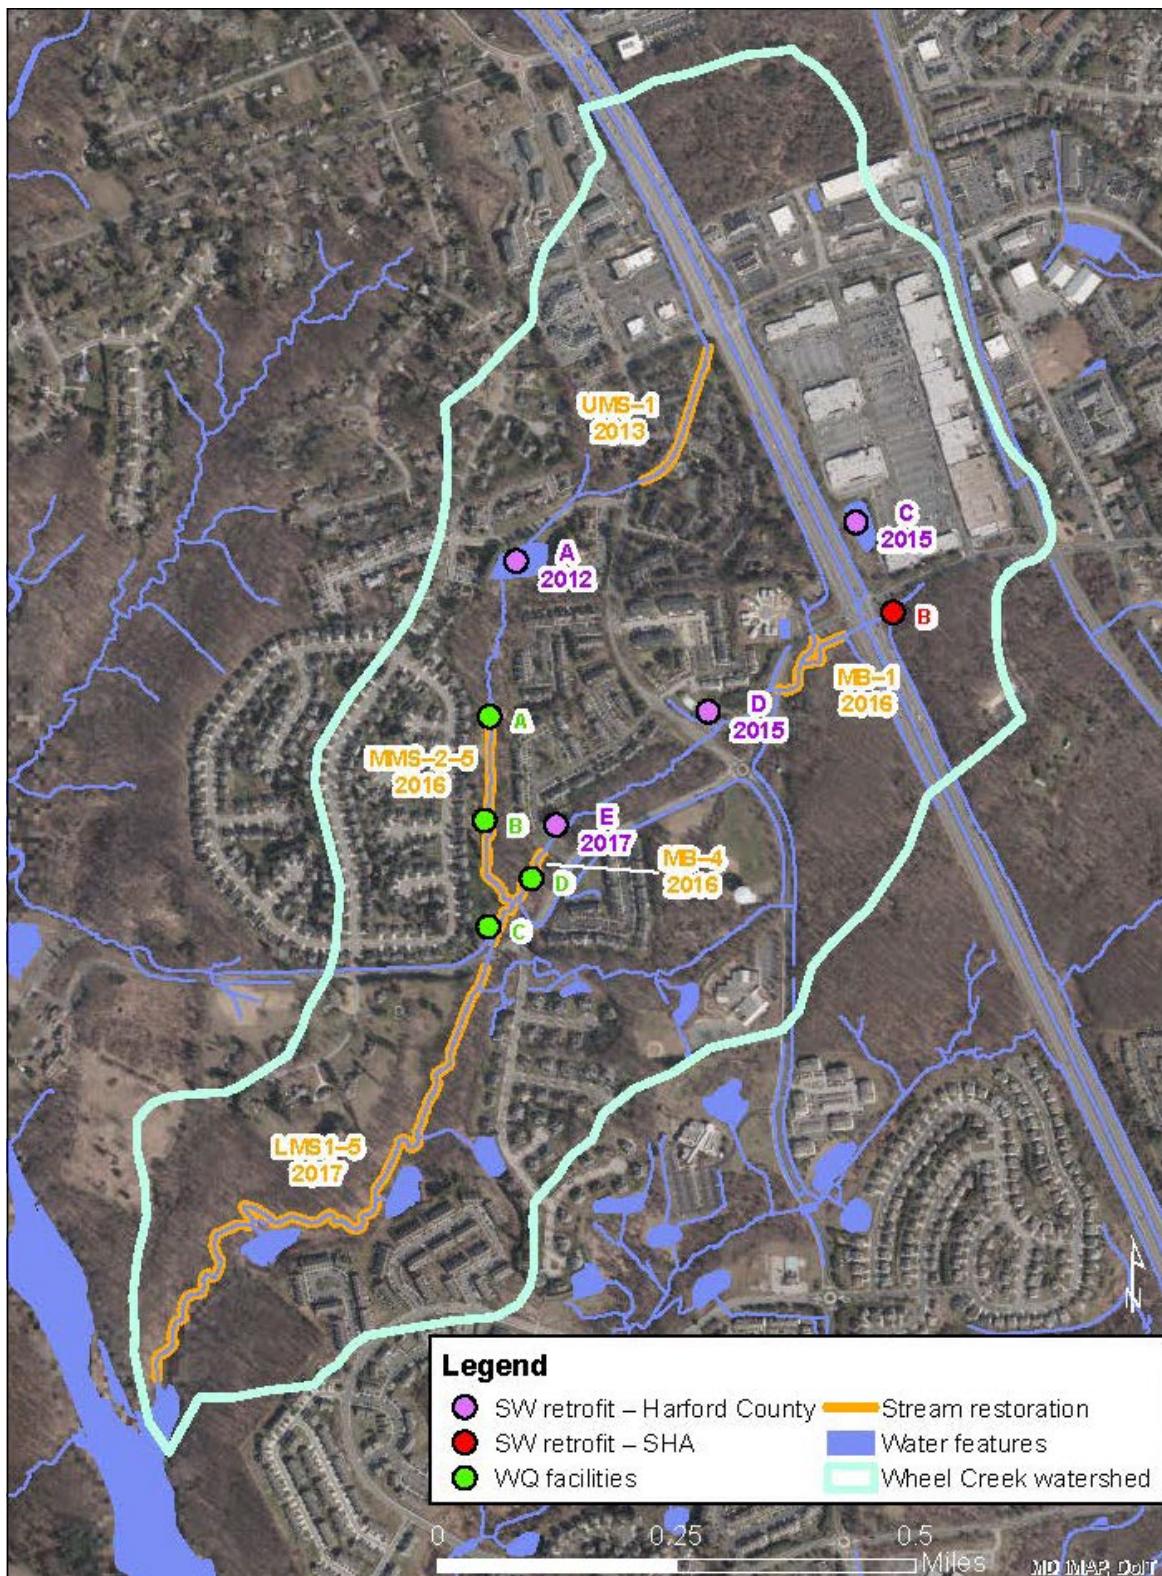
Figure 2-2. Stream restoration and stormwater retrofit sites in Wheel Creek watershed

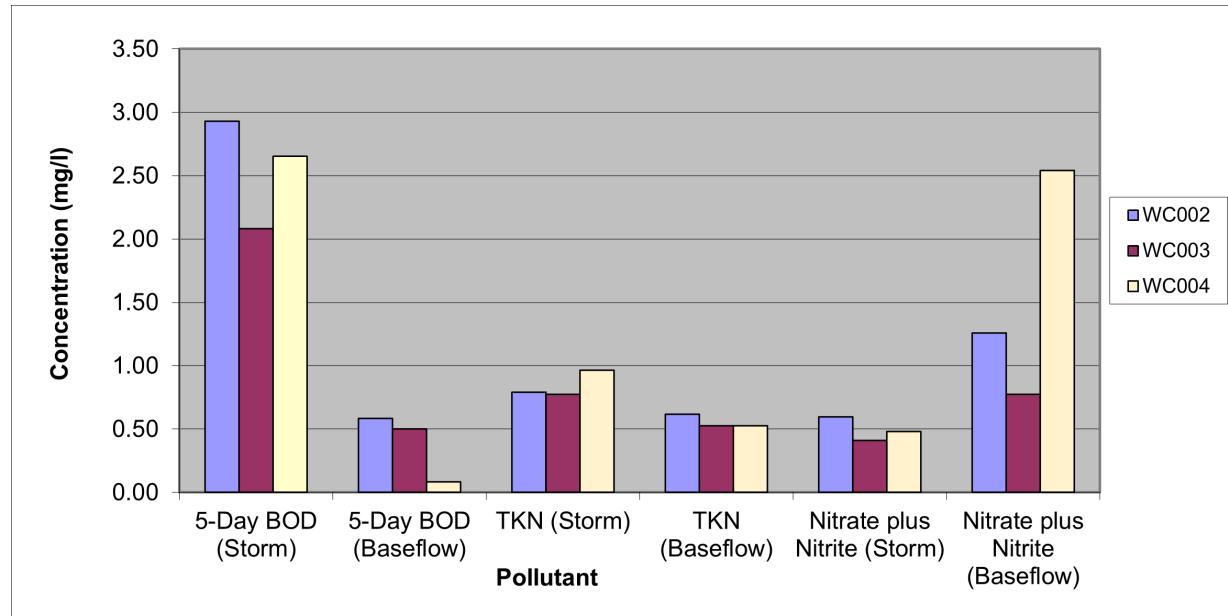
Figure 4-1. Nitrogen and 5-day BOD average storm event mean and baseflow mean concentrations in Wheel Creek, July 2022 – June 2023

Under baseflow conditions, average concentrations of combined nitrate plus nitrite, orthophosphate, chloride, lead, and zinc were highest at Station WC004 compared to the other two stations downstream (Figures 4-1 through 4-6). Samples collected at Station WC003 had the highest average concentrations of TSS, TPH, and *E. coli* during baseflow conditions, while Station WC002 samples had the highest average concentrations of BOD, ammonia, orthophosphate, TKN, total phosphorus, and copper during baseflow conditions. Concentrations of ammonia were disproportionately highest at Station WC002 at 300.0% higher than the next highest mean concentration. The higher concentration of ammonia at Station WC002 may indicate a continued nutrient or sewer input in the vicinity of the station, such as leakage from a sanitary sewer line. Higher average chloride values at Station WC004 may be the result of mobilization of chloride in groundwater as a result of runoff from legacy deicing compound application at the Festival of Bel Air Shopping Center and along Route 24.

Under stormflow conditions, average EMCs were highest at Station WC004 for ammonia, TKN, TSS, chloride, copper, lead, and zinc (Figures 4-1 through 4-6). Average EMCs for BOD, combined nitrate plus nitrite, orthophosphate, total phosphorus, and *E. coli* were highest at Station WC002. TPH was non-detect in all stormflow samples. All average stormflow EMCs exceeded corresponding baseflow mean concentrations at all stations except combined nitrate plus nitrite and chloride (all three stations), ammonia (Stations WC002 and WC003), and TPH (Station WC003). Average EMCs of all pollutants at all stations were lower than Maryland and national average values (Table 4-4).

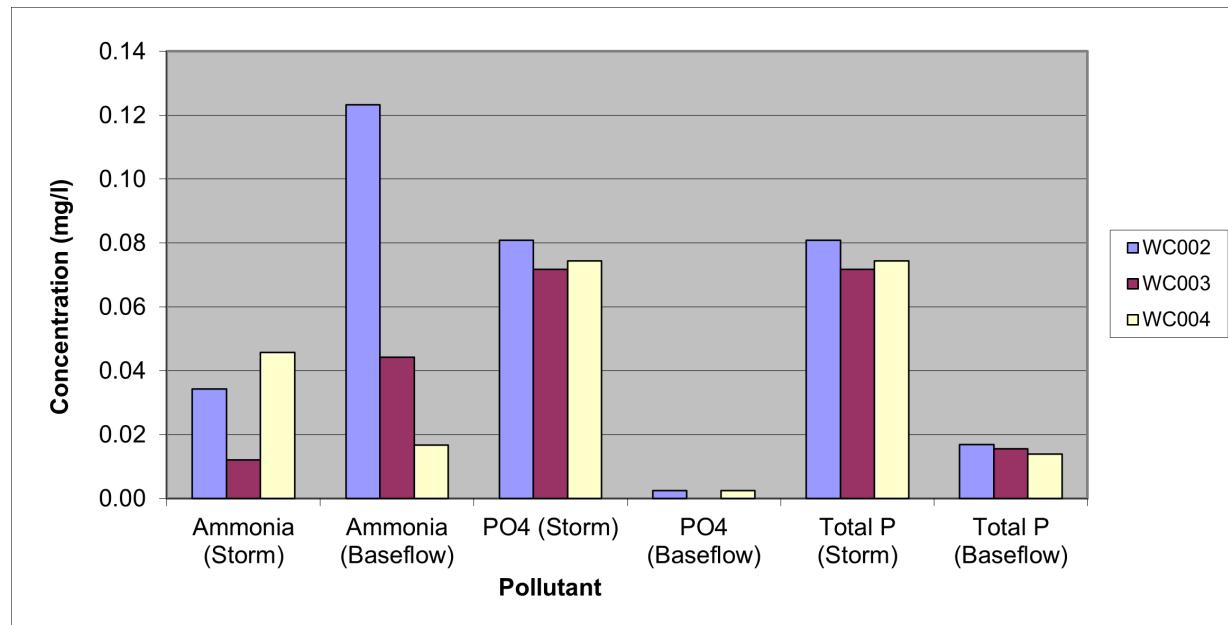
Figure 4-2. Ammonia and phosphorus average storm event mean and baseflow mean concentrations in Wheel Creek, July 2022 – June 2023

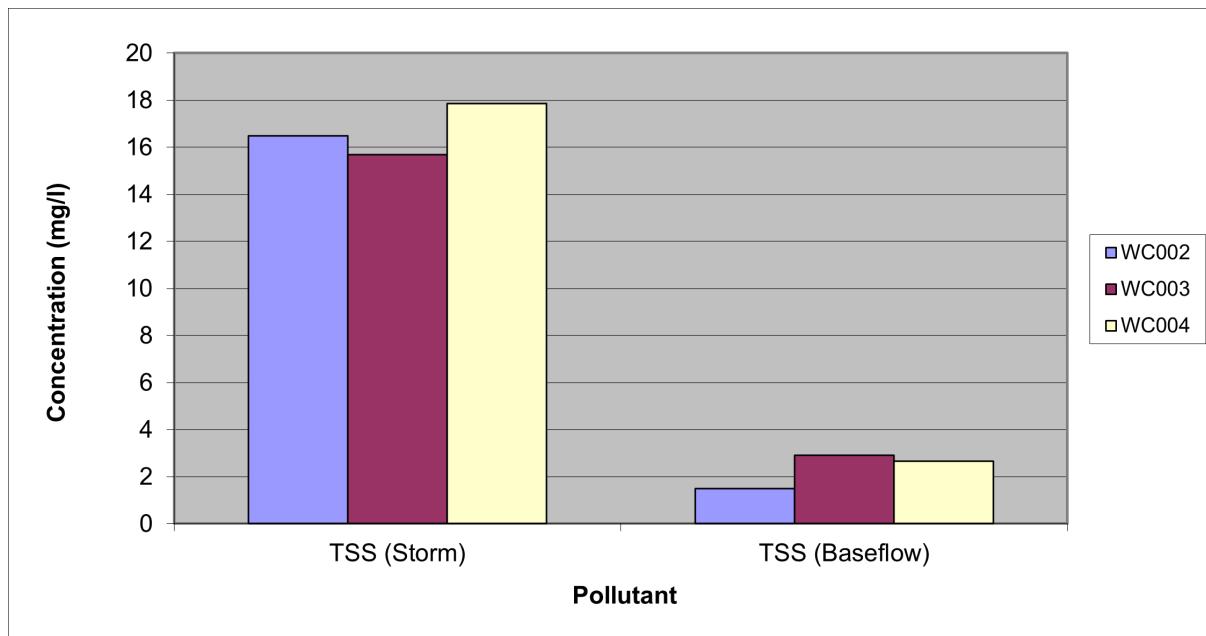
Figure 4-3. TSS average storm event and baseflow mean concentrations in Wheel Creek, July 2022 – June 2023

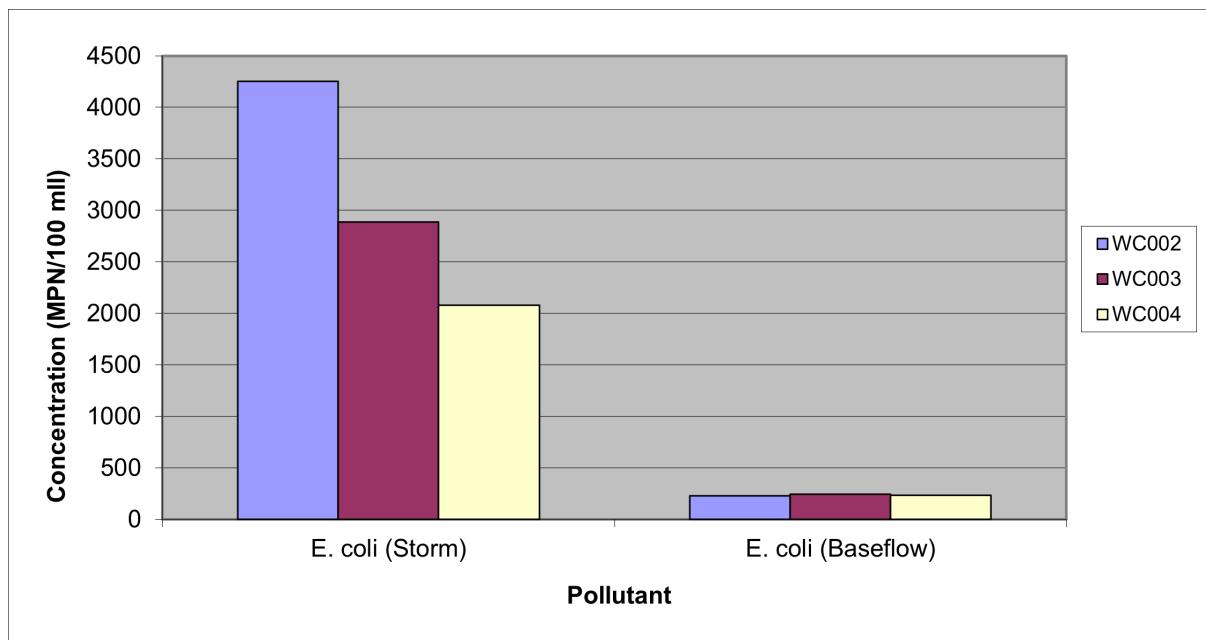
Figure 4-4. *E. coli* average storm and baseflow mean concentrations in Wheel Creek, July 2022 – June 2023

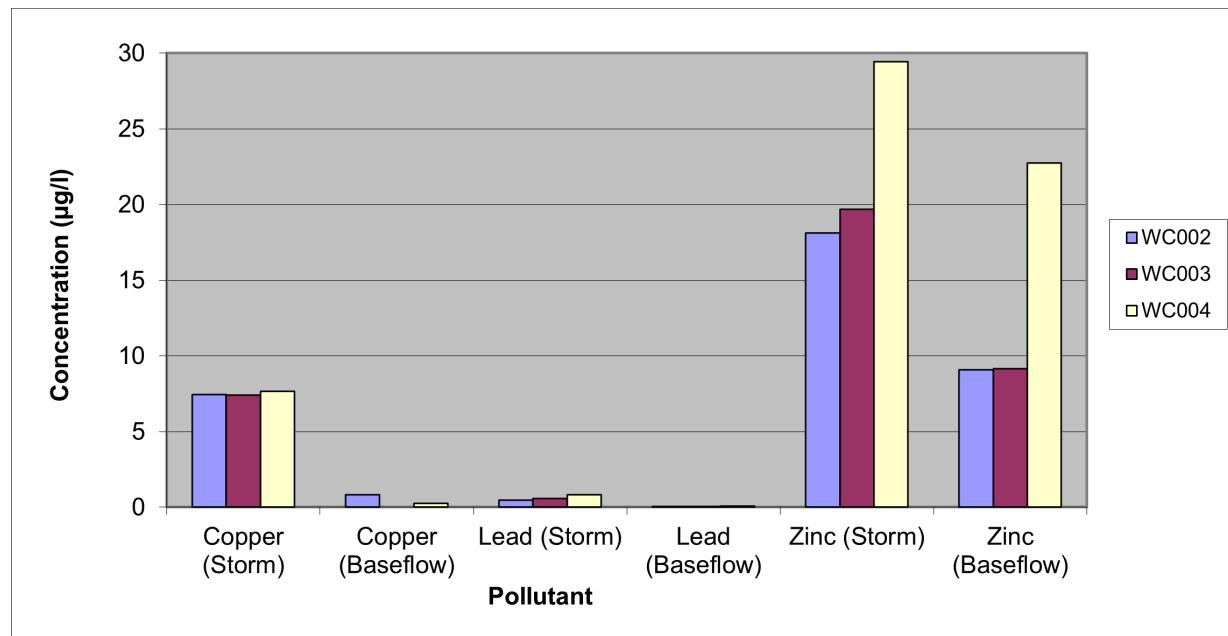
Figure 4-5. Metal average storm event mean and baseflow mean concentrations in Wheel Creek, July 2022 – June 2023

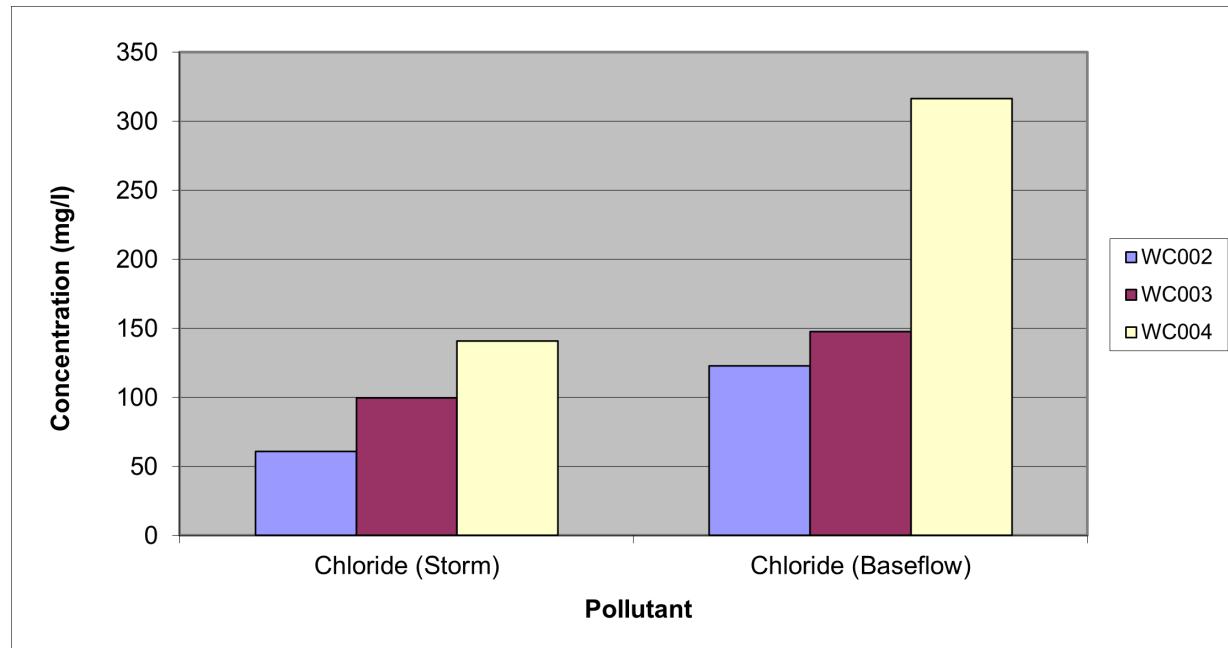
Figure 4-6. Chloride average storm event mean and baseflow mean concentrations in Wheel Creek, July 2022 – June 2023

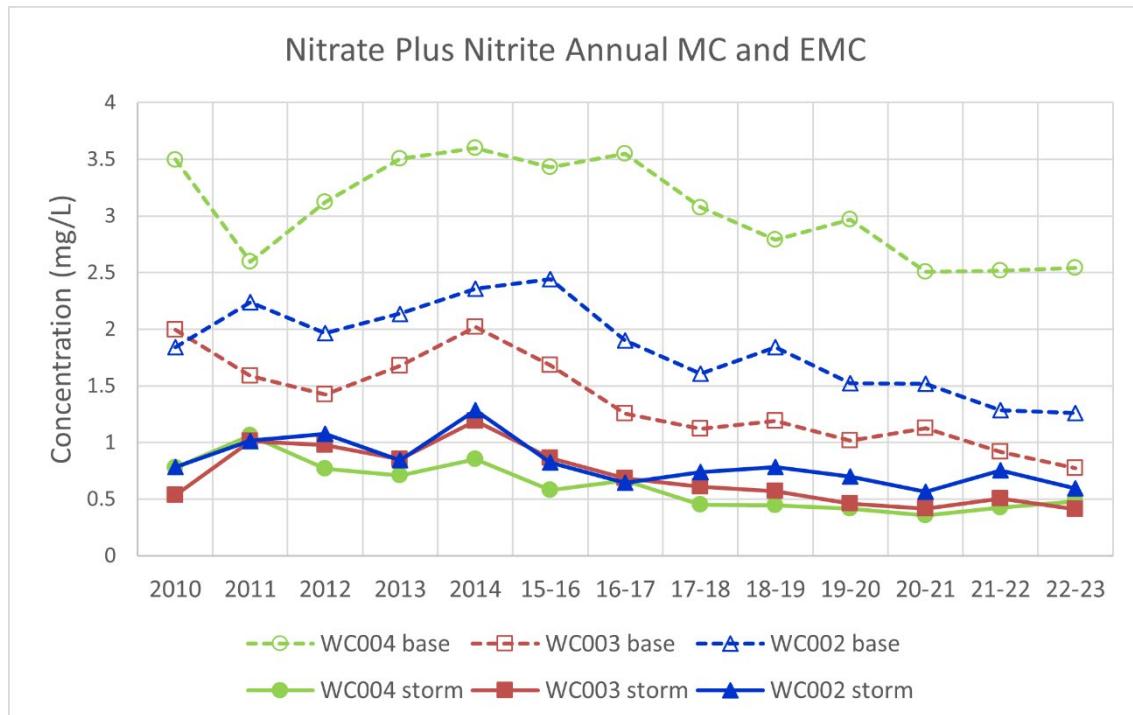
Figure 4-7. Time series plot of average annual baseflow MC and stormflow EMC for nitrate-nitrite (2010-FY2023)

As described below, some of the plots show a potential change in long-term trend in annual concentration data that can be associated with completion of restoration projects in the watershed. For nitrate plus nitrite through FY2023, the prevailing trend continues gradually downward at all stations since approximately 2014, coinciding with the completion of most of the restoration projects. Storm EMCs for several of the parameters, including total phosphorus, TSS, copper, and BOD show signs of gradually increasing trend until approximately FY2017 and then notably falling in FY2018 through FY2020. From FY2020 through FY2023, storm EMCs for total phosphorus, copper, and BOD largely remained stable and lower than pre-restoration conditions, with minor fluctuations noted for total phosphorus and copper. Storm EMCs for TSS continued to show a declining trend through FY2023. Average storm EMCs for TKN behaved similarly through FY2018 but, despite decreases in all calculated concentrations except baseflow at Station WC002 in FY2023, concentrations have shown an increasing trend from FY2019 through FY2023 at all stations. Similarly, EMCs for ammonia gradually decreased through FY2017, from which point there has been variability in average storm EMCs and baseflow MCs but still an increasing trend through FY2022. Drastic declines in all EMCs for ammonia were observed in FY2023, but the prevailing trend still appears to be increasing. Lead and zinc EMCs were higher and more variable from 2010 through FY2018 before showing reductions in FY2019. Since then, EMCs for both constituents have remained stable with only minor fluctuations in concentrations each year. The time series data may indicate that the restoration efforts are having the desired effect of reducing parameters under specific flow regimes except for total phosphorus, TKN, and ammonia.

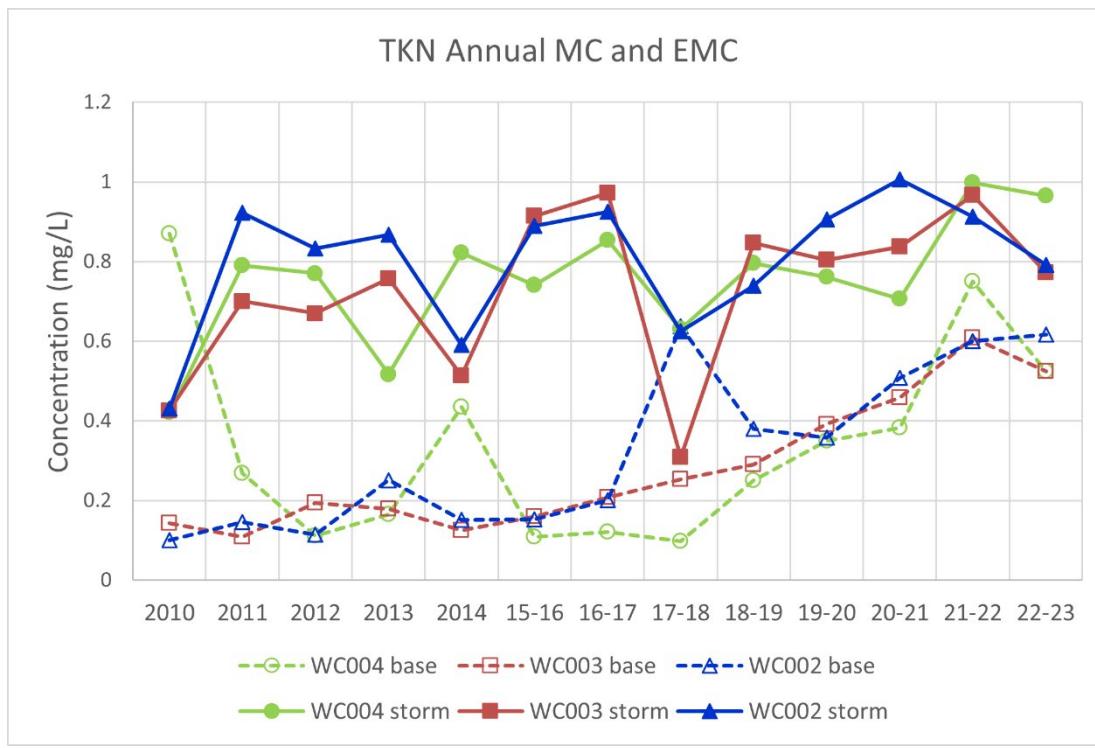
Figure 4-8. Time series plot of average annual baseflow MC and stormflow EMC for TKN (2010-FY2023)

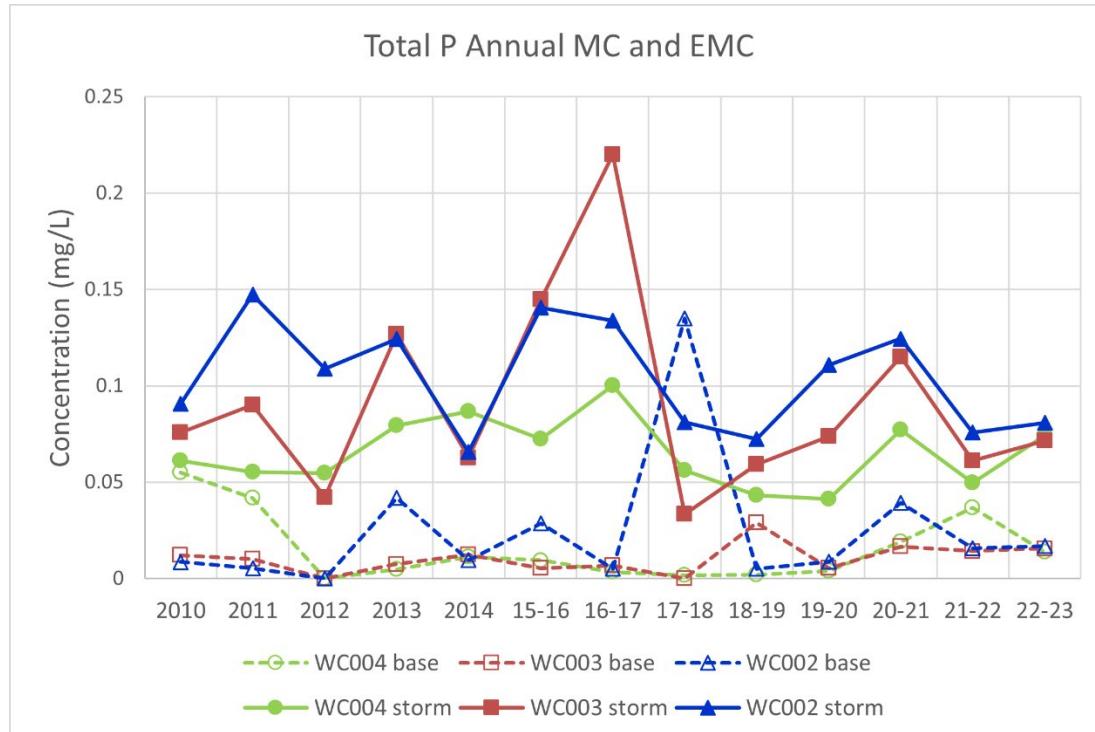
Figure 4-9. Time series plot of average annual baseflow MC and stormflow EMC for total phosphorus (2010-FY2023)

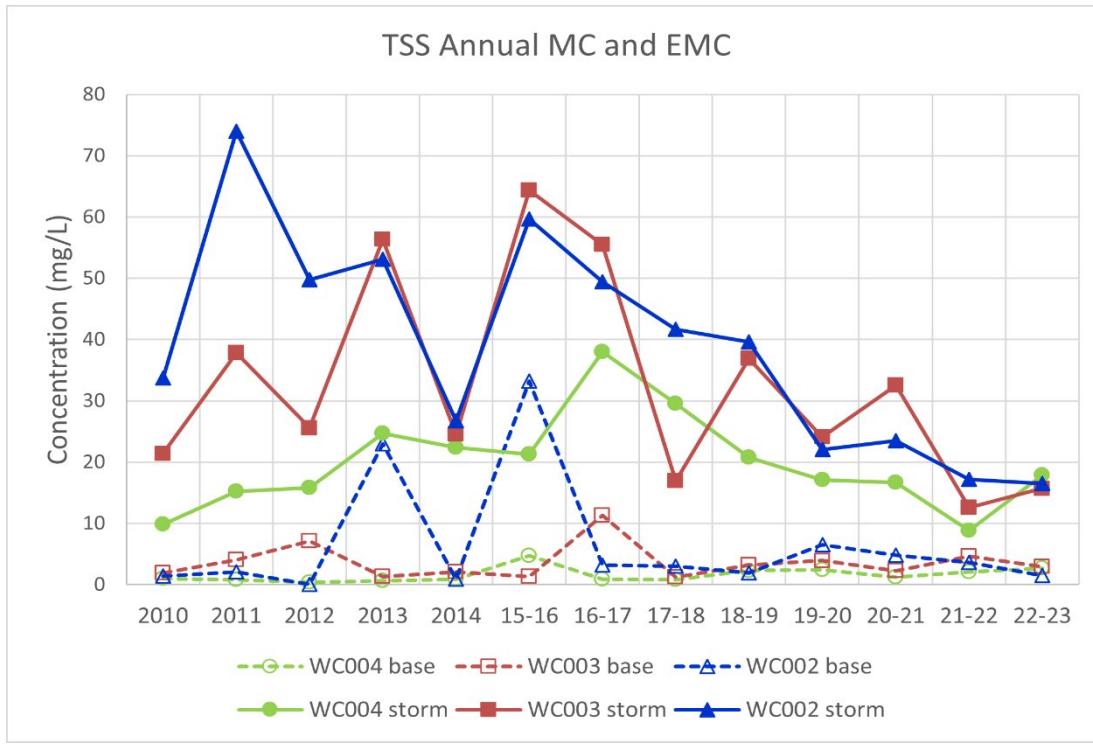
Figure 4-10. Time series plot of average annual baseflow MC and stormflow EMC for TSS (2010-FY2023)

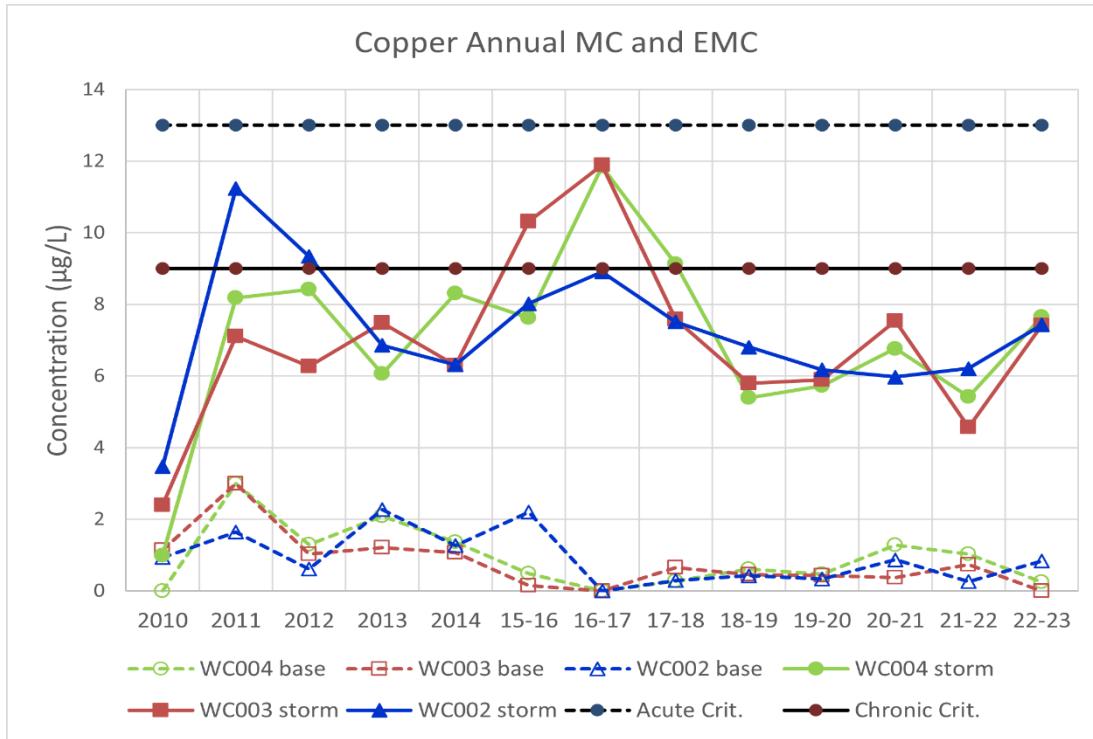
Figure 4-11. Time series plot of average annual baseflow MC and stormflow EMC for copper (2010-FY2023)

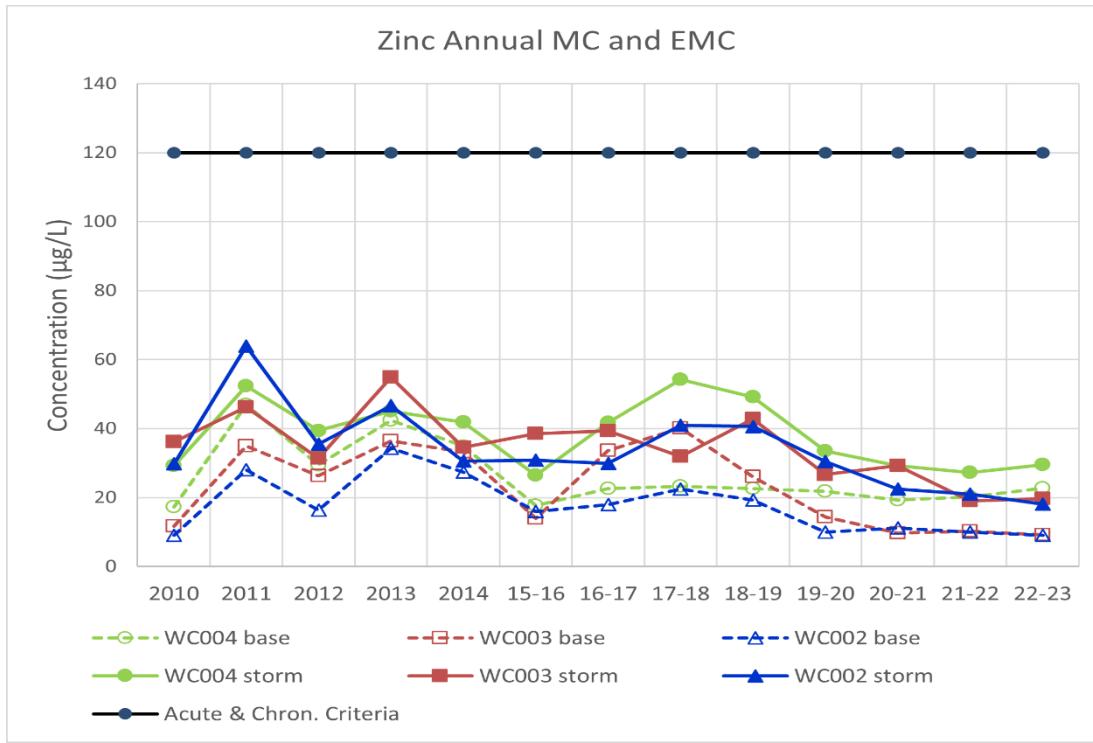
Figure 4-12. Time series plot of average annual baseflow MC and stormflow EMC for zinc (2010-FY2023)

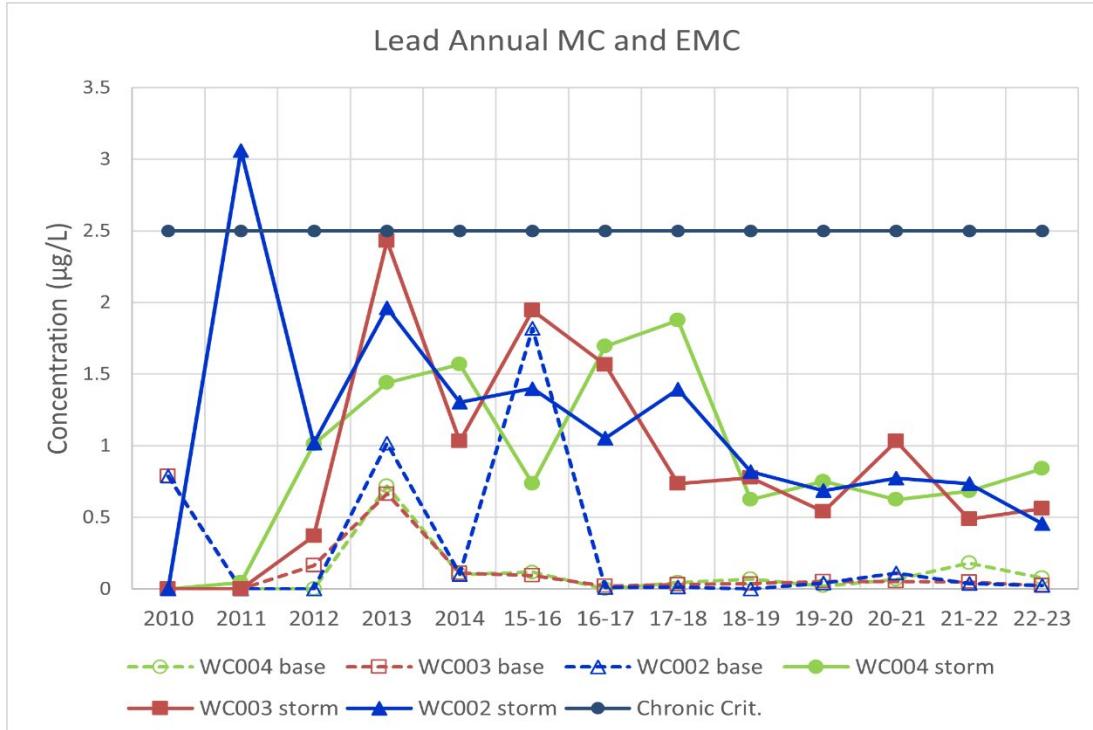
Figure 4-13. Time series plot of average annual baseflow MC and stormflow EMC for lead (2010-FY2023). Note: the acute criterion is not shown to maintain small scale.

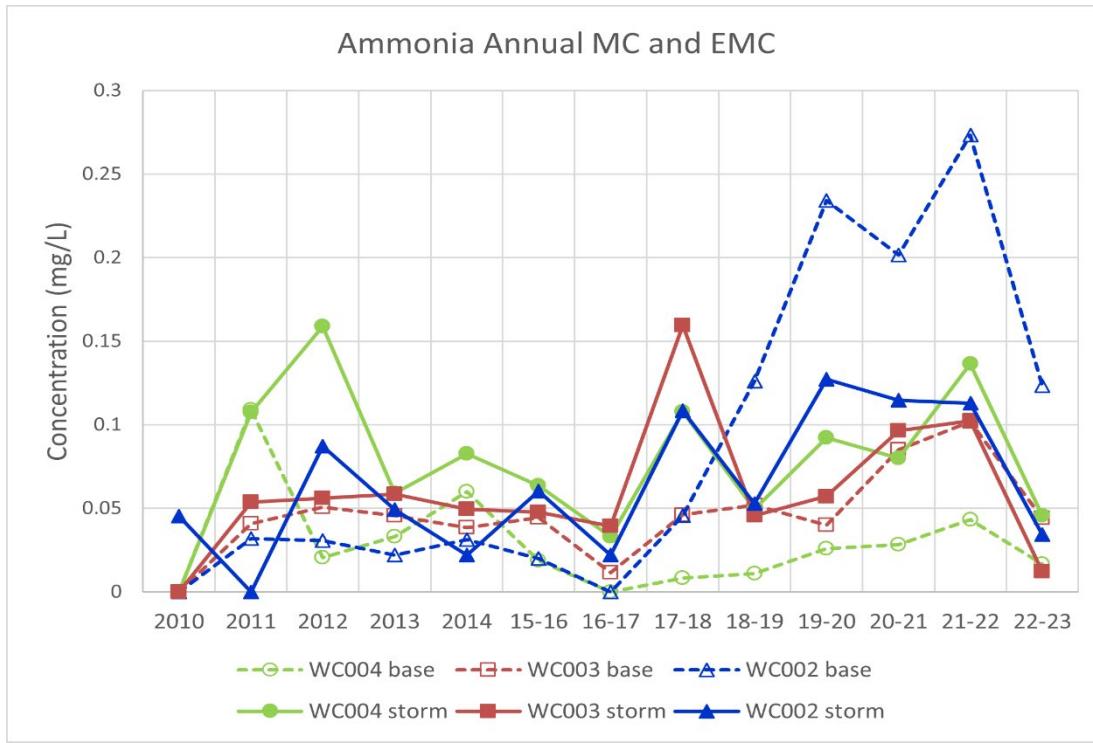
Figure 4-14. Time series plot of average annual baseflow MC and stormflow MC for ammonia (2010-FY2023)

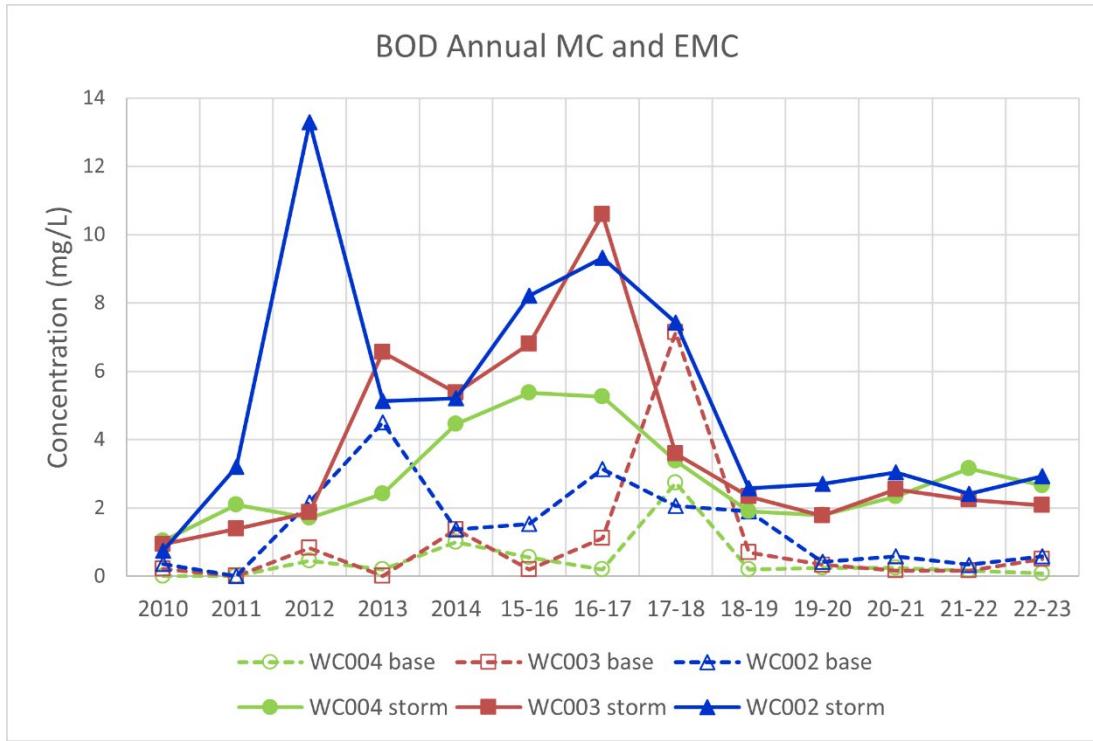
Figure 4-15. Time series plot of average annual baseflow MC and stormflow MC for BOD (2010-FY2023)

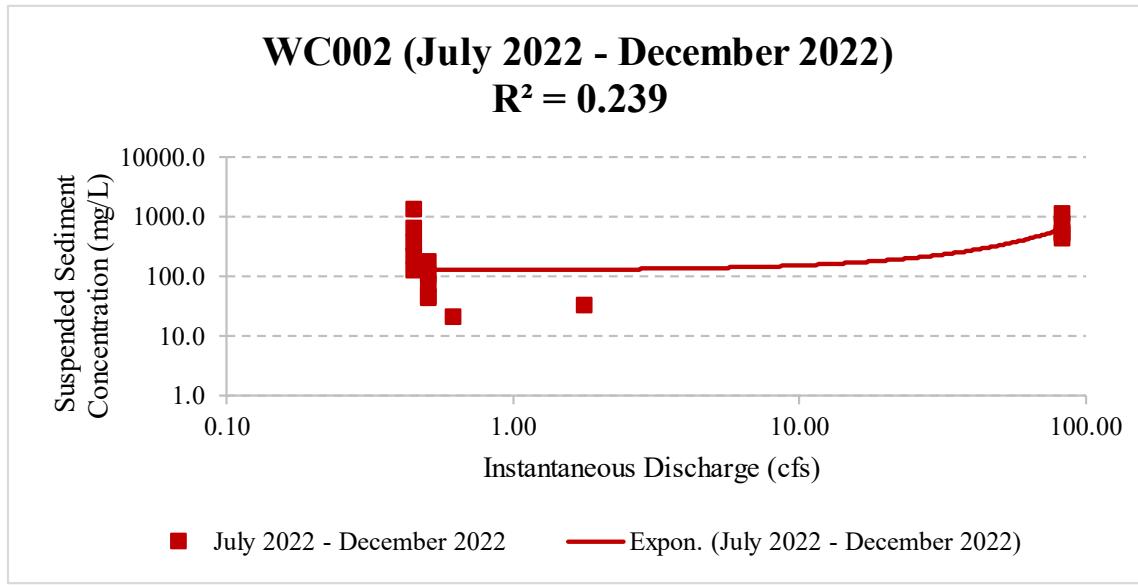
Figure 4-16. Suspended sediment curve for Wheel Creek Station 002 (July 2022 – December 2022)

Sediment transport curves were created for each station using concentrations of suspended sediment in samples and corresponding flow rate values for storms monitored from July 2022 through December 2022. Average instantaneous discharges for each sample were similar to those reported in the previous year. Results at Station WC002 showed a low correlation between discharge and suspended sediment concentration ( $r^2 = 0.239$ ; Figure 4-16). The sediment concentration correlation at Station WC002 was lower than reported last year and had higher concentrations per discharge. The sediment transport curve prepared for Station WC003 showed a moderate correlation between discharge and suspended sediment concentration ( $r^2 = 0.365$ ; Figure 4-17). The sediment concentration correlation at Station WC003 was less than reported last year and had lower concentrations per discharge. Results at Station WC004 showed a very low correlation between discharge and suspended sediment concentration ( $r^2 = 0.159$ ; Figure 4-18). The sediment concentration correlation at Station WC004 was much less than reported last year, likely due to less recorded sediment concentrations per discharge providing a less accurate representation of the relationship at this station.

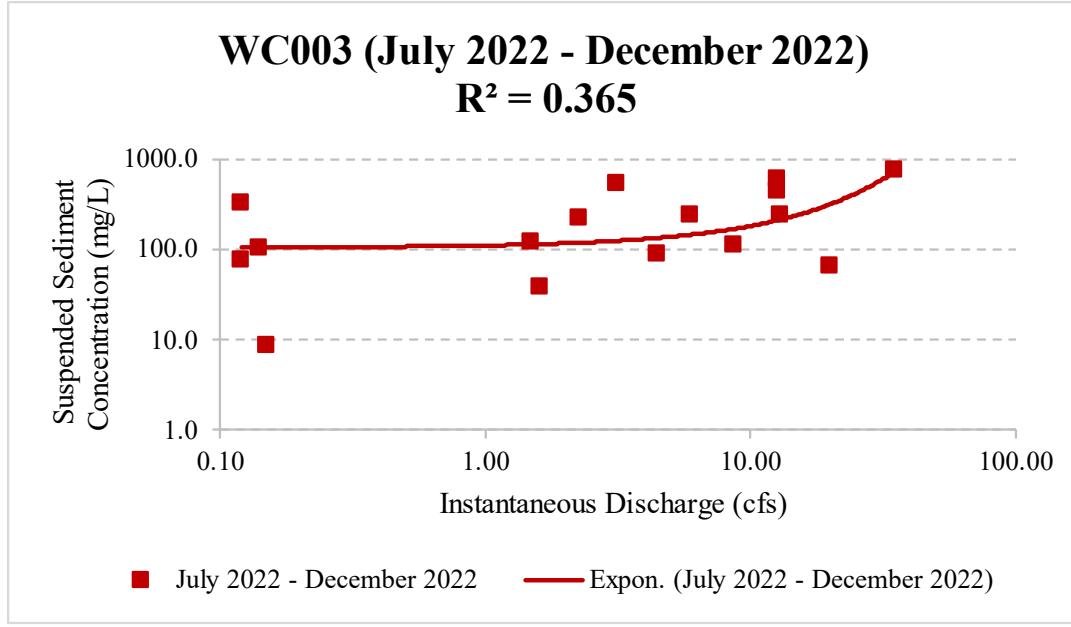
Figure 4-17. Suspended sediment curve for Wheel Creek Station 003 (July 2022 – December 2022)

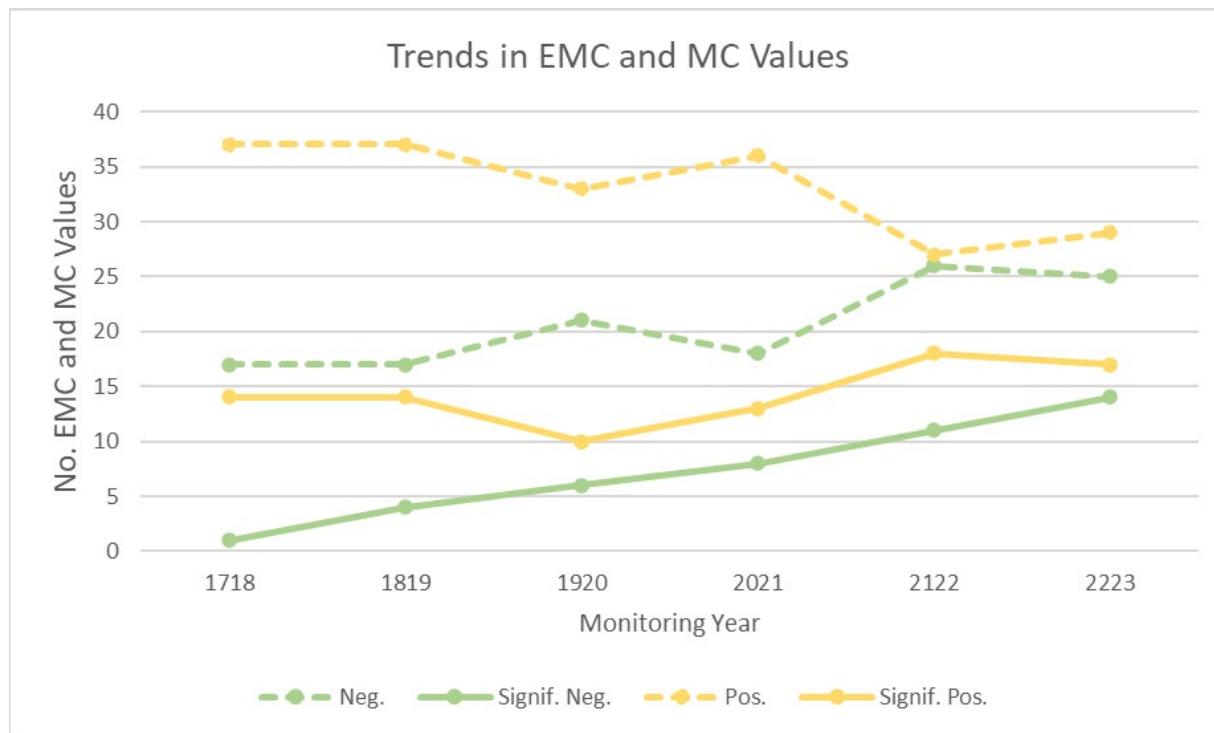
Figure 5-1. Time series plot of trend categories, FY2018 to FY2023

The time-series statistical test performed on baseflow concentration and individual storm EMC data collected showed significant, downward trends for both baseflow and storm flow nitrate plus nitrite and zinc at all stations. Additional constituents that significantly decreased included stormflow TSS at Station WC002 and baseflow copper at Station WC004. Constituents that significantly increased over time were the following: baseflow TSS at Stations WC002 and WC004, baseflow ammonia at all stations, stormflow ammonia at Stations WC002 and WC003, baseflow TKN at all stations, stormflow TKN at Stations WC003 and WC004, baseflow lead at Station WC004, and baseflow total phosphorus at all stations. During the post-restoration period, the number of parameters trending downward (i.e., improving pollutant concentrations) has gradually increased over time and parameters trending significantly downward has increased year over year (Figure 5-1). The number of upward-trending (i.e., worsening pollutant concentrations) parameters has generally decreased while the number of significantly upward-trending parameters has only slightly increased since FY2018. While the increasing number of significantly trending parameters indicates data consistency, it can be argued that the continual increase in number of significantly downward trending parameters indicates effectiveness of the restoration projects is gradually improving over time.

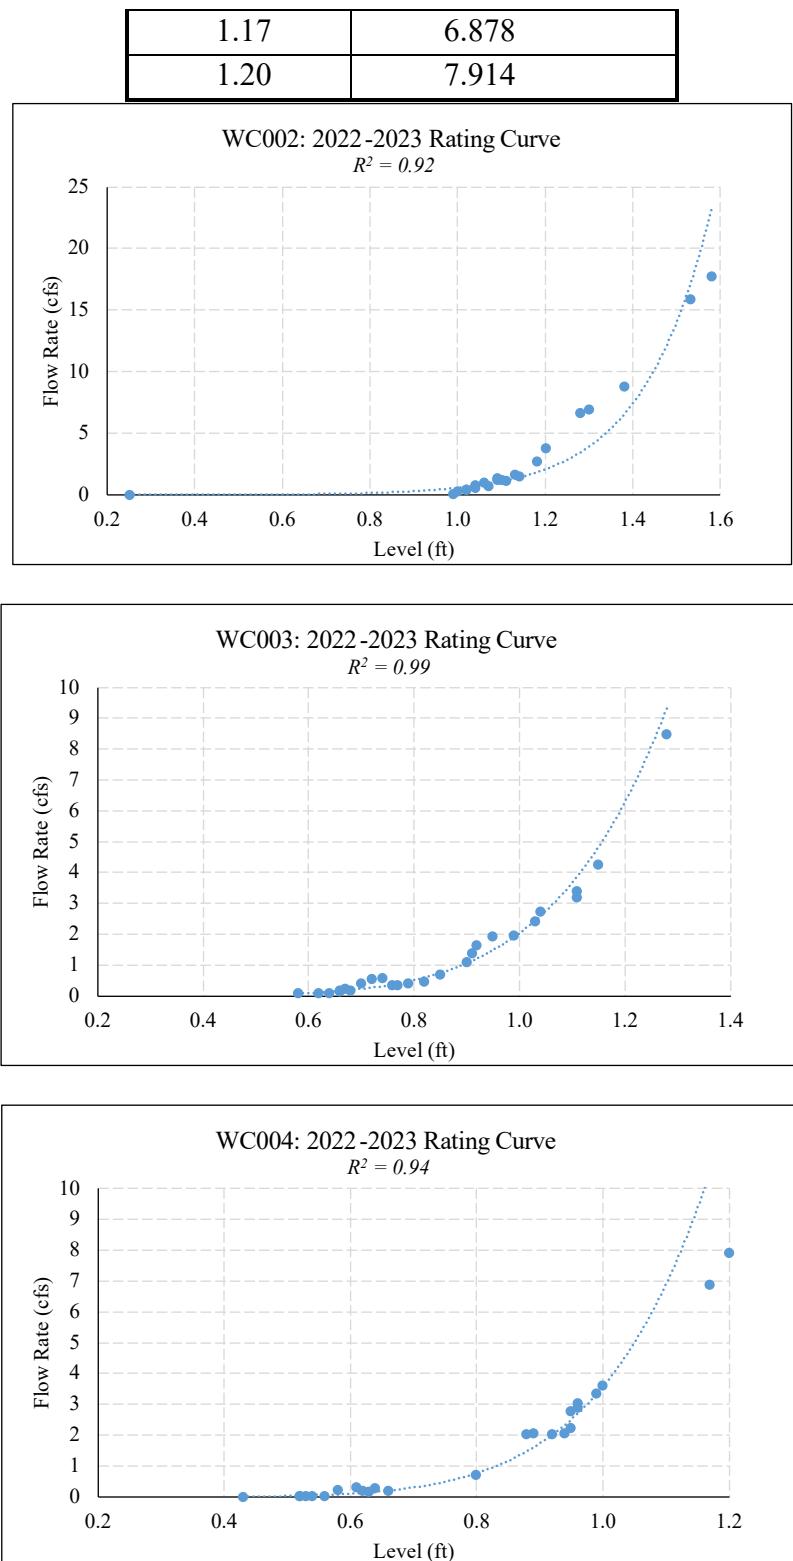
Figure B-1. Rating Curves for Stations WC002, WC003, and WC004

Complete flow series for each station were compiled from the Solinst and ISCO logger data. Staff performed quality control on the level time series to remove any anomalous data (e.g., resulting from manipulation during Solinst data offloads). Levels were corrected to reflect observed staff gauge readings, and linear corrections were applied to the time series at each station to compensate for logger drift. A rating curve was established at each of the three logging stations to convert each logger’s level data to flow rate (Appendix B) and updated annually.

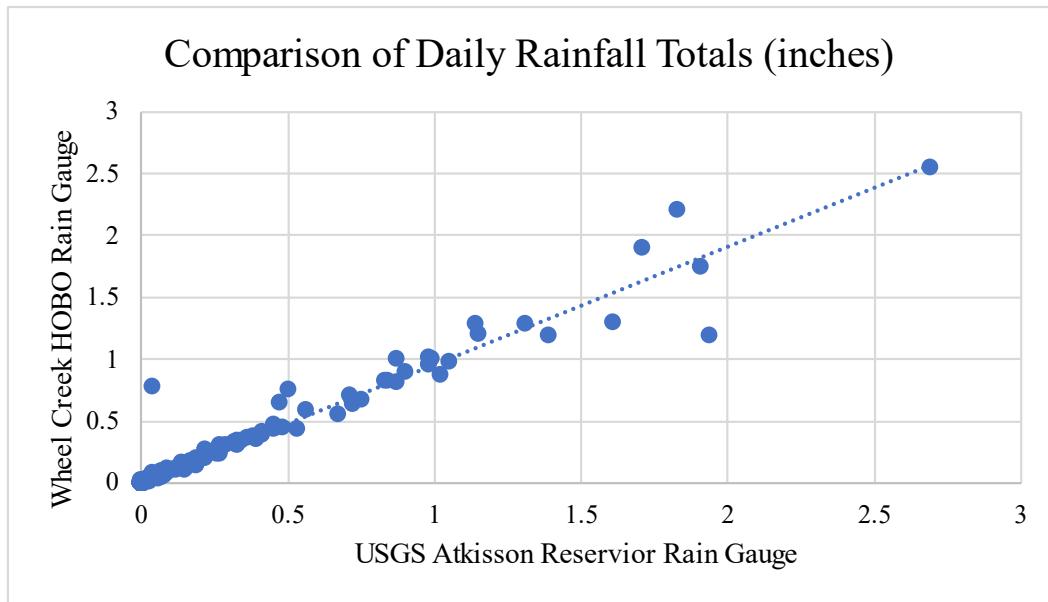
Figure C-1. Comparison of Daily Rainfall Totals for the USGS and Wheel Creek gauges

gauge is presented in Appendix C. Rainfall records from USGS' Atkisson Reservoir gauge (0.8 miles away to the SW), the secondary rainfall recorder, were used to supplement the onsite data in cases where onsite gauge data were unavailable due to power interruptions or mechanical failures. When the onsite rain gauge experienced a malfunction, a local Weather Underground station ([www.wunderground.com](http://www.wunderground.com); Bel Air South Station) was used for storm event rainfall totals since it is closer to the monitoring stations than the USGS gauge; the USGS rain gauge represents the official totals used for comparison over the entire duration of the year.
