## Appendix G1 - Assessment of Controls (BMP Effectiveness Monitoring)

**WHEEL CREEK  
WATER CHEMISTRY MONITORING  
YEAR 13 REPORT**

Harford County  
Department of Public Works  
Watershed Protection and Restoration  
212 South Bond Street  
Bel Air, Maryland 21014

Final, December 12, 2023

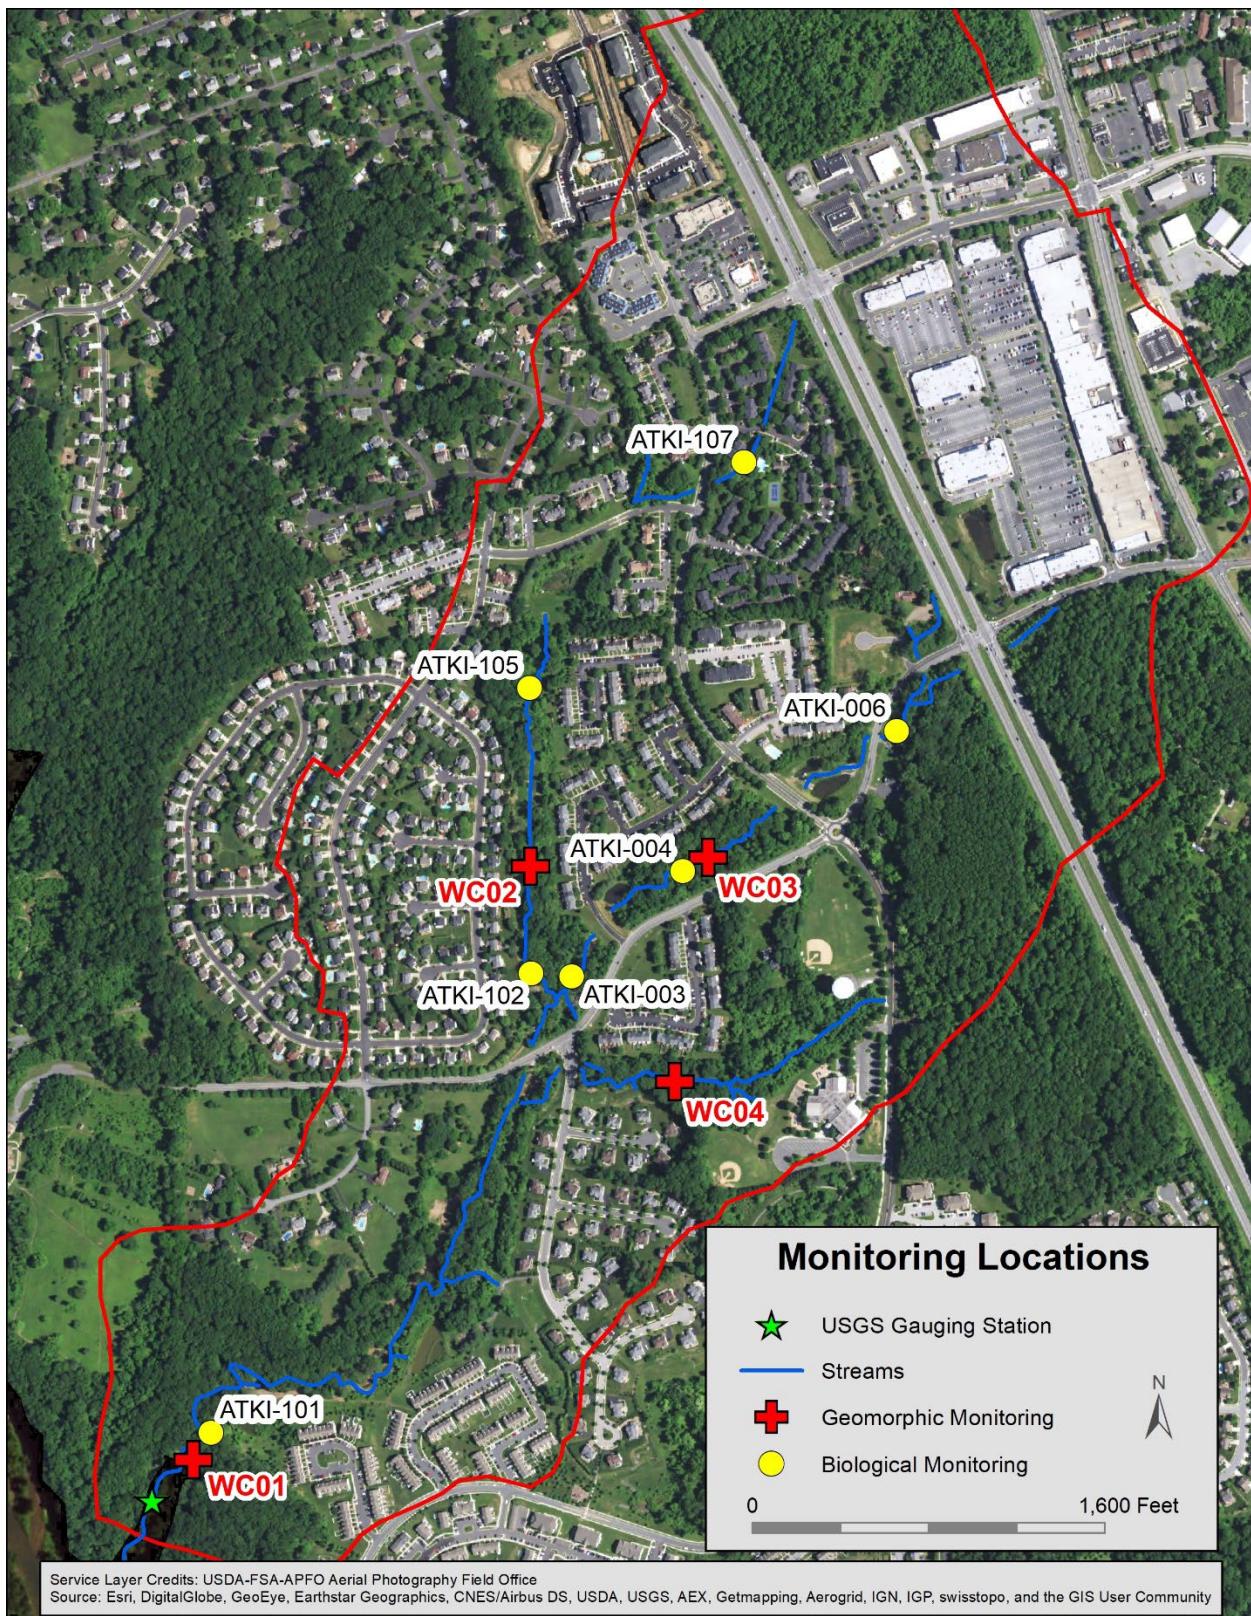
Figure 2-1. Wheel Creek monitoring locations

KCI installed and surveyed three (3) benchmark monuments at each reach during the initial baseline monitoring effort (2010) to establish consistent survey elevations from year to year, as well as start and end points for each survey reach. Two benchmarks (one concrete monument and one capped iron rebar pin) were placed on either side of the channel, whereby a measuring tape run from the left bank pin to the right bank monument marks the starting point (i.e., station 0+00) in the channel for the longitudinal profile. The concrete monument was set in 2-inch PVC piping to a depth of 30 inches, with a rounded stove bolt set in the concrete to establish the monumented benchmark elevation, which will be used to compare longitudinal profiles over time. A third monument (capped iron rebar) was placed at the upstream end of the reach to mark the end of the survey reach. Versar re-surveyed these benchmarks at WC03 and WC04 during the Post-Restoration Years 1, 2, 3, 4, 5, and 6 efforts to enable overlays between past surveys.

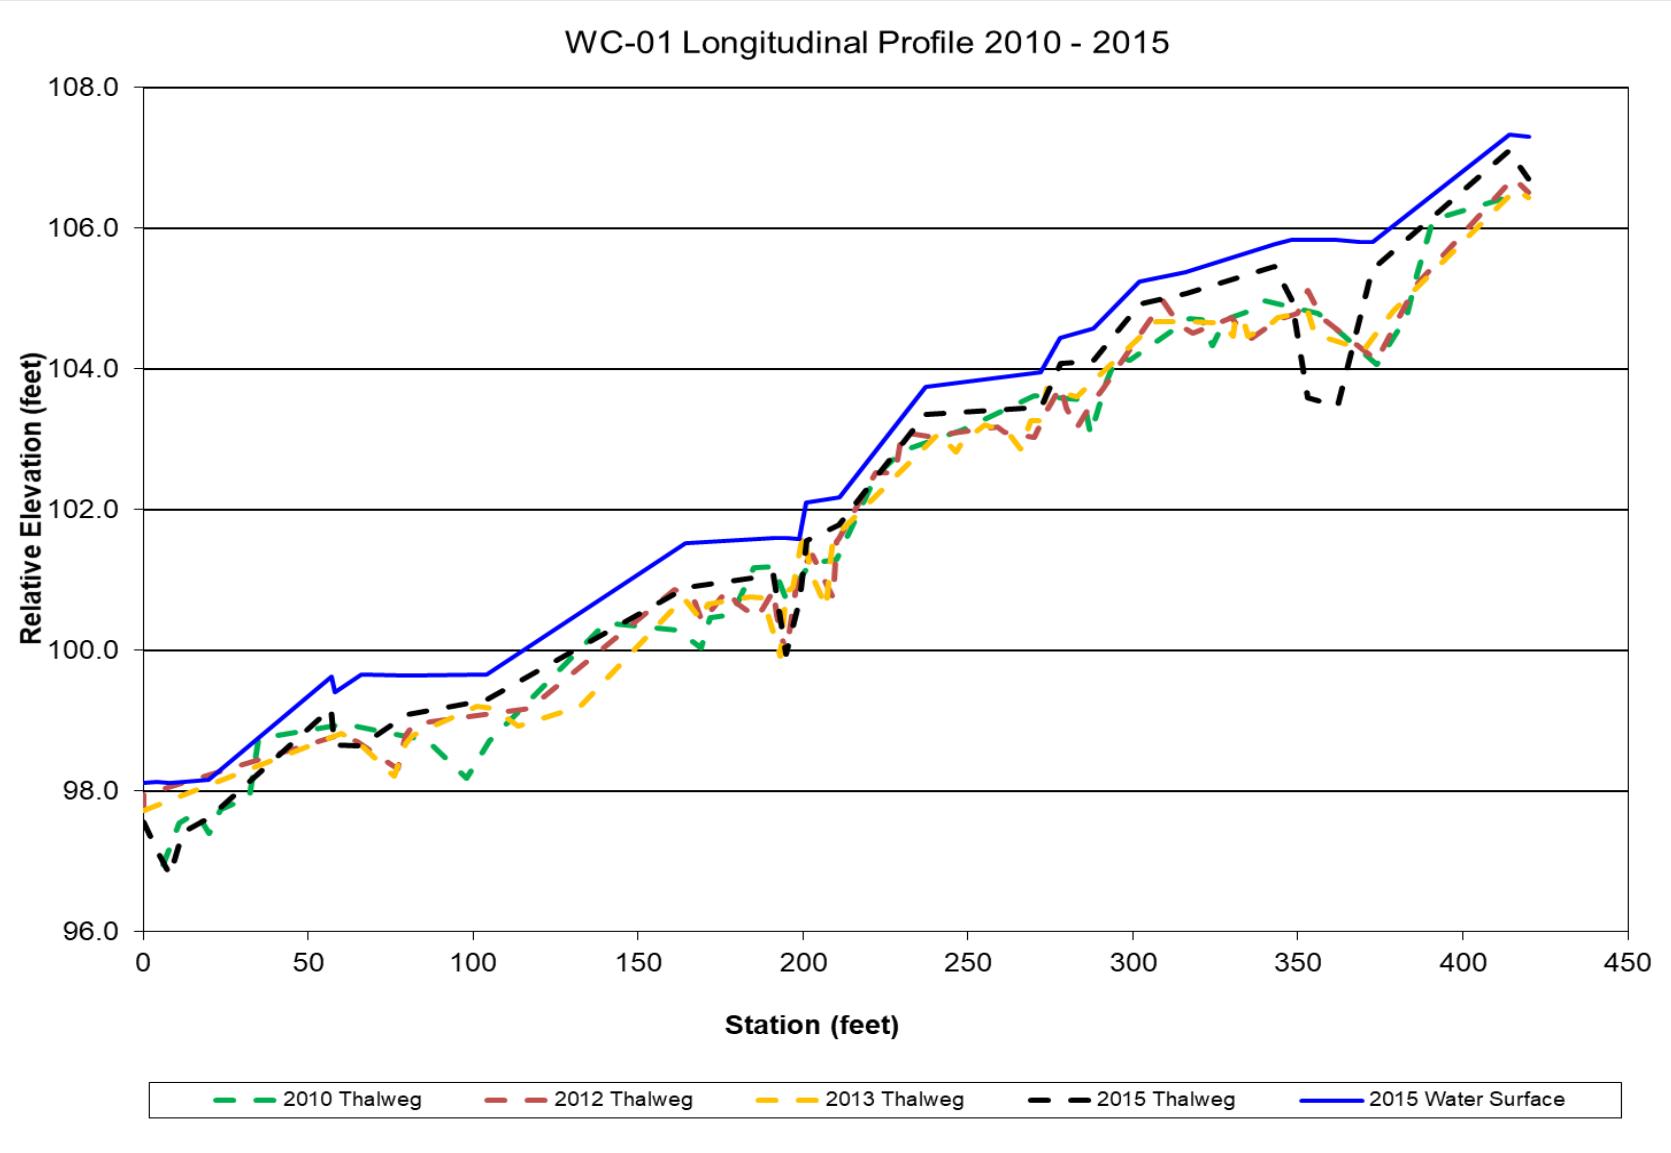
Figure C-1. WC-01 Longitudinal Profile (Pre-Restoration)

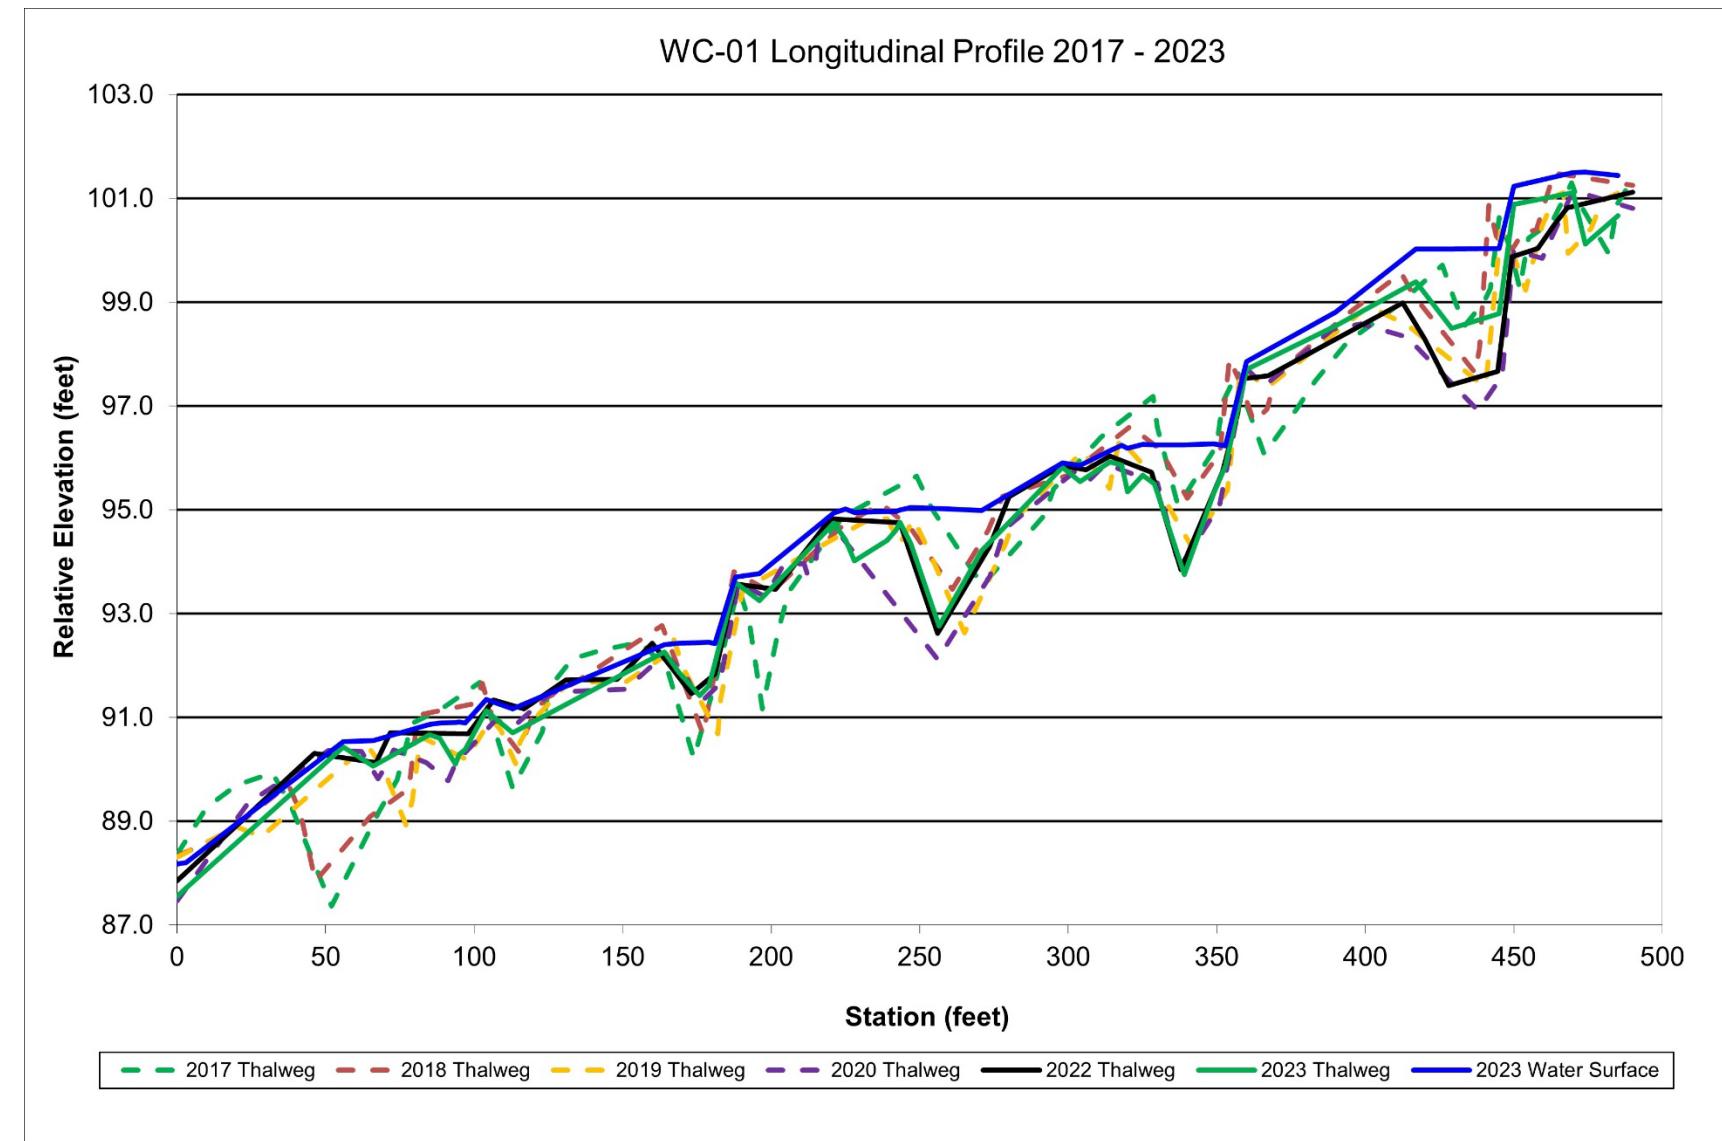
Figure C-2. WC-01 Longitudinal Profile (Post-Restoration)

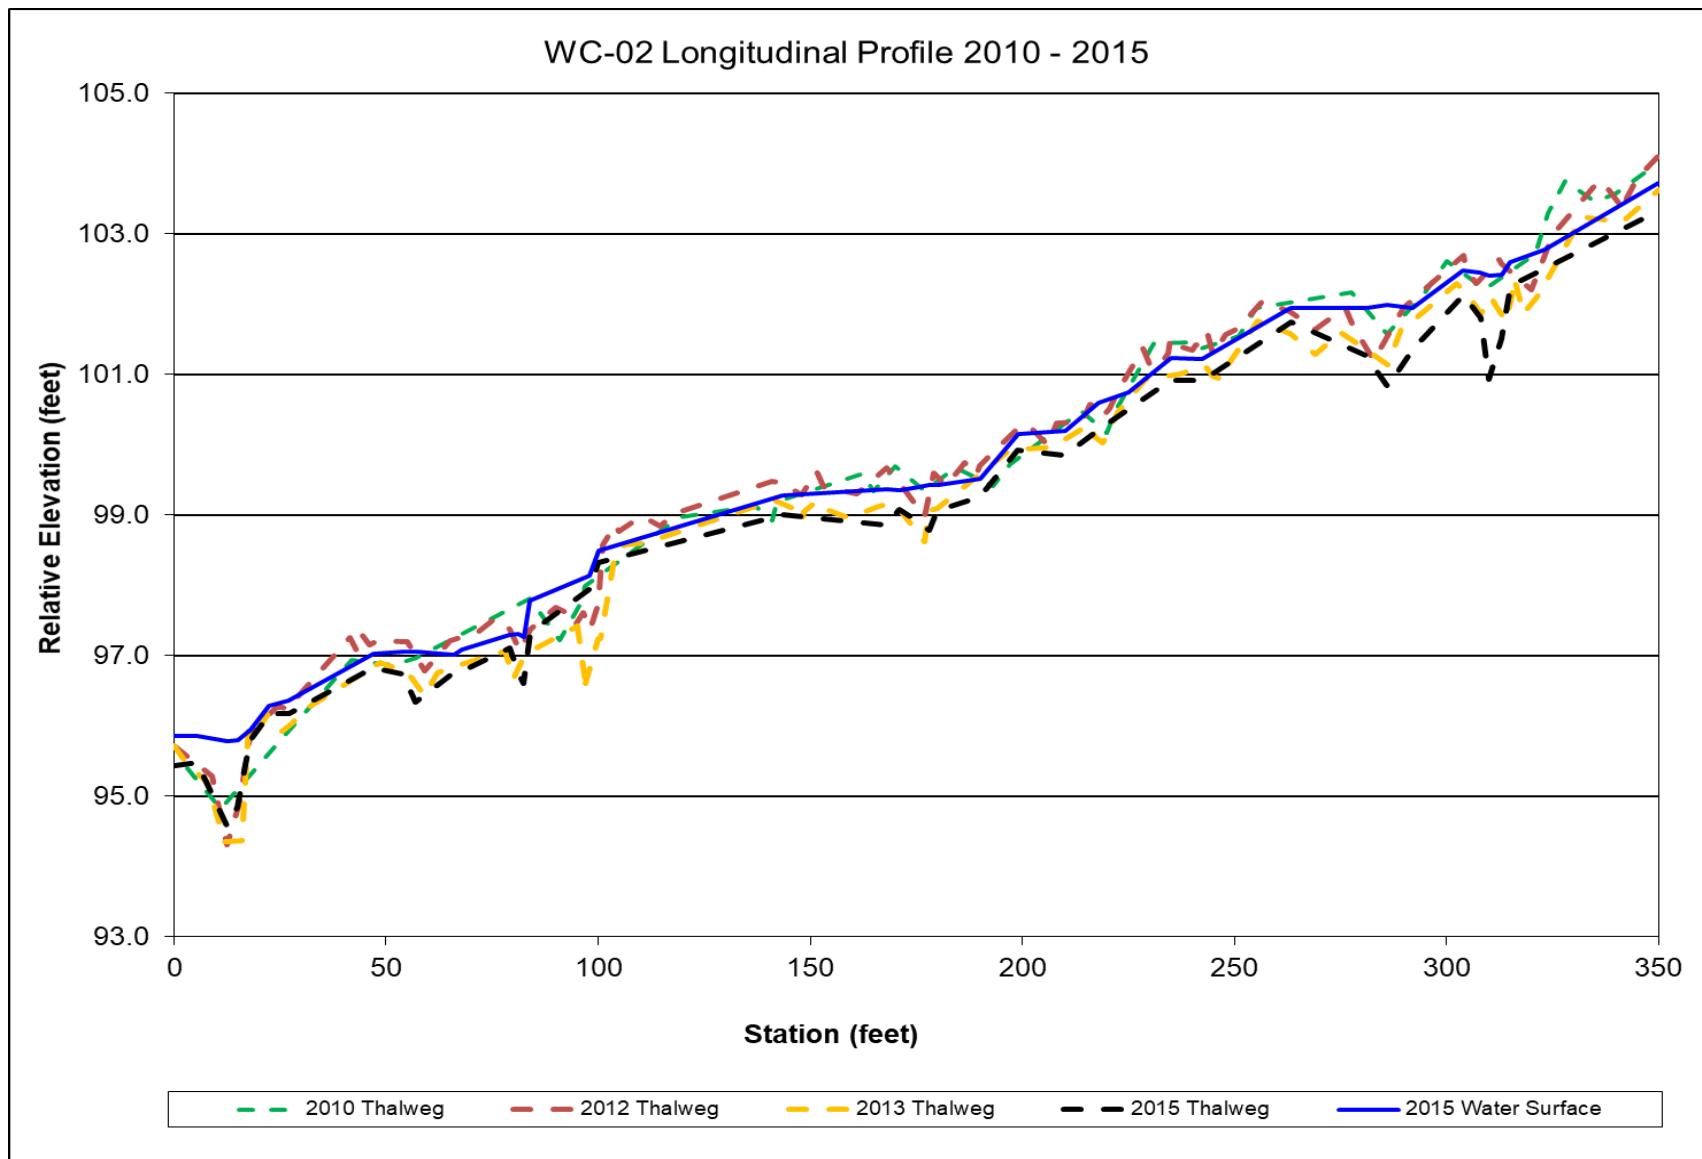
Figure C-3. WC-02 Longitudinal Profile (Pre-Restoration)

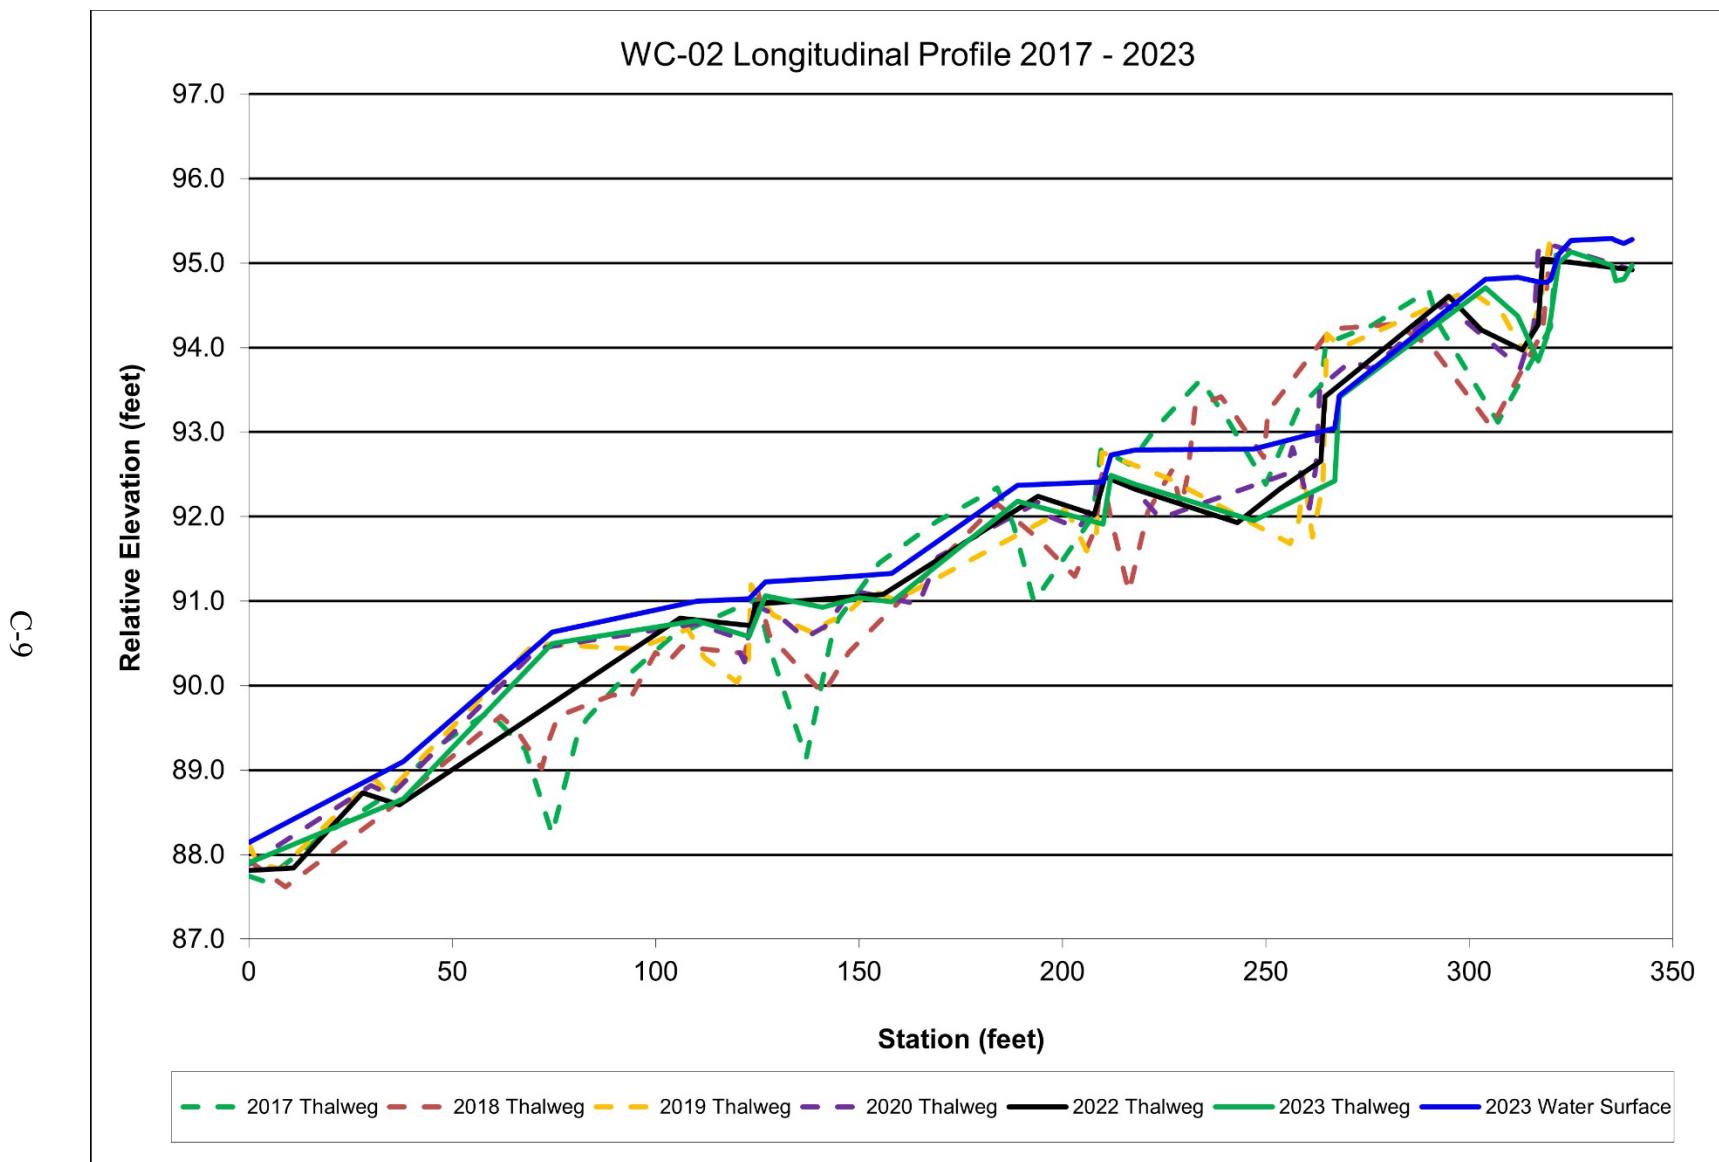
Figure C-4. WC-02 Longitudinal Profile (Post-Restoration)

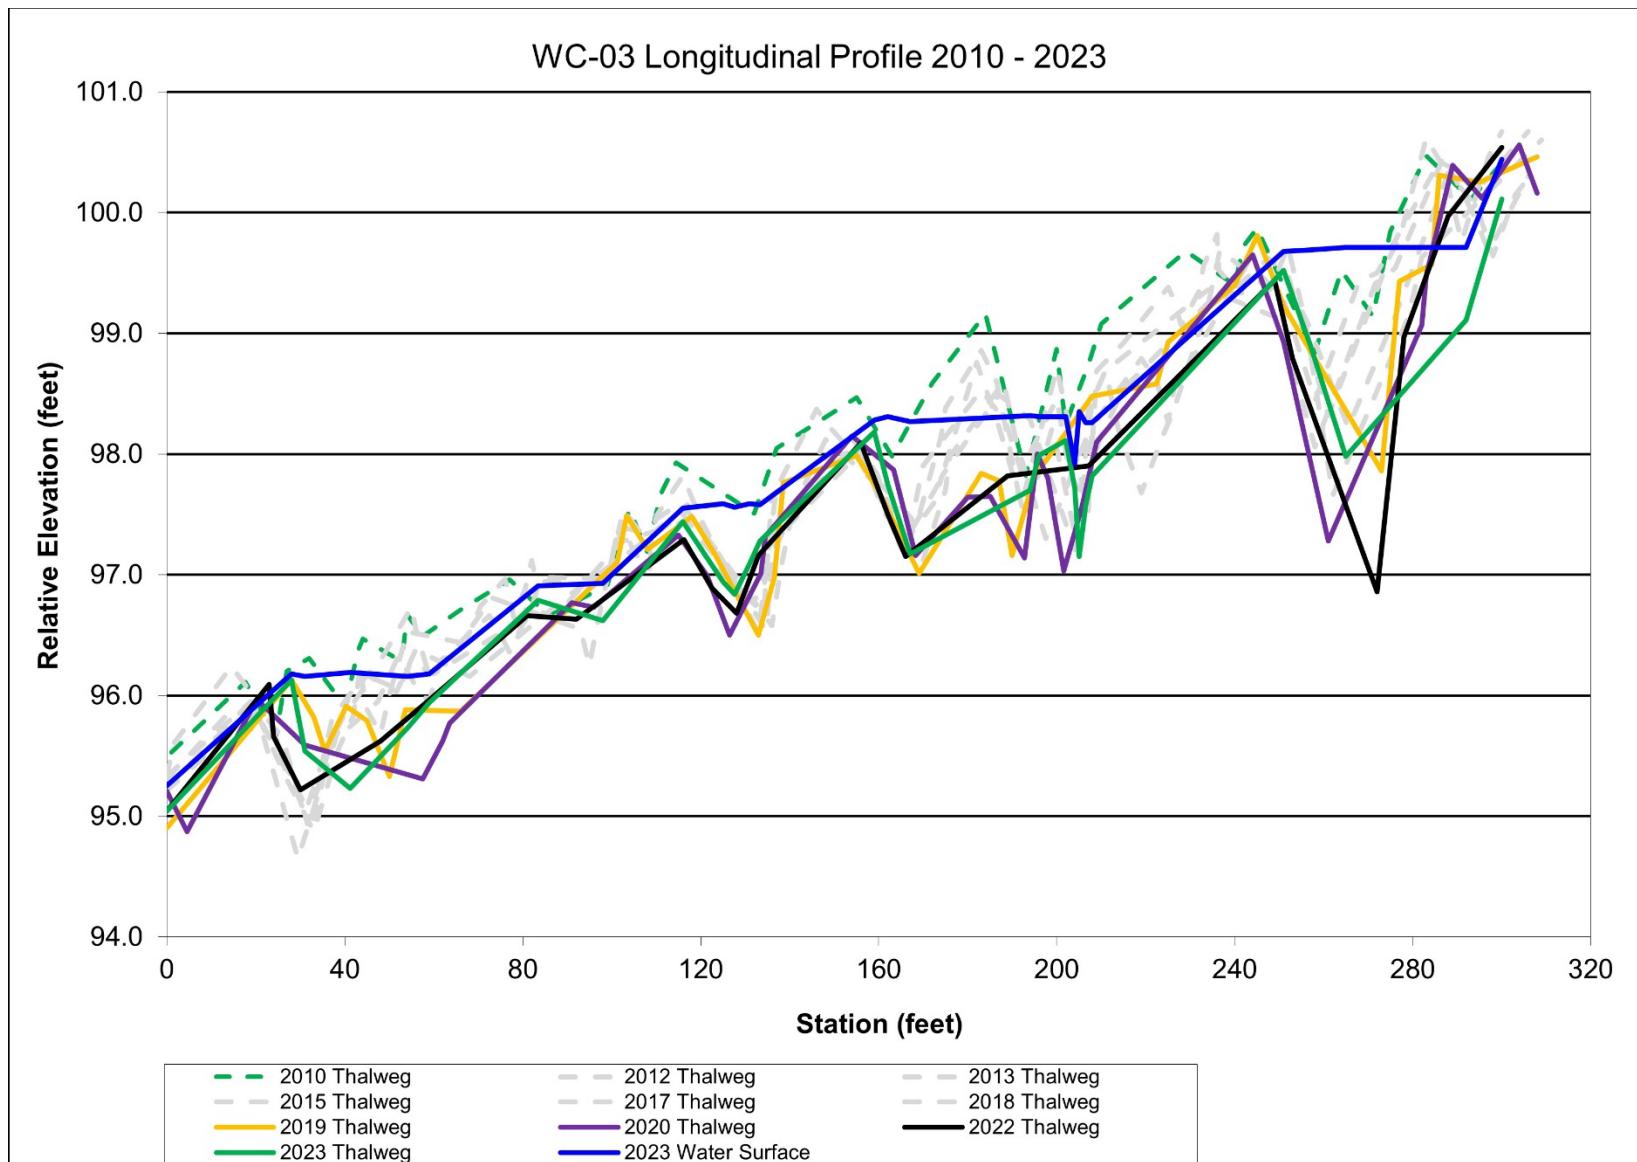
Figure C-5. WC-03 Longitudinal Profile (Pre- and Post-Restoration)

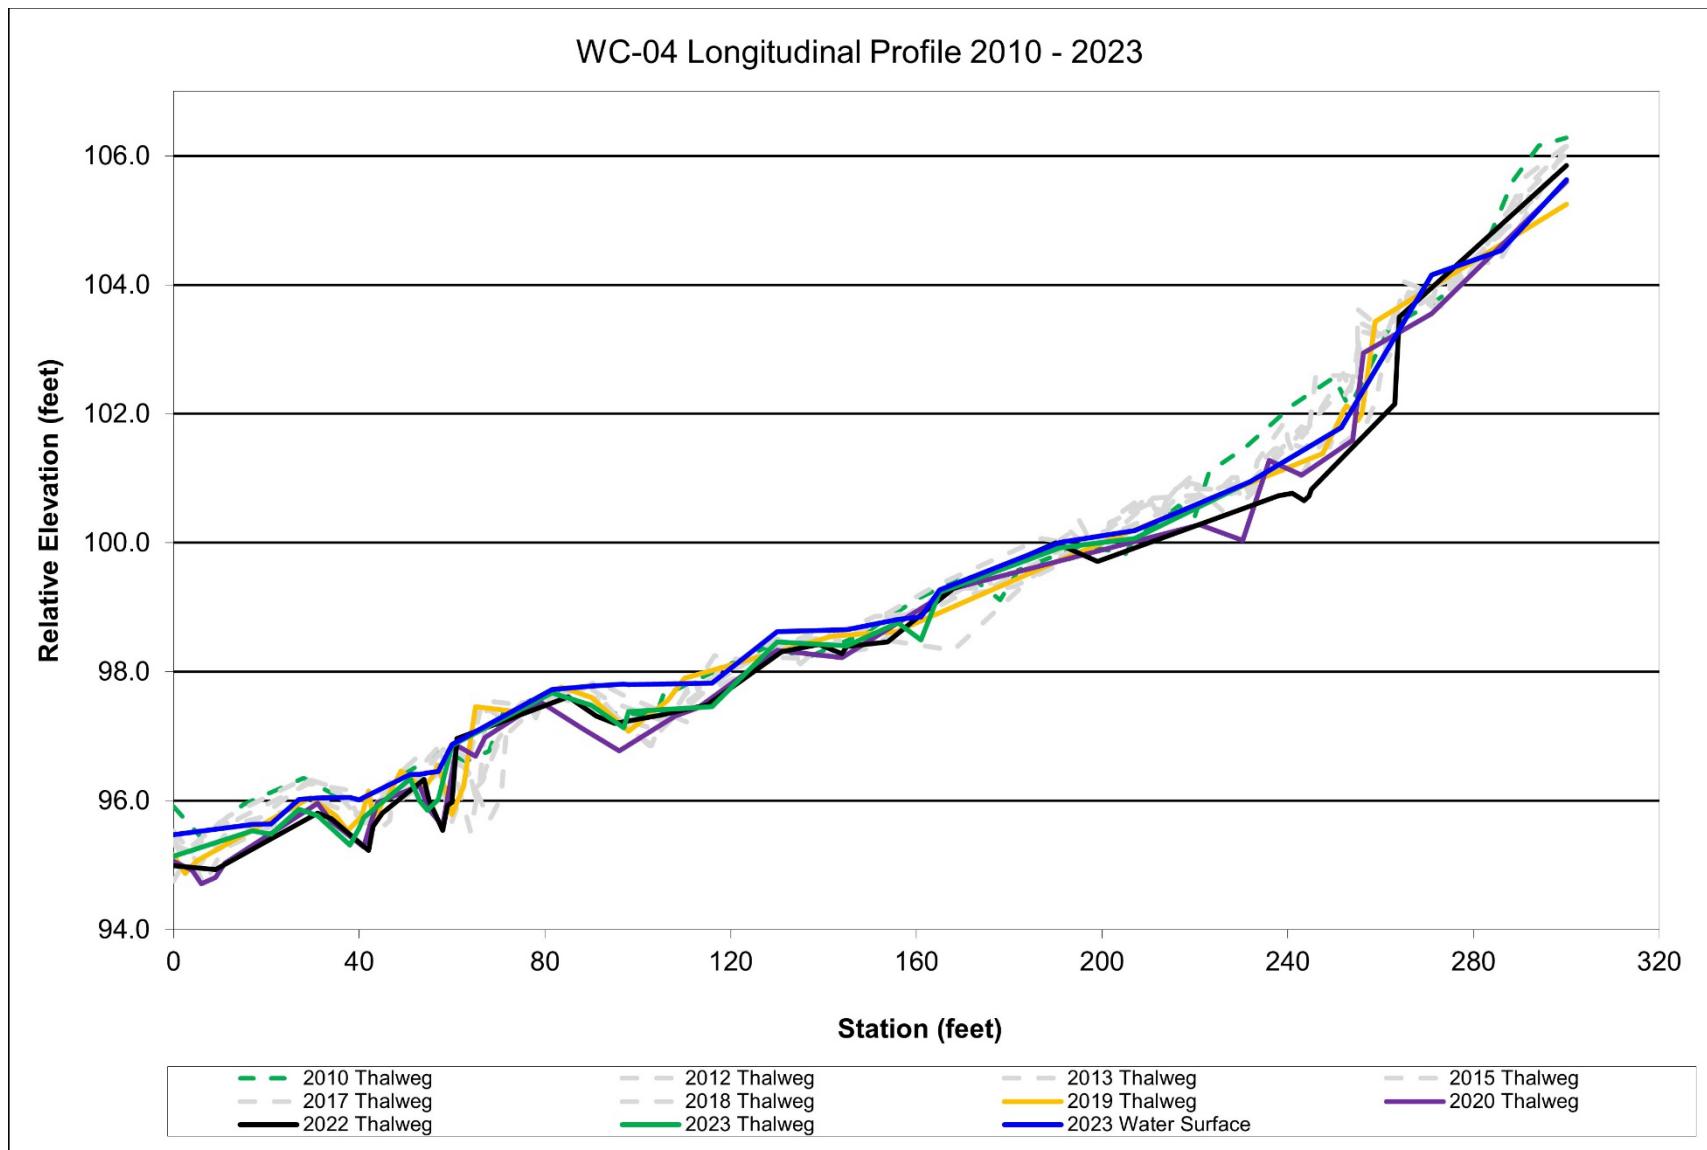
Figure C-6. WC-04 Longitudinal Profile (Pre- and Post-Restoration)

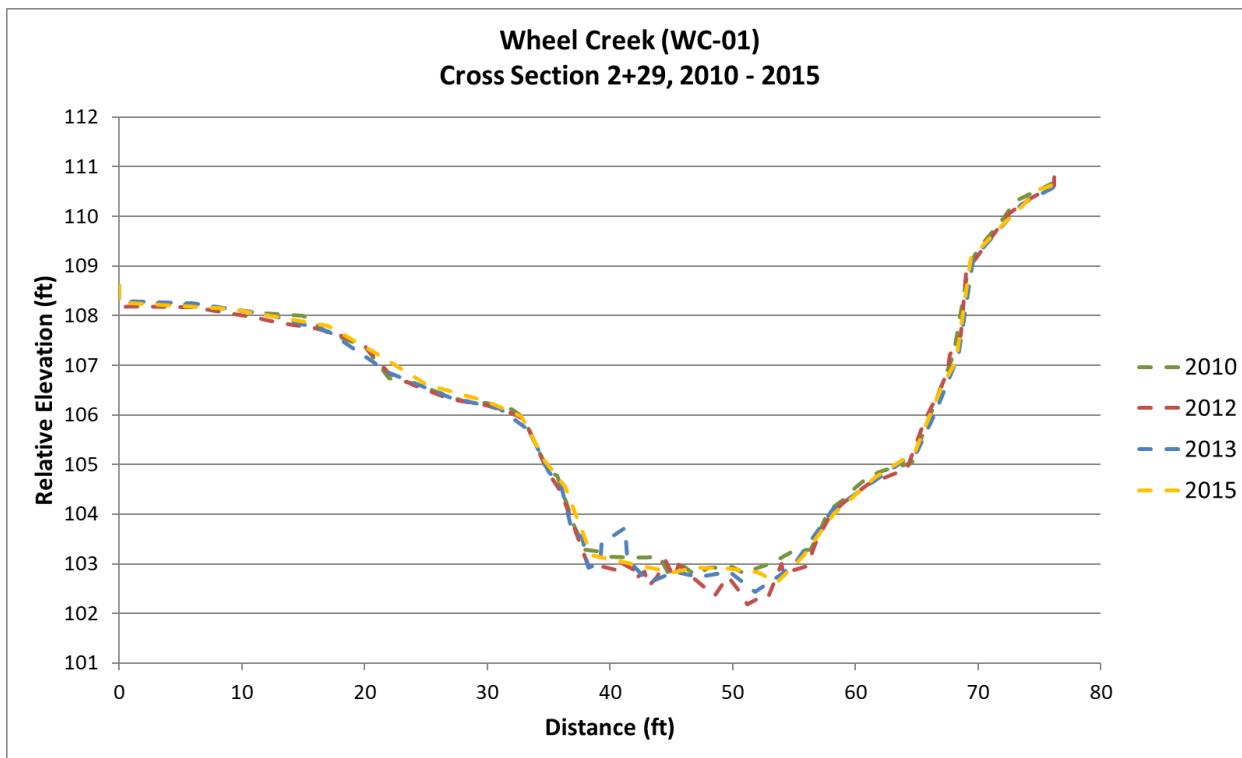
Figure C-7. WC01 Cross-section 1 (Pre-Restoration)

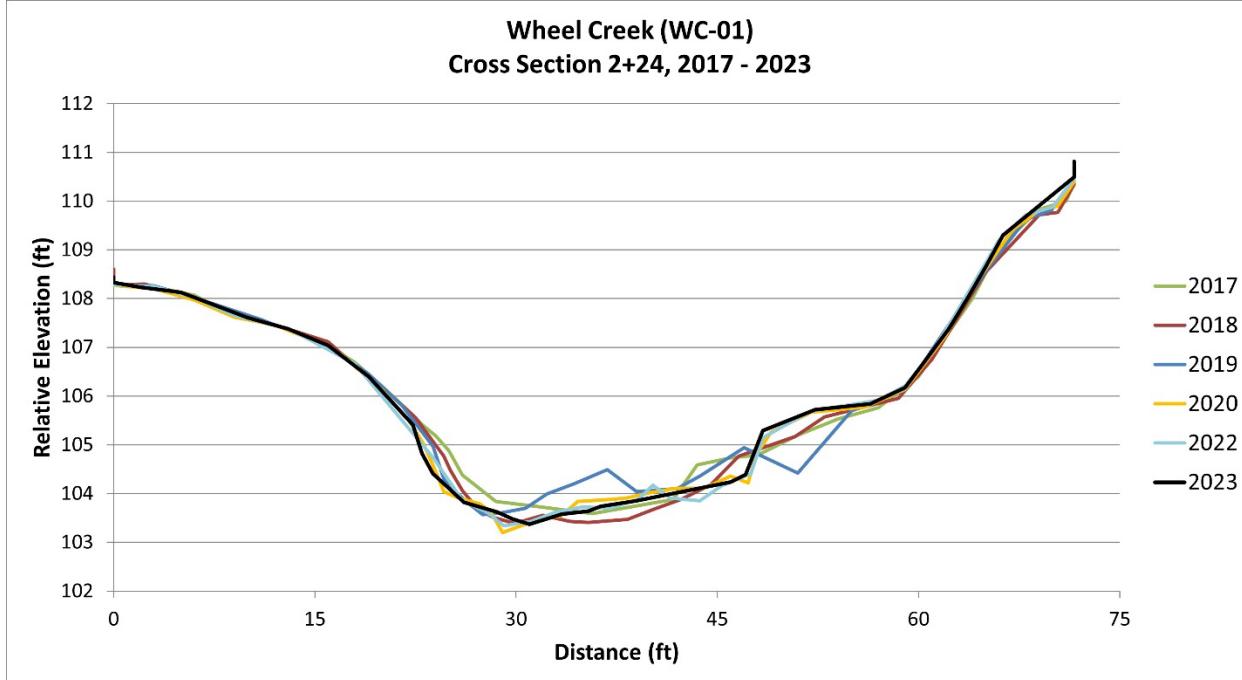
Figure C-8. WC01 Cross-section 1 (Post-Restoration)

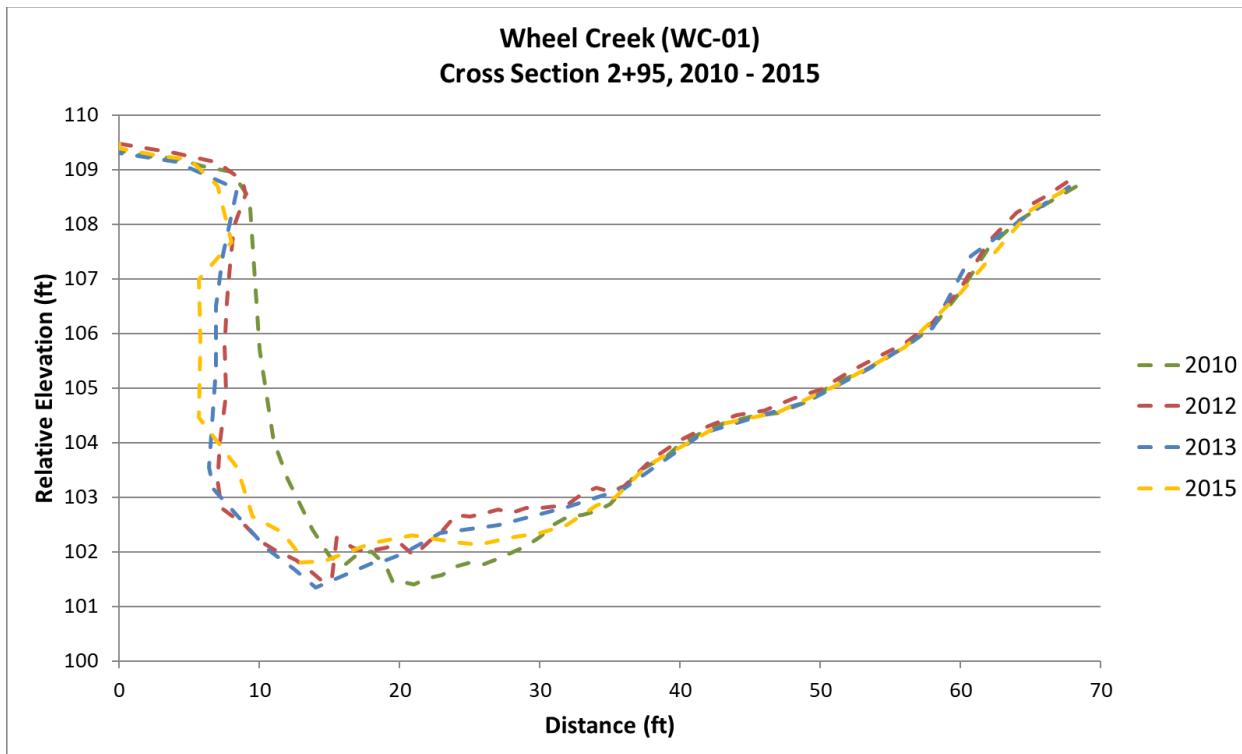
Figure C-9. WC01 Cross-section 2 (Pre-Restoration)

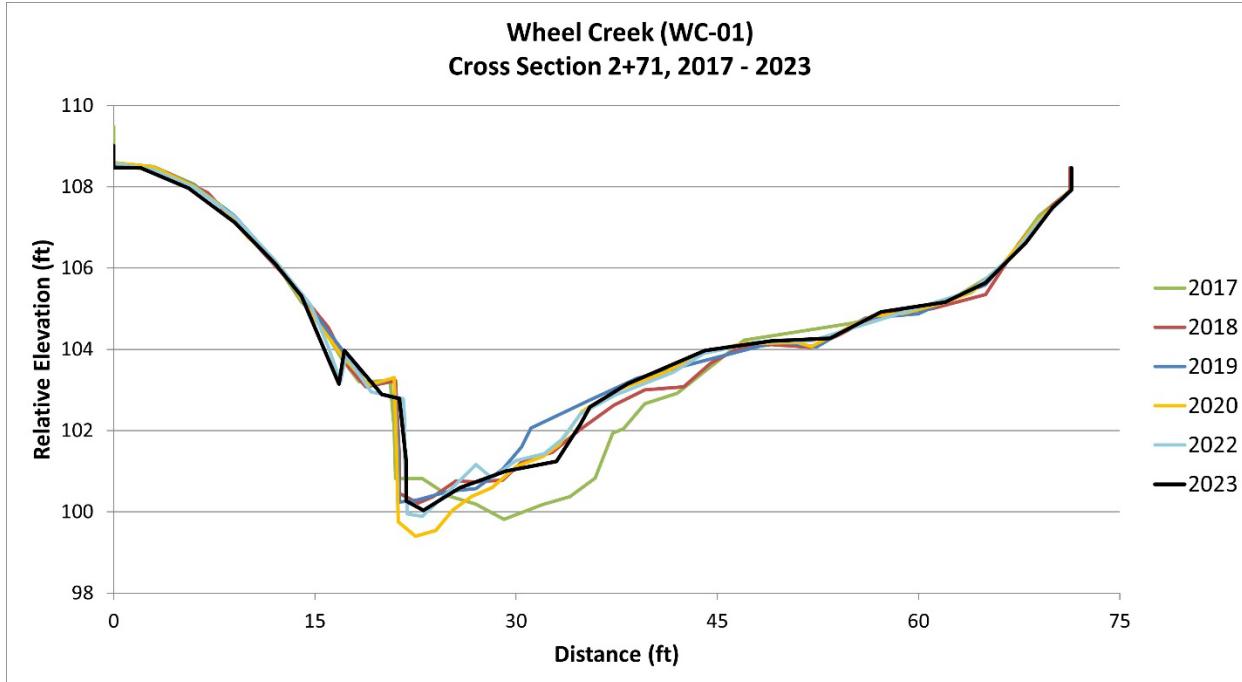
Figure C-10. WC01 Cross-section 2 (Post-Restoration)

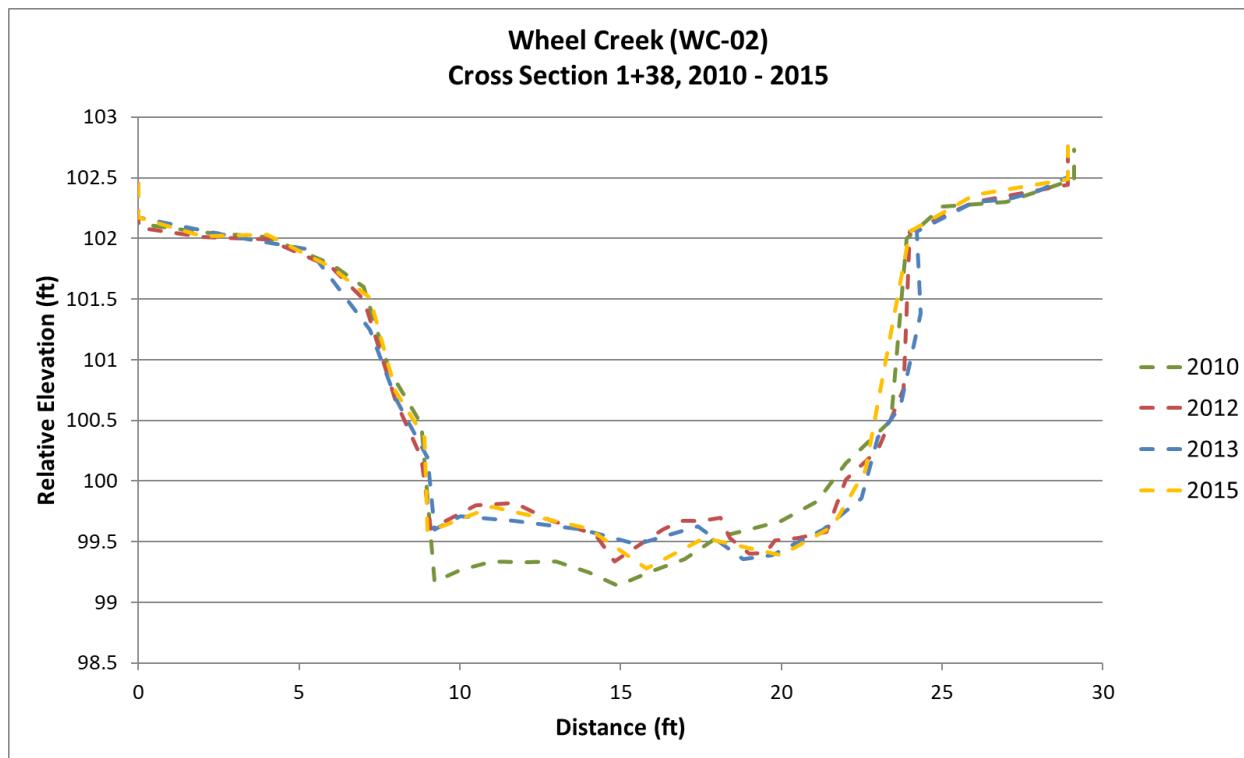
Figure C-11. WC02 Cross-section 1 (Pre-Restoration)

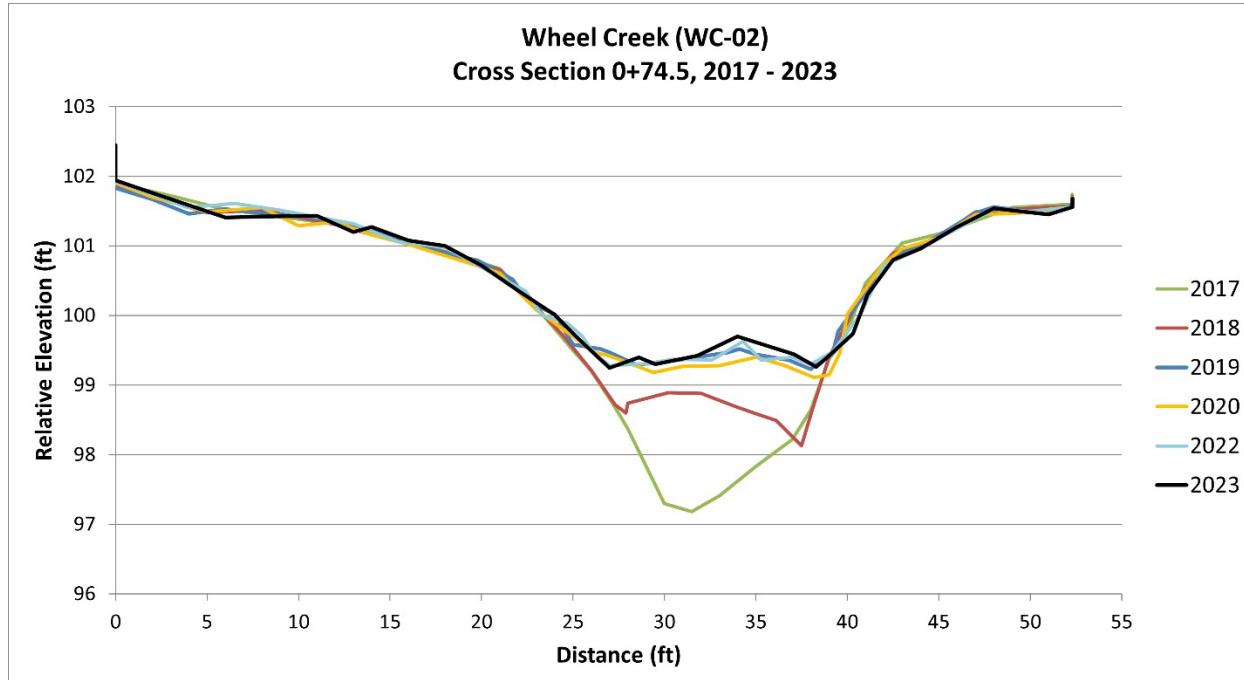
Figure C-12. WC02 Cross-section 1 (Post-Restoration)

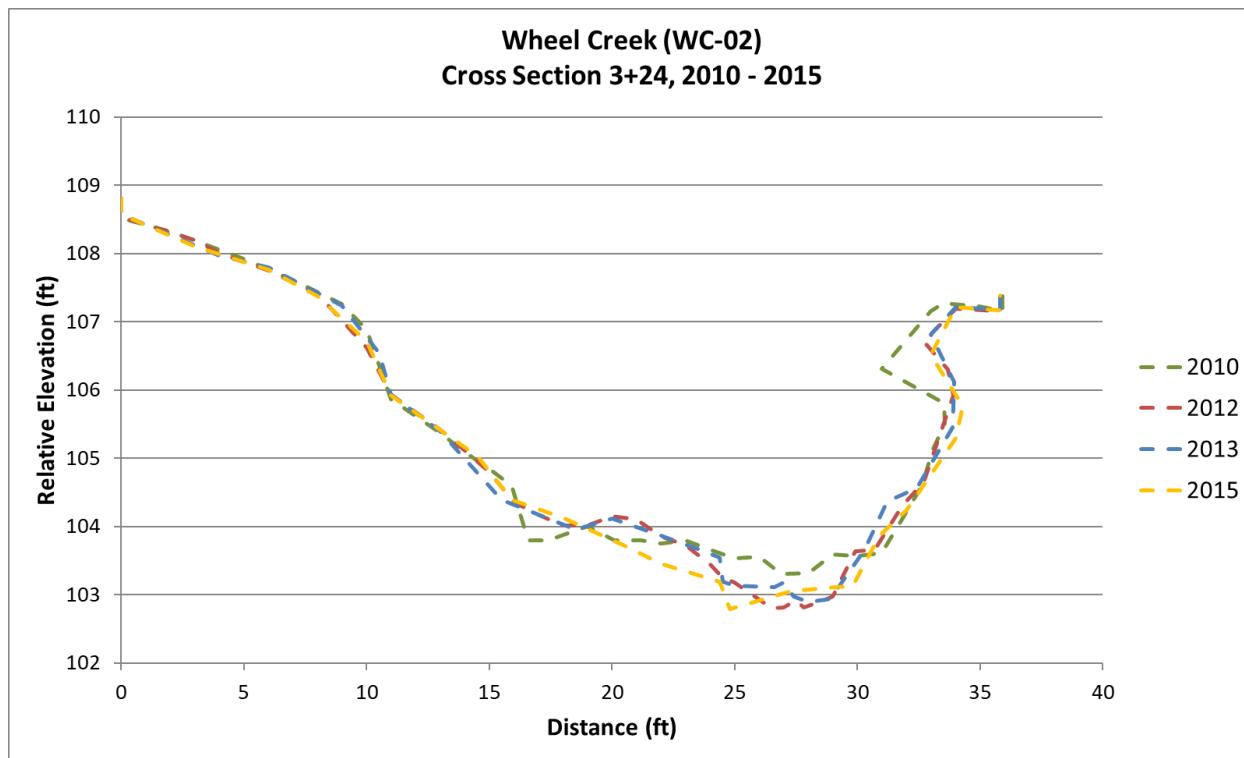
Figure C-13. WC02 Cross-section 2 (Pre-Restoration)

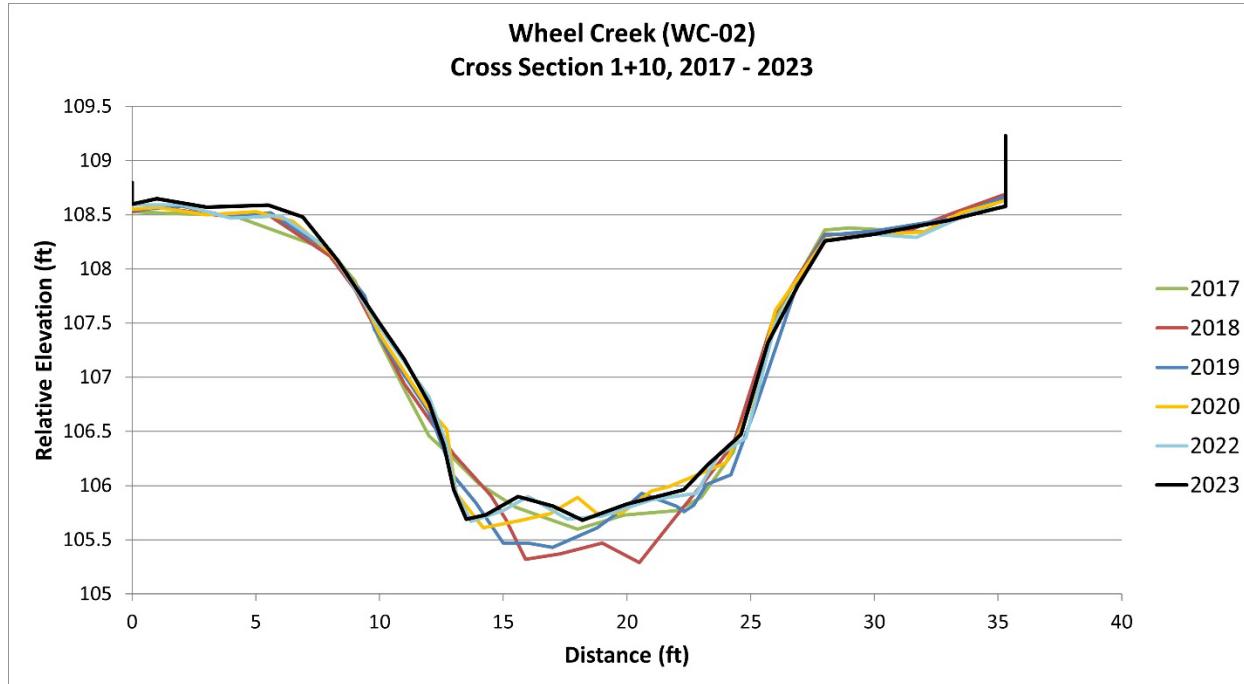
Figure C-14. WC02 Cross-section 2 (Post-Restoration)

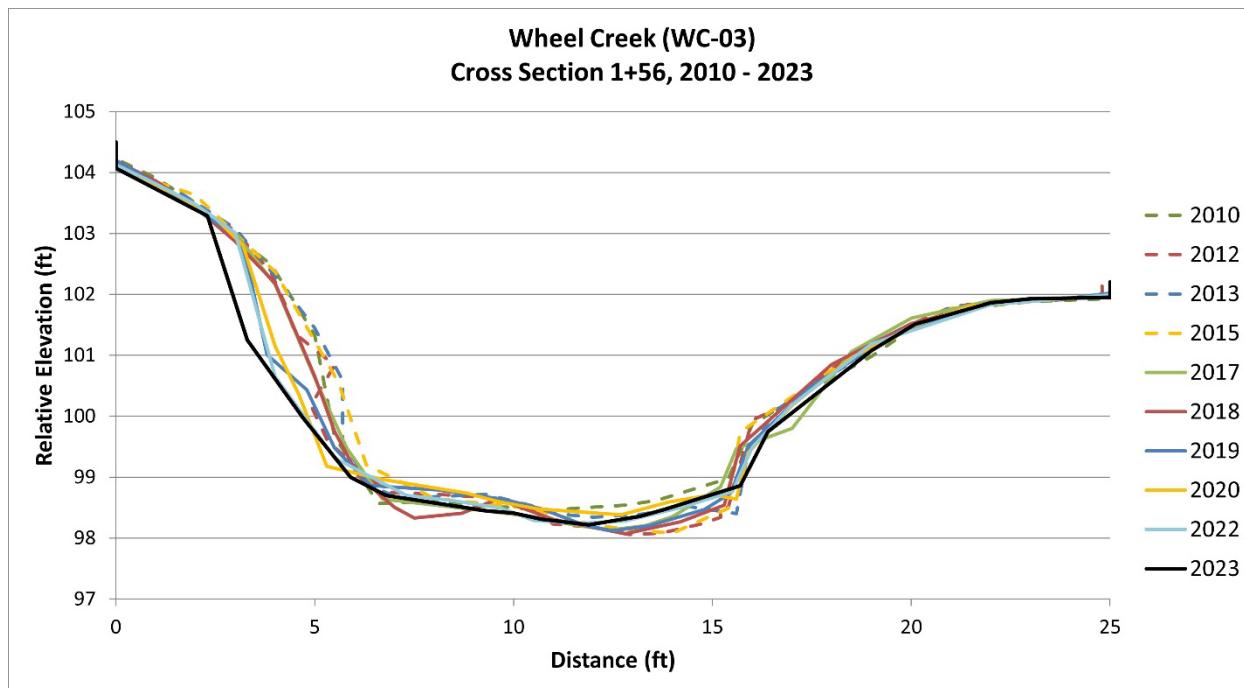
Figure C-15. WC03 Cross-section 1 (Pre- and Post-Restoration)

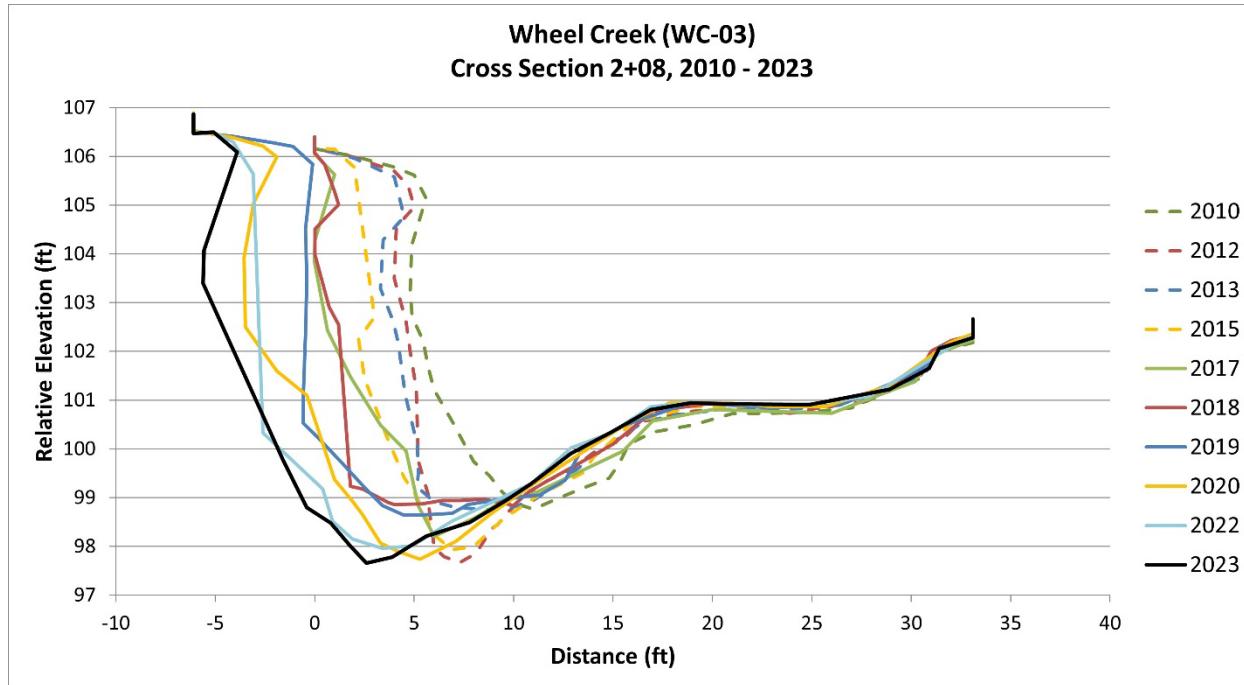
Figure C-16. WC03 Cross-section 2 (Pre- and Post-Restoration)
