## Appendix G1 - Assessment of Controls (BMP Effectiveness Monitoring)

**WHEEL CREEK  
WATER CHEMISTRY MONITORING  
YEAR 13 REPORT**

Harford County  
Department of Public Works  
Watershed Protection and Restoration  
212 South Bond Street  
Bel Air, Maryland 21014

Final, December 12, 2023

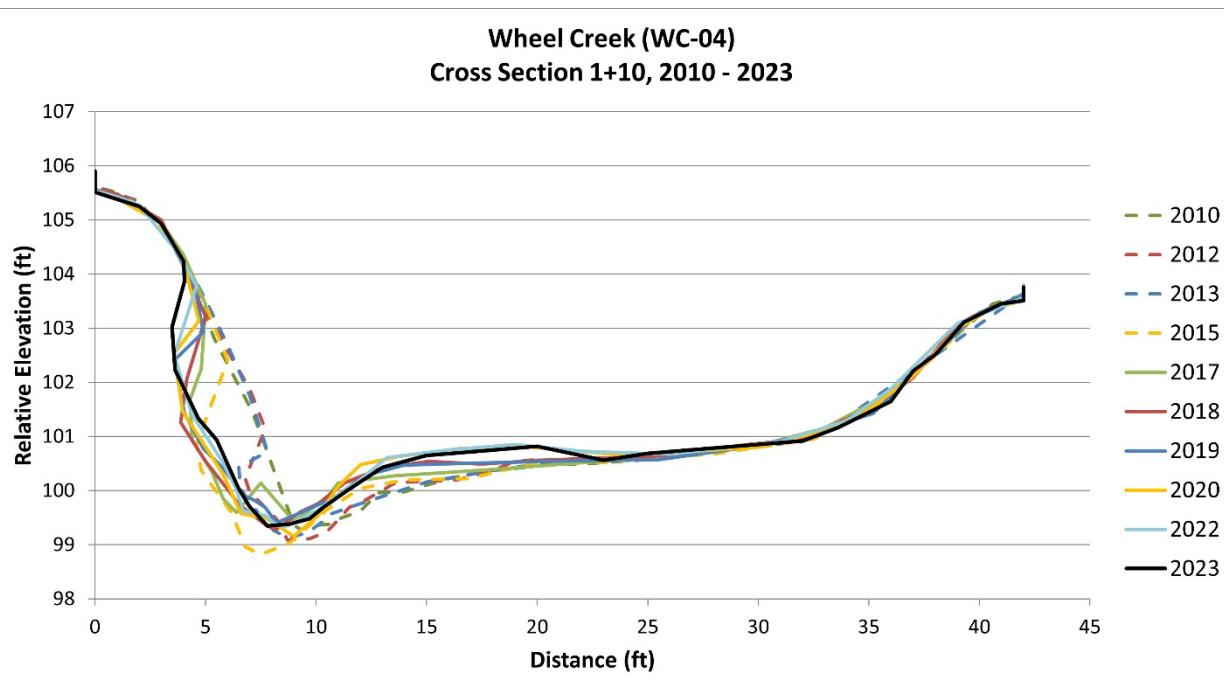
Figure C-17. WC04 Cross-section 1 (Pre- and Post-Restoration)

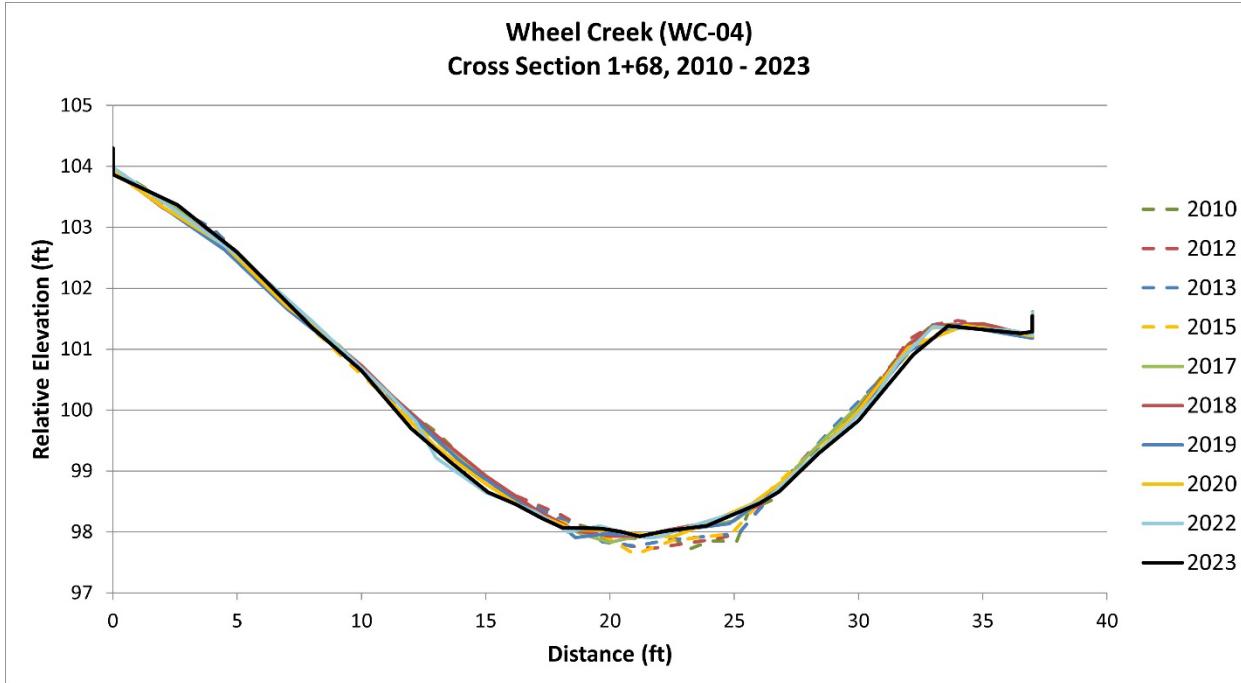
Figure C-18. WC04 Cross-section 2 (Pre- and Post-Restoration)

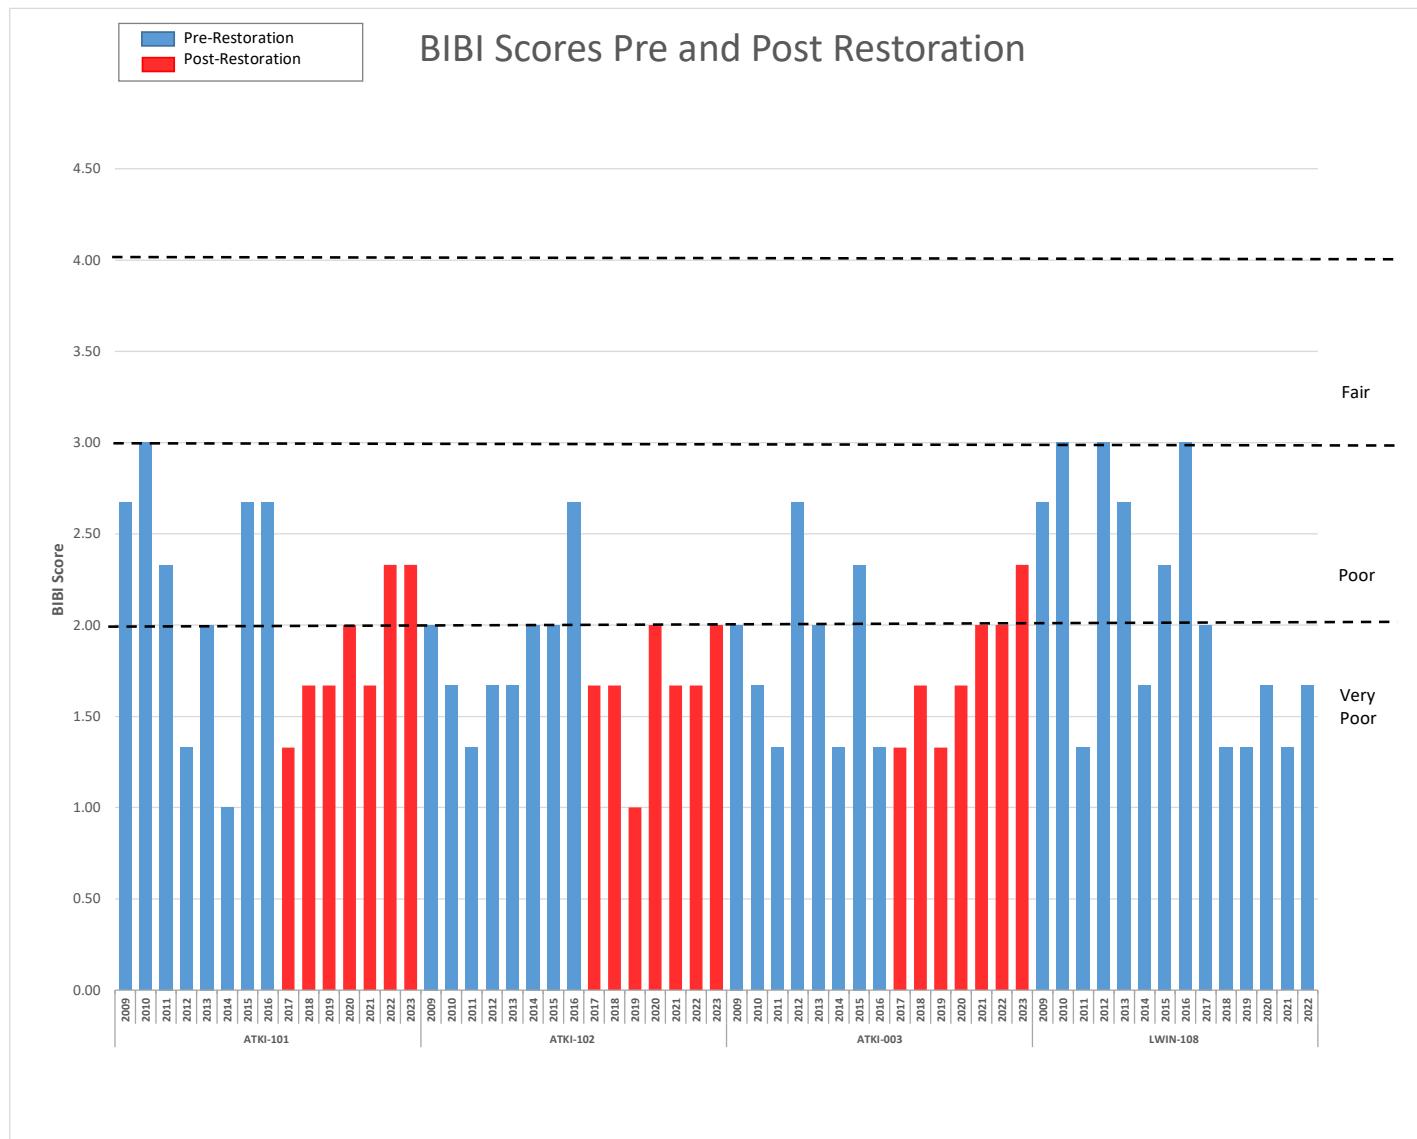
Figure 2 – Wheel Creek BIBI Scores by Year

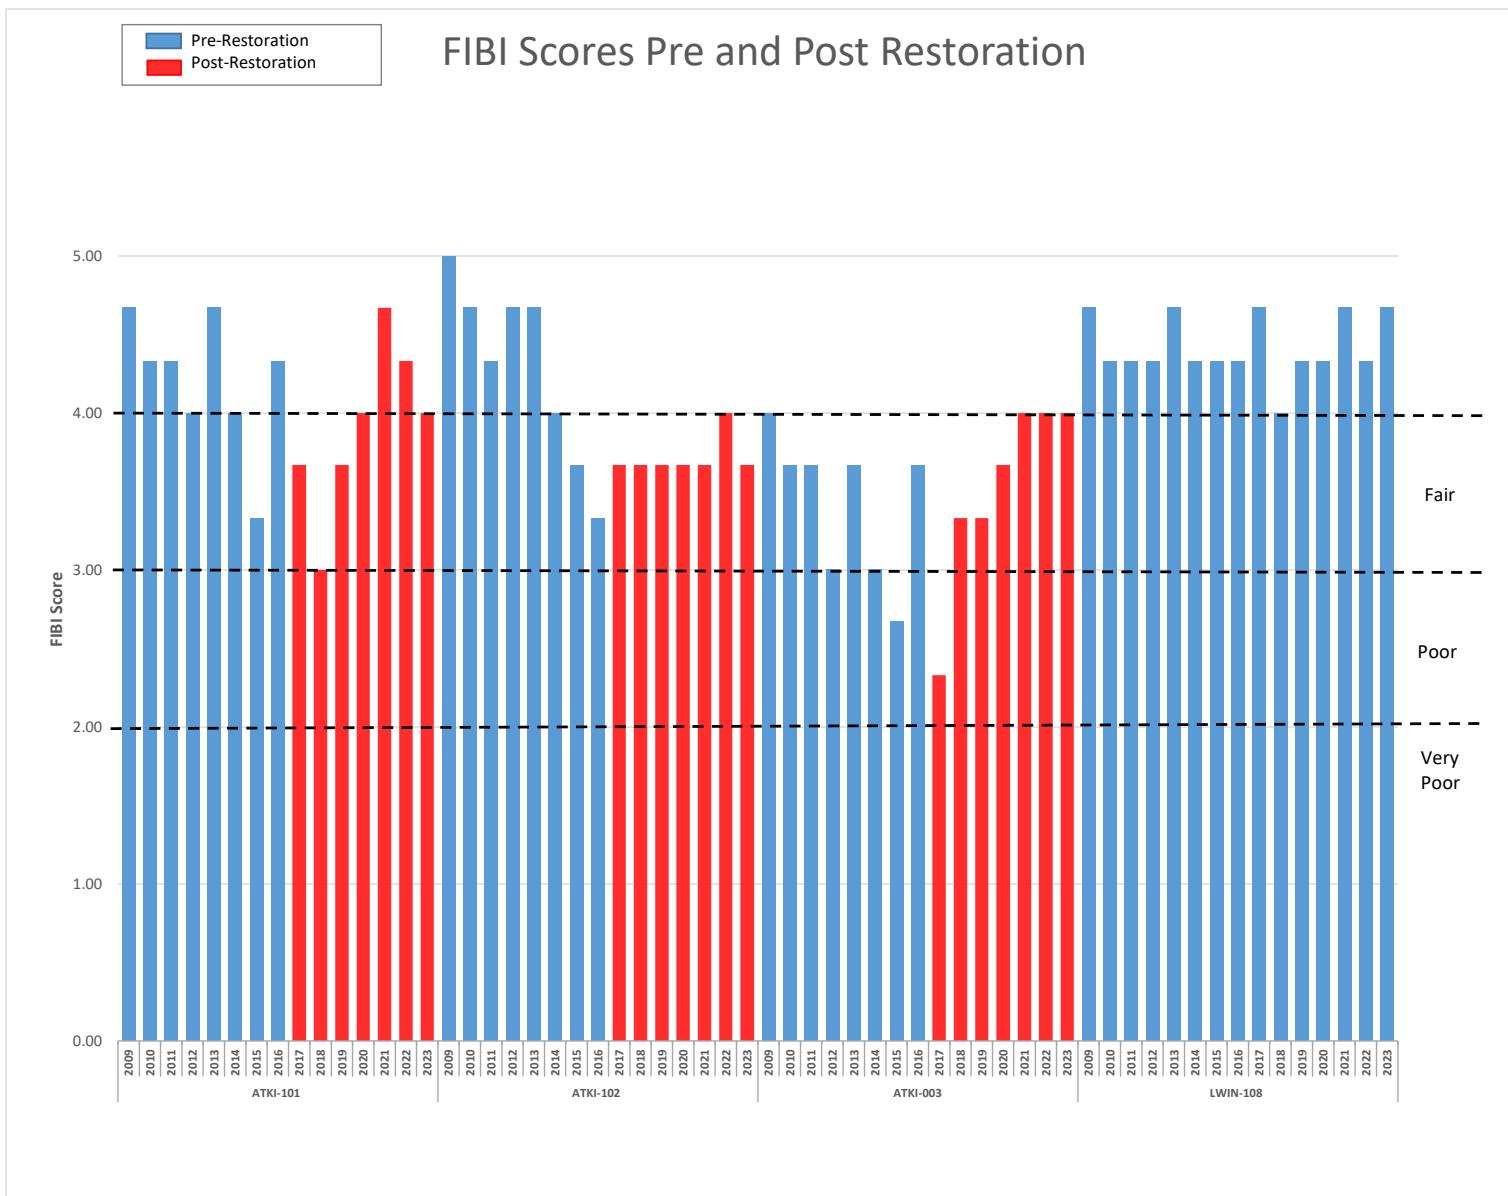
Figure 3 – Wheel Creek FIBI Scores by Year

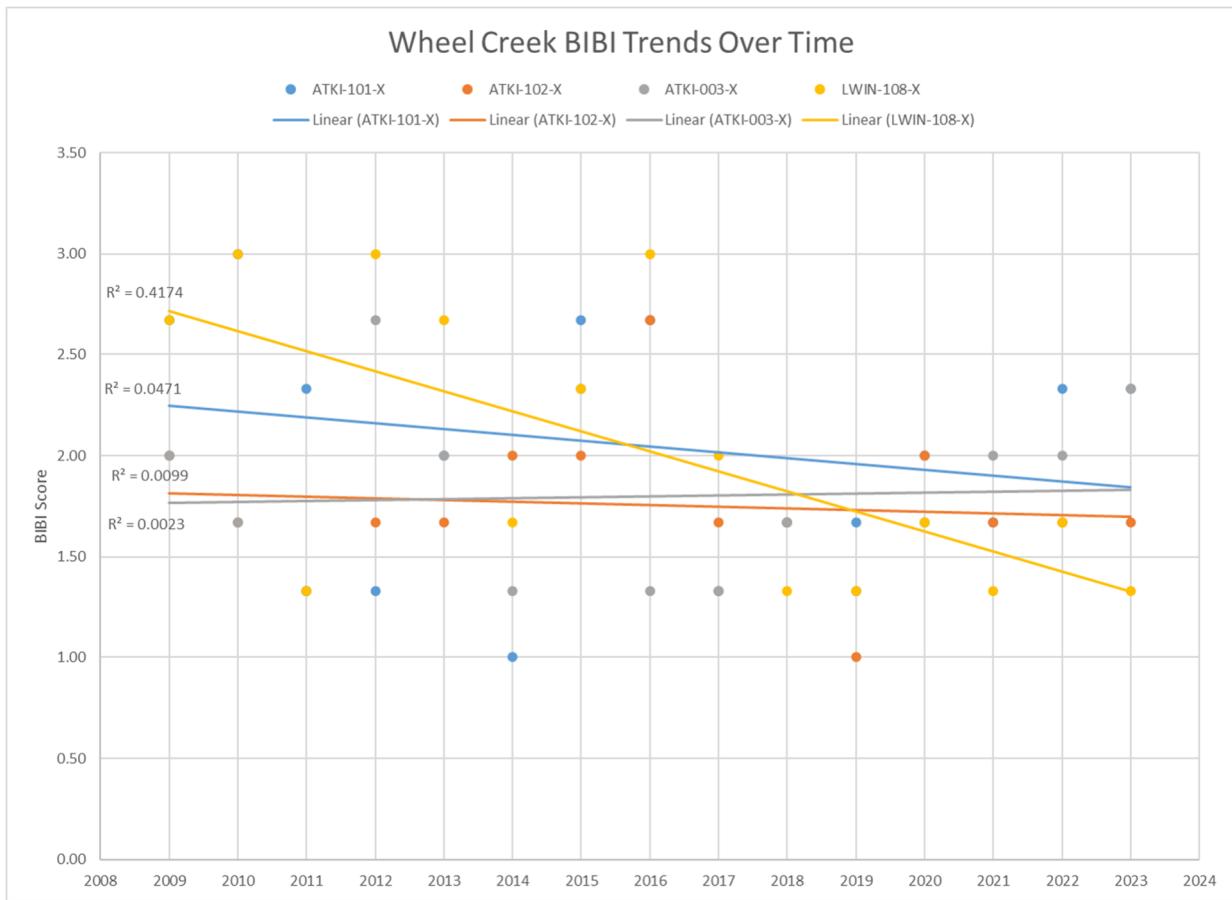
**Figure 4 - BIBI Trends over time (2009 - 2023)**

Though there has been little additional development around Wheel Creek the stream itself could be facing urban stream syndrome. Urban stream syndrome can be defined as framework of common responses seen in streams that are in or near urban settings (Booth et al 2016). Frequent stream responses can include increased nutrient loads and increases dominance of tolerant species (Walsh et al 2005). Despite restoration efforts some pollutants and nutrients can have legacy effects on a stream causing the stream to remain impaired, ultimately preventing the stream from supporting benthic communities. Lastly, the proximity of Wheel Creek to healthy and biologically diverse communities may not be conducive to dispersal or migration of benthic taxa causing the re-establishment of more sensitive populations to be delayed or non-existent (Southerland et al 2018).

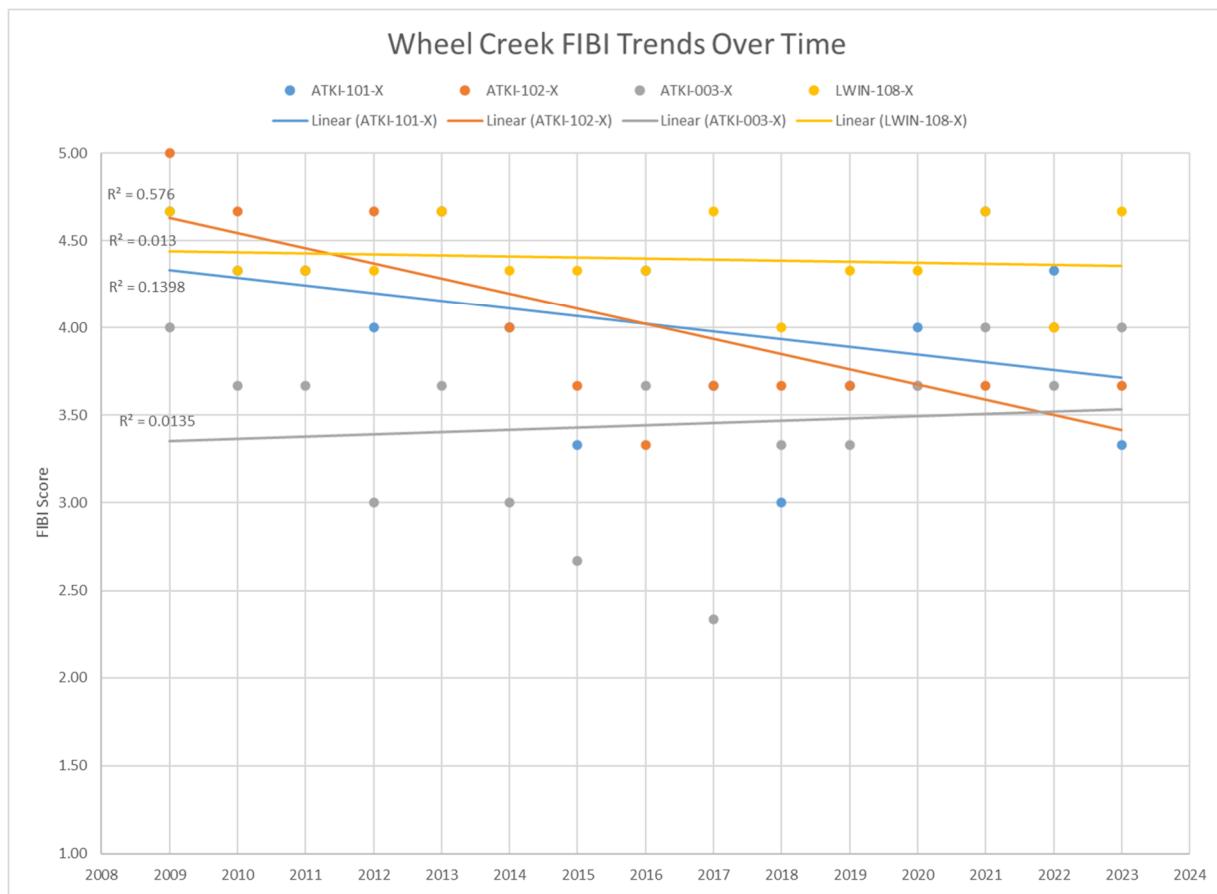
Figure 5 - FIBI Trends over time (2009 - 2023)
