Appendix E3 - Stormwater Restoration (Restoration Monitoring)

C. Milton Wright High School Stream Restoration Post Construction

Annual Monitoring Report – Year 3

Harford County, Maryland

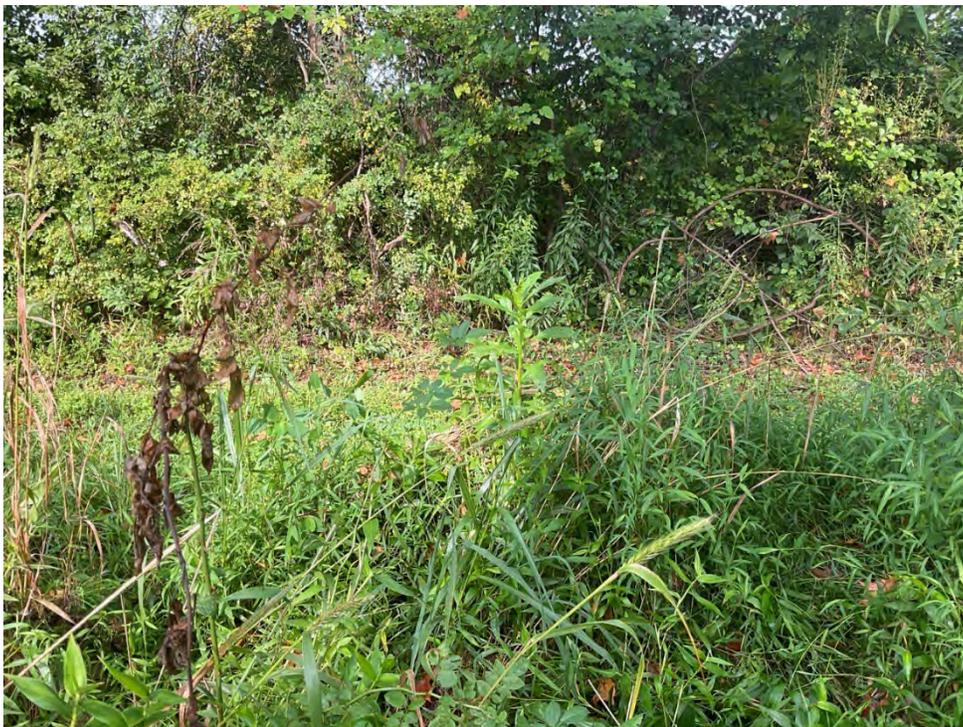
Photo 56. Looking at the right bank at Plot-14 during Year 3.

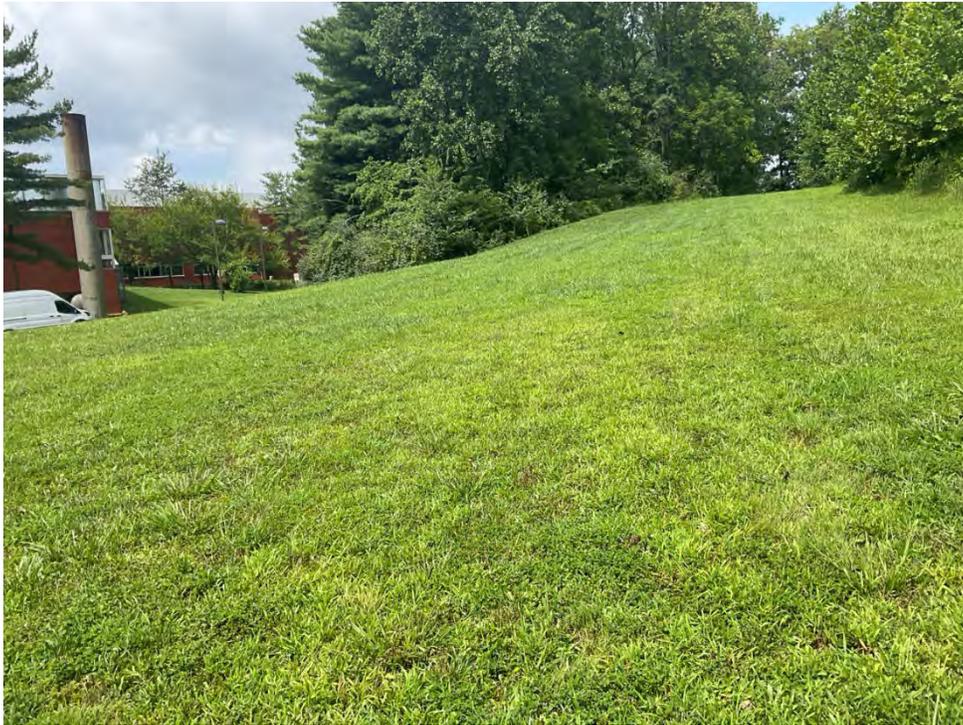
Photo 57. Looking west at the Turf Grass Zone during Year 3.

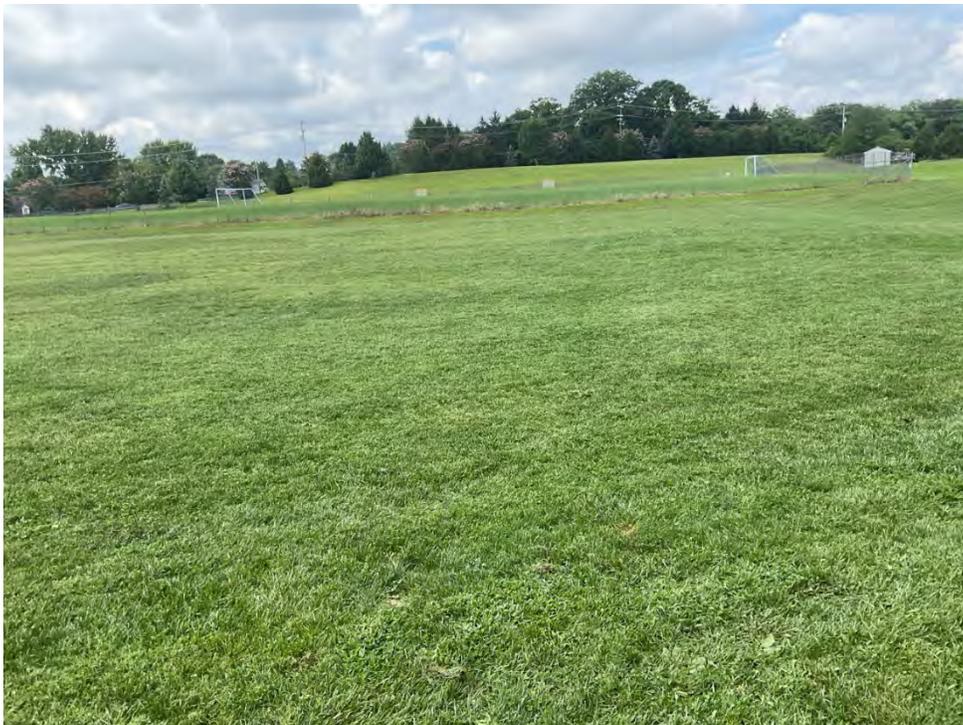
Photo 58. Looking west at the Turf Grass Zone during Year 3.

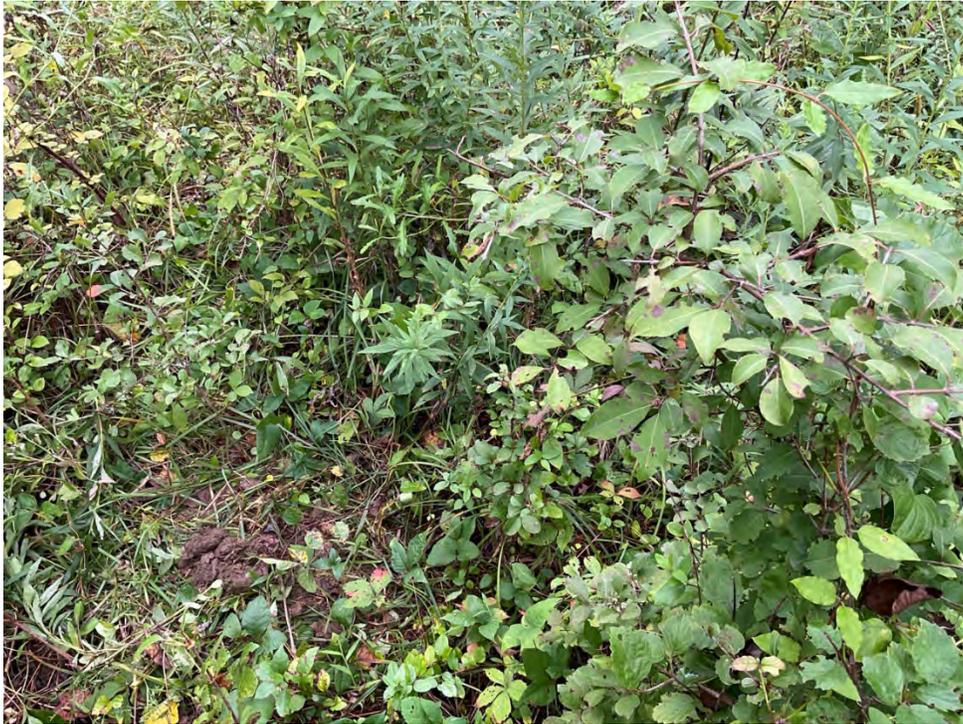
Photo 1: Looking NE at Temporary Wetland Impact Monitoring Plot WET-1 during Year 3.

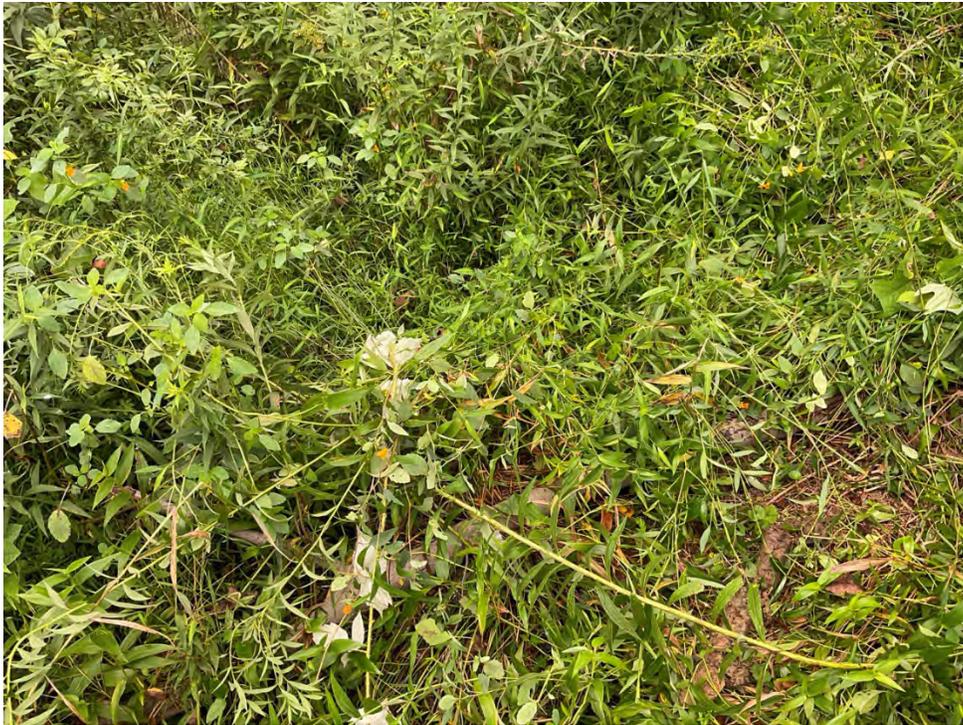
Photo 2: Looking W at Temporary Wetland Impact Monitoring Plot WET-2 during Year 3.

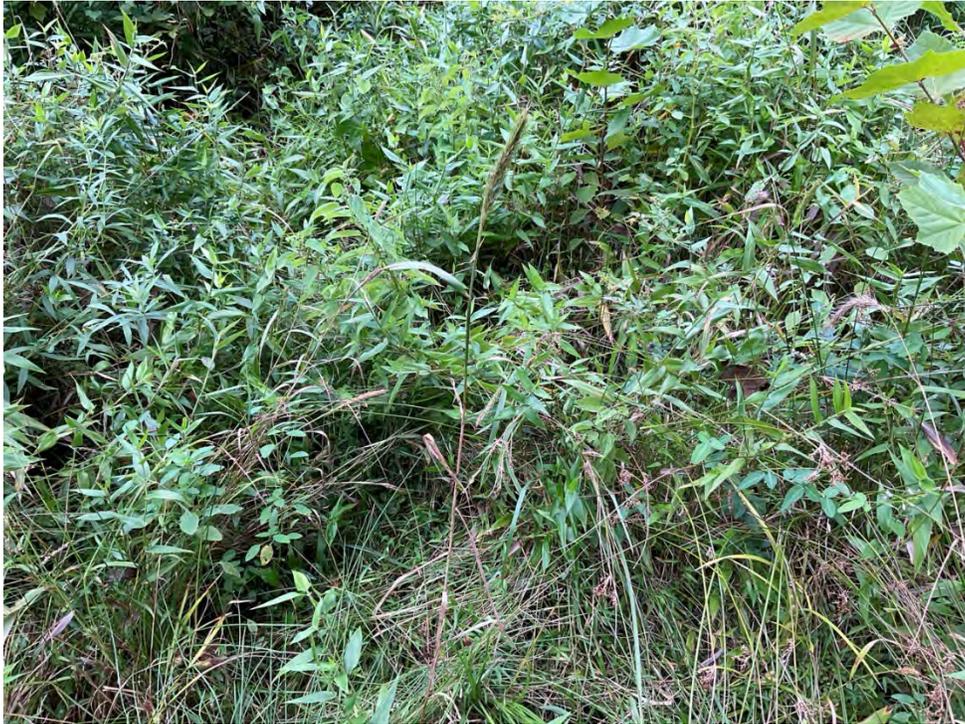
Photo 3: Looking NW at Temporary Wetland Impact Monitoring Plot WET-3 during Year 3.

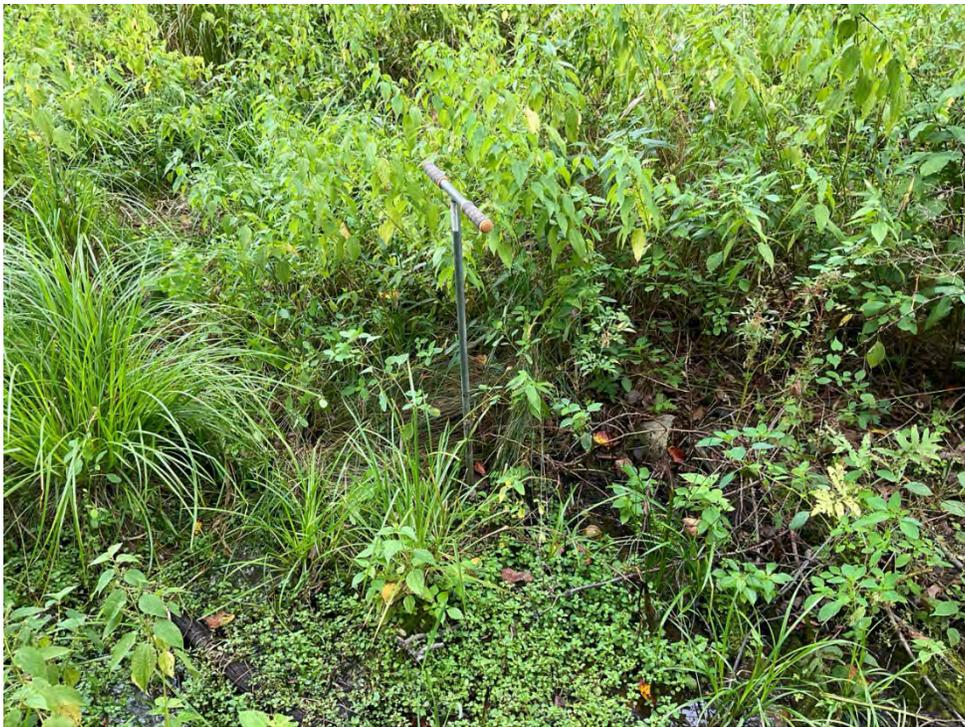
Photo 4: Looking W at Temporary Wetland Impact Monitoring Plot WET-4 during Year 3.

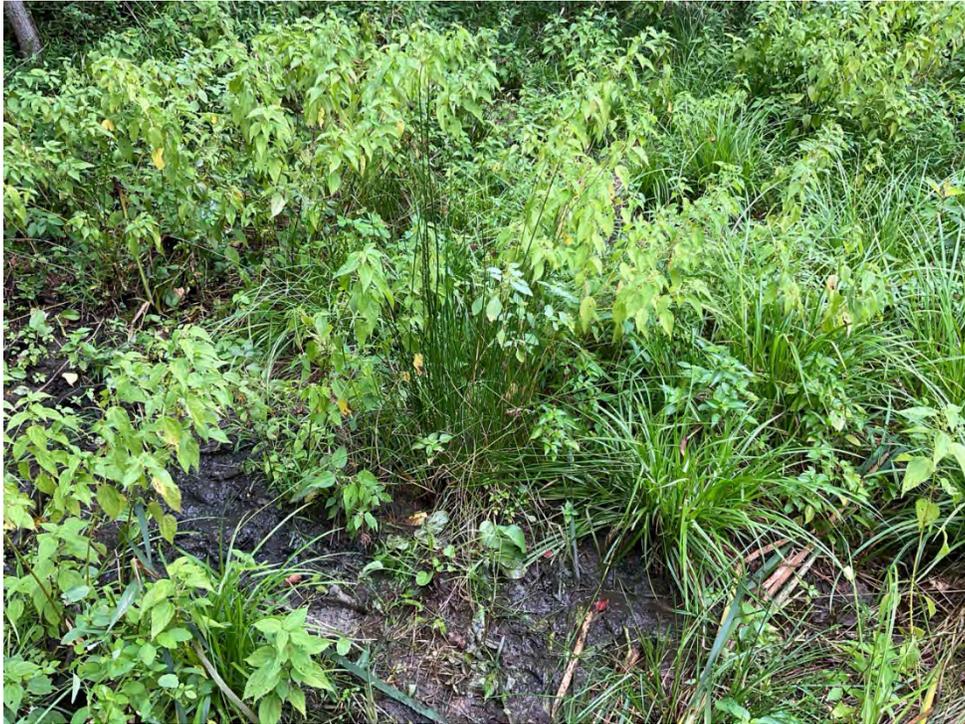
Photo 5: Looking E at Temporary Wetland Impact Monitoring Plot Wet-5 during Year 3.

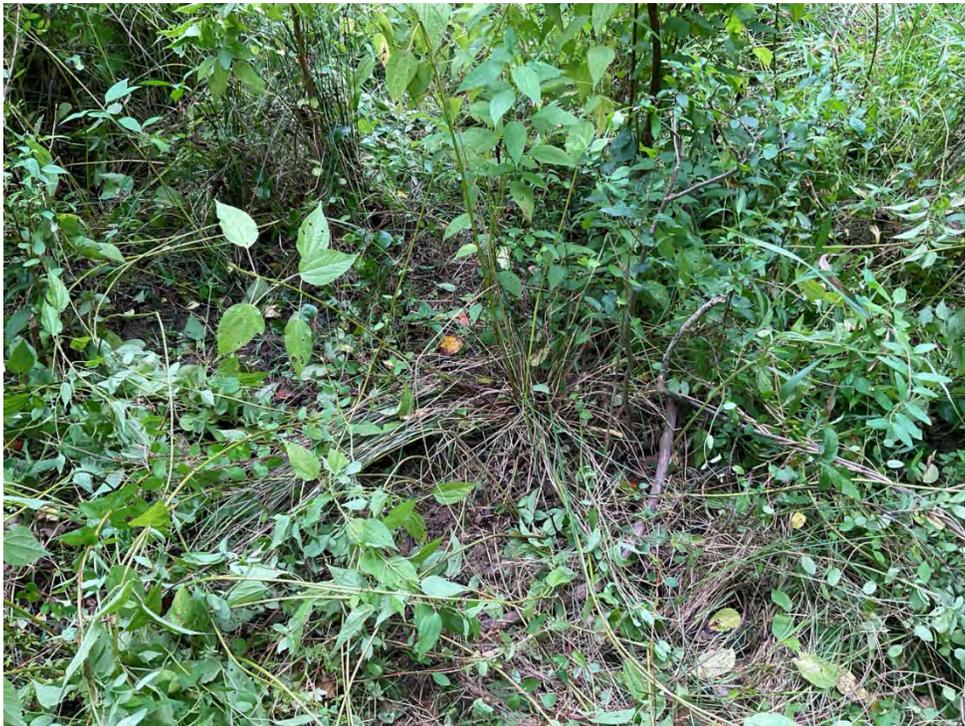
Photo 6: Looking W at Temporary Wetland Impact Monitoring Plot WET-6 during Year 3.

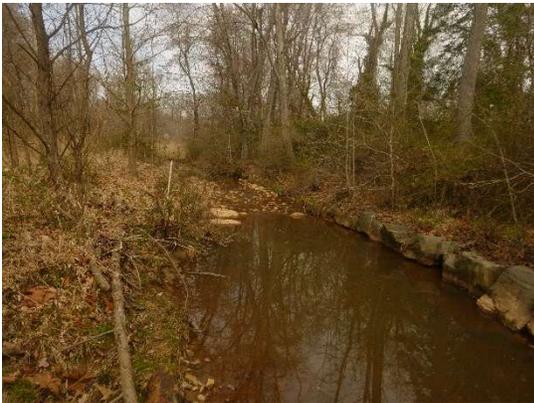
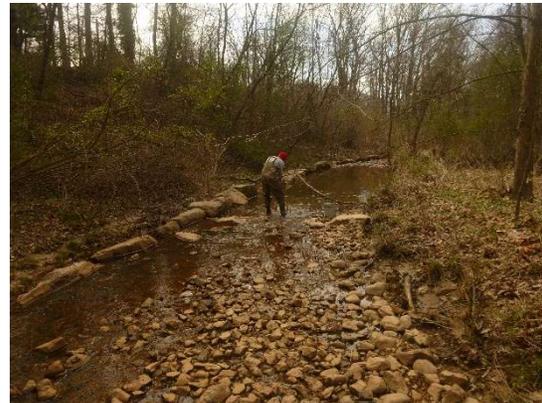
Figure 3-1. Photographs of upstream (left) and downstream (right) sampling conditions at the Foster Branch station FOST-01 during the spring sampling event on March 28, 2025

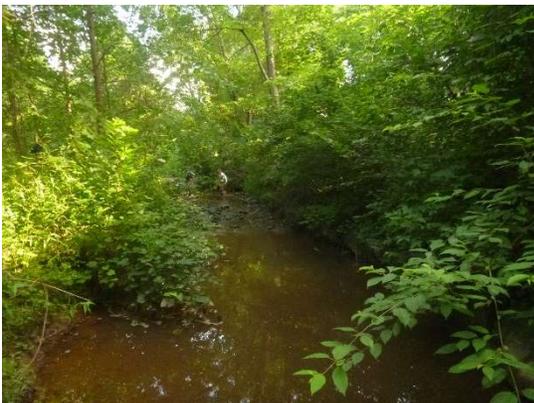
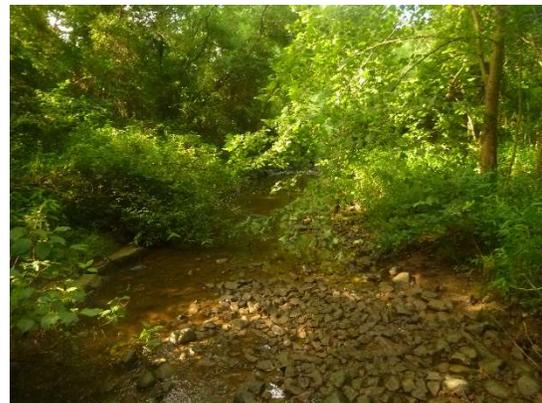
Figure 3-2. Photographs of upstream (left) and downstream (right) sampling conditions at the Foster Branch station FOST-01 during the summer sampling event on July 16, 2025

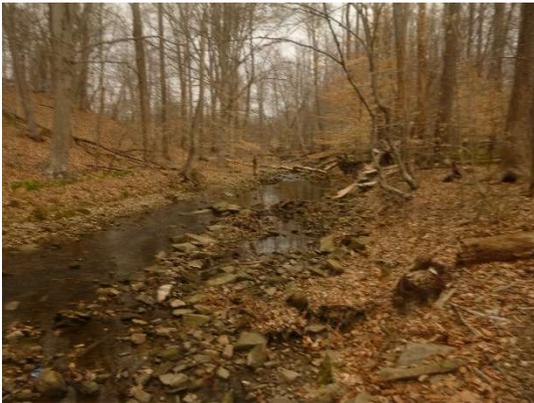
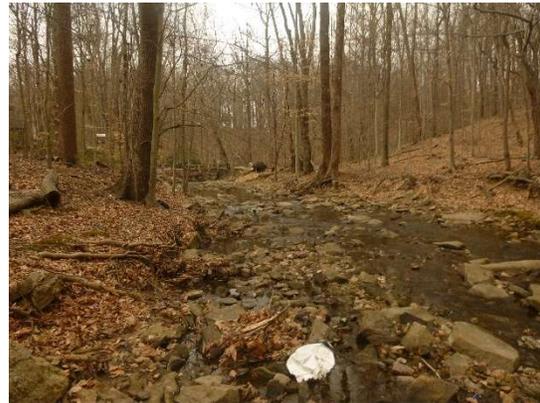
Figure 3-3. Photographs of upstream (left) and downstream (right) sampling conditions at the Plumtree Run station PLUM-01 during the spring sampling event on March 28, 2025

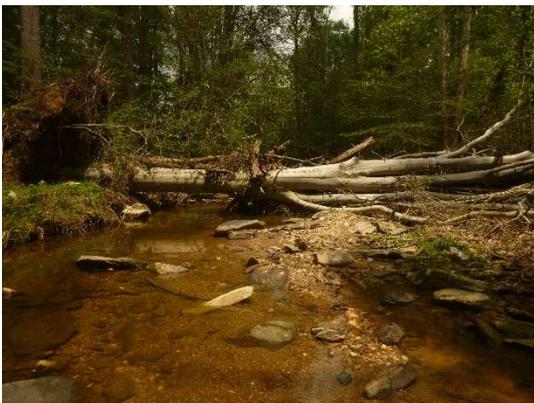
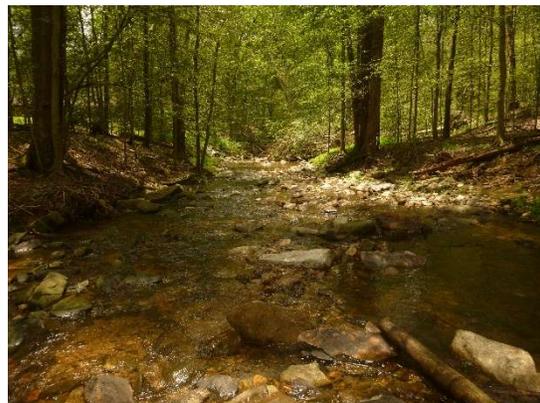
Figure 3-4. Photographs of upstream (left) and downstream (right) sampling conditions at the Plumtree Run station PLUM-01 during the summer sampling event on July 15, 2025

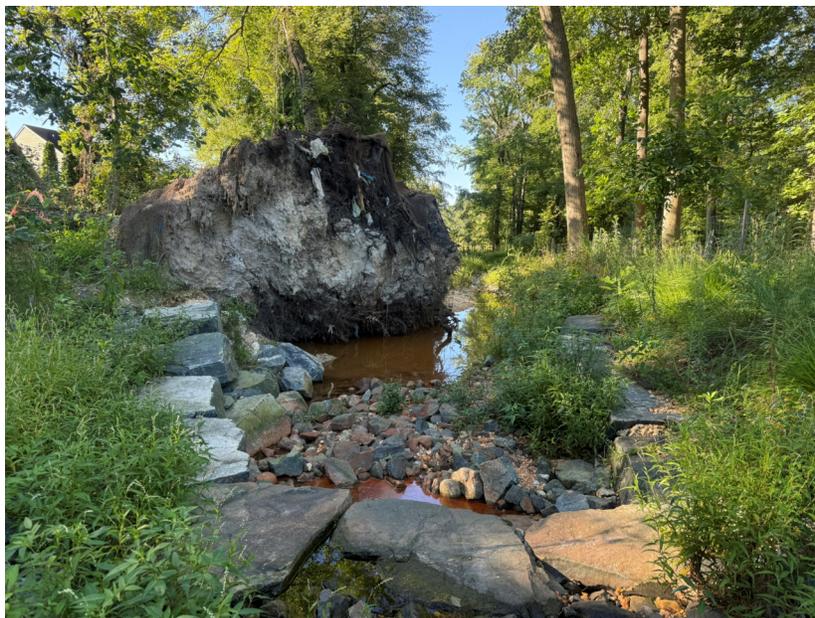
Just downstream of CV-07 near STA 5+75, a group of trees have fallen on the left bank (See Figures 3 and 4). The resulting tree throw pulled up part of the bank and bed immediately downstream of the cross vane's left sill tie-in. The cross vane appears to be unimpacted and stable. Besides the bank upheaval, there is currently limited impact to the stream profile. The root mass is lifted above the water level and the trunks on the upland bank. The upheaval may have deepened the pool and exposed the left bank, but it may stabilize as sediment from the roots falls back to the stream. The area should be monitored but remedial action may not be needed given the lack of structural impact to the cross vane.

Figure 3: Tree throw from upstream side

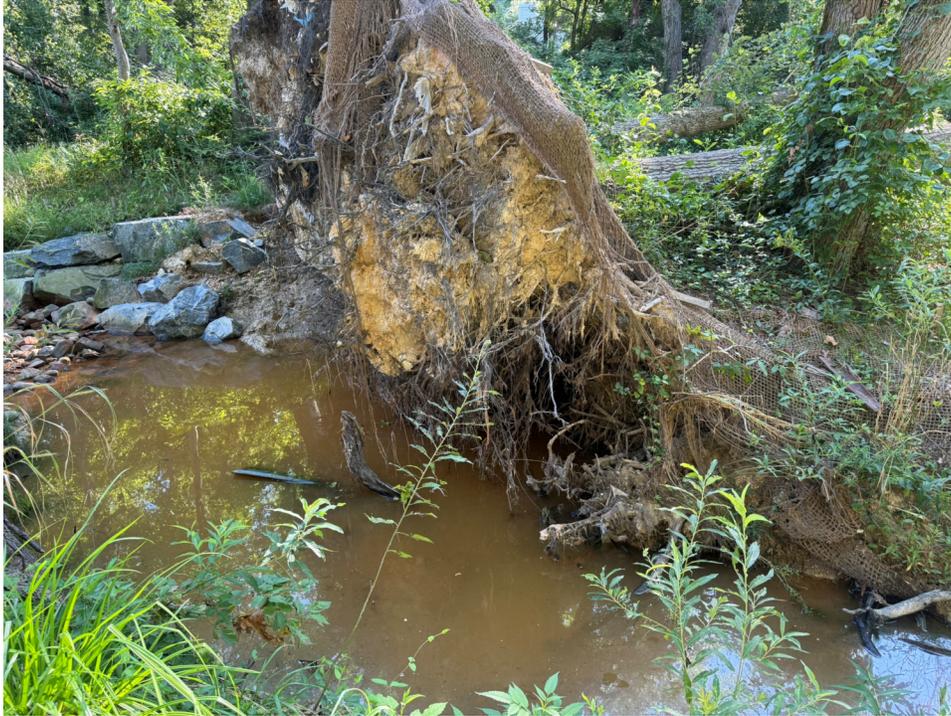
Figure 4: Tree throw from downstream side

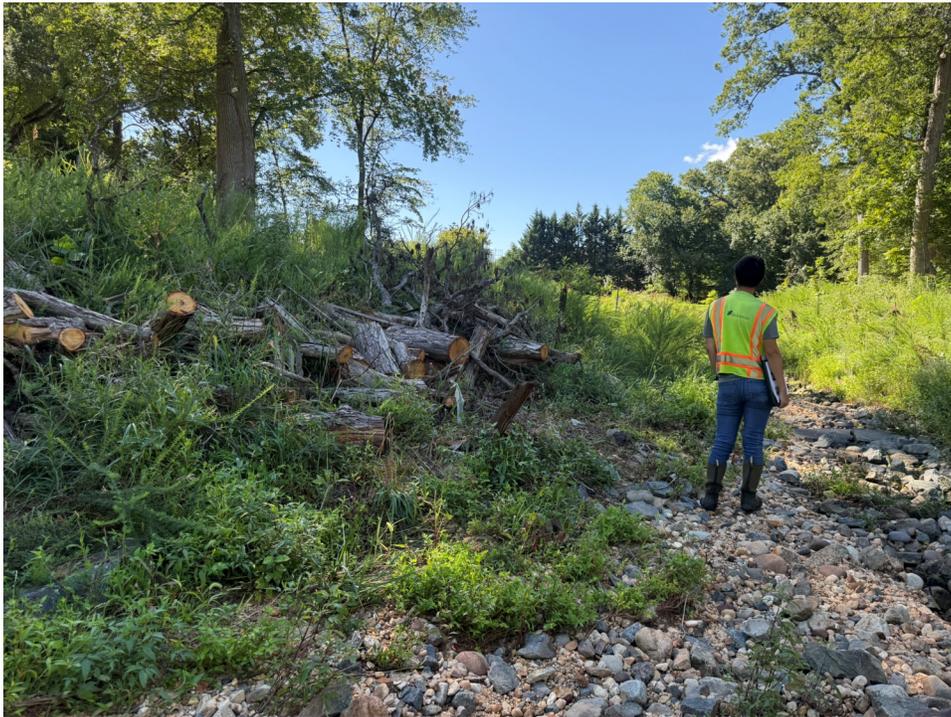
Figure 4: Woody debris piled up on left bank

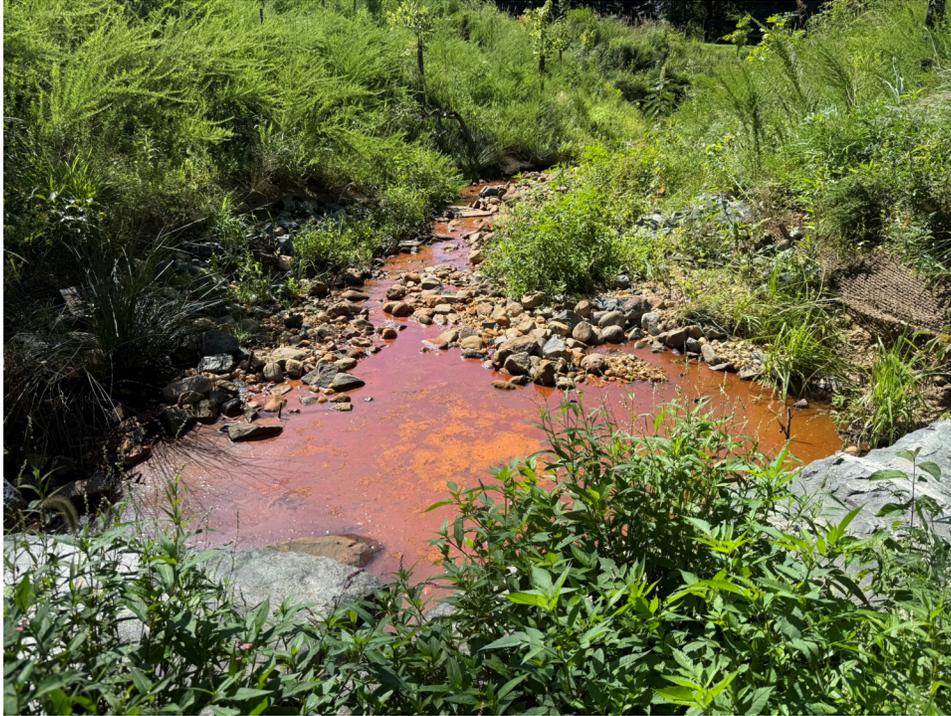
Figure 6: Iron flocculate near downstream end.

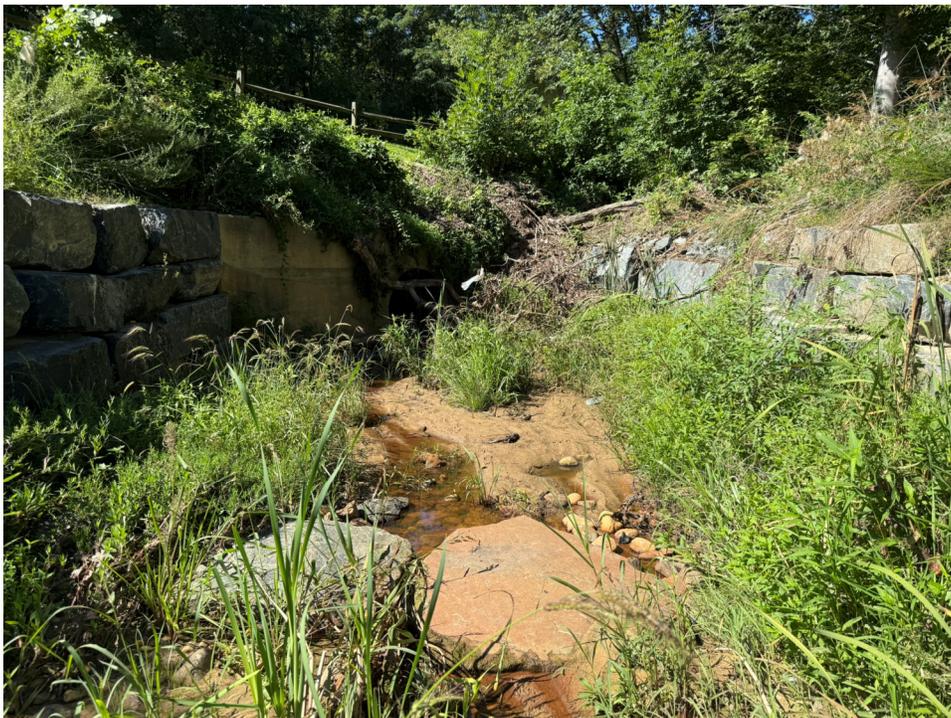
Additionally, near the downstream culvert and imbricated boulder walls, sandy sediment continues to aggregate likely due to backwatering from the culvert (Figure 13).

Figure 7: Sandy sediment buildup in downstream end.

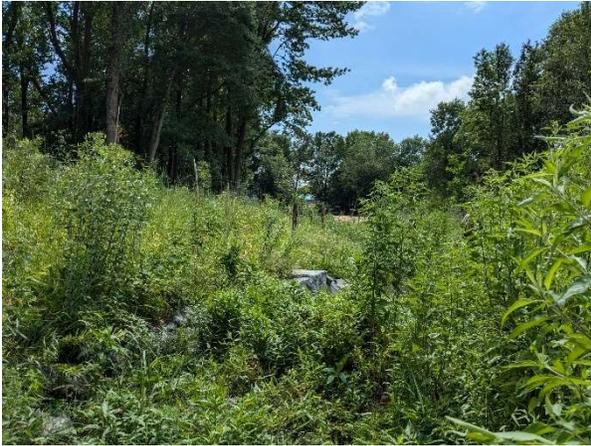
Photo Station 01 (2024): Top of restored stream, near first structure. Steep right bank (looking downstream) and more gradual left bank. Boneset is dominant vegetative species.

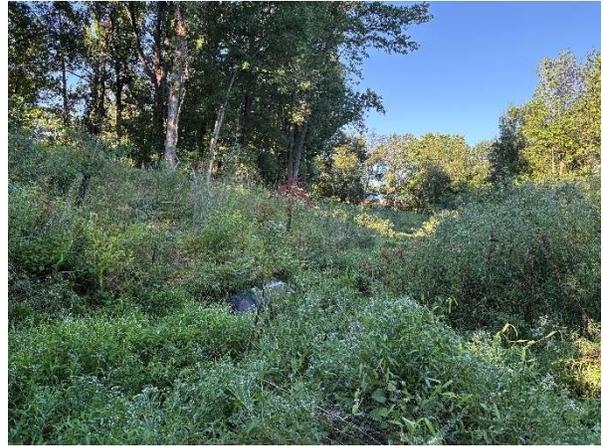
Photo Station 01 (2025): Top of restored stream, near first structure. Steep right bank (looking downstream) and more gradual left bank. Boneset is dominant vegetative species.

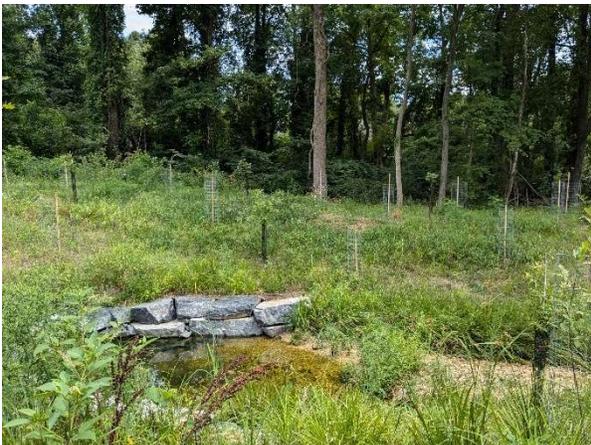
Photo Station 02 (2024): From top of right bank at the edge of the mulch path looking across the stream. Pool is partially filled with water with low baseflow on day photo was taken.

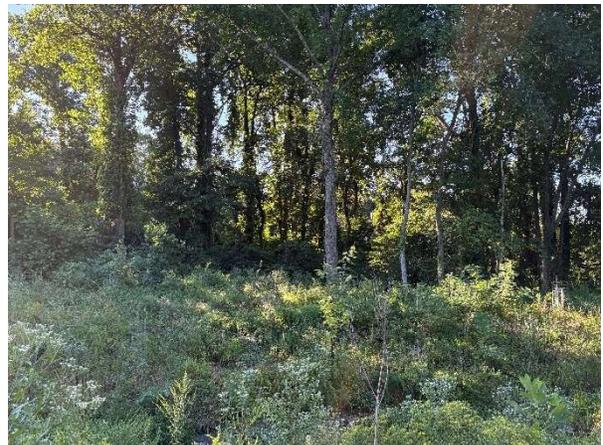
Photo Station 02 (2025): From top of right bank at the edge of the naturalizing mulch path looking across the stream. Structure obscured by tall vegetation.

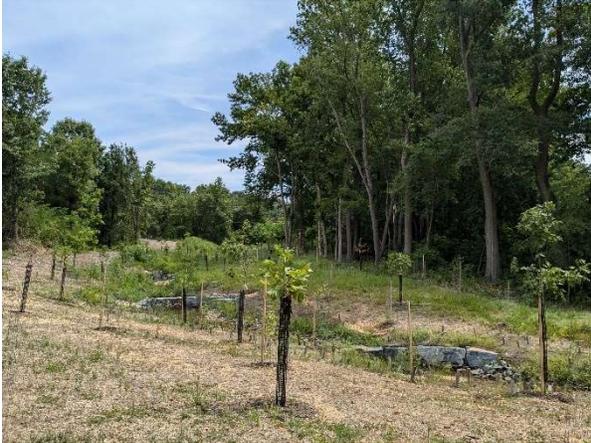
Photo Station 03 (2024): From the right bank looking across the stream. Area of low herbaceous establishment although trees appear healthy. Soil is compacted with gravel at surface.

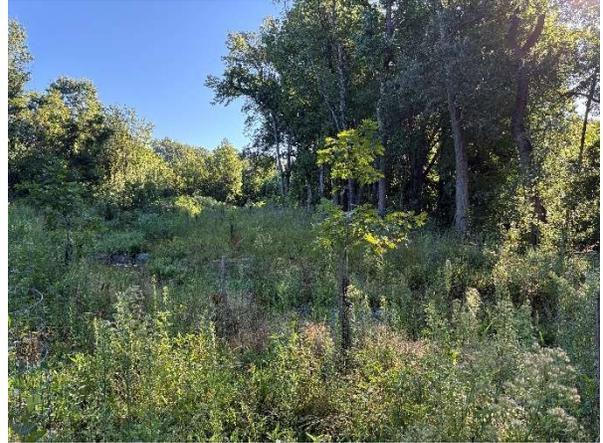
Photo Station 03 (2025): From the right bank looking across the stream. Mix of native and invasive herbaceous cover. Soil is compacted with gravel at surface.

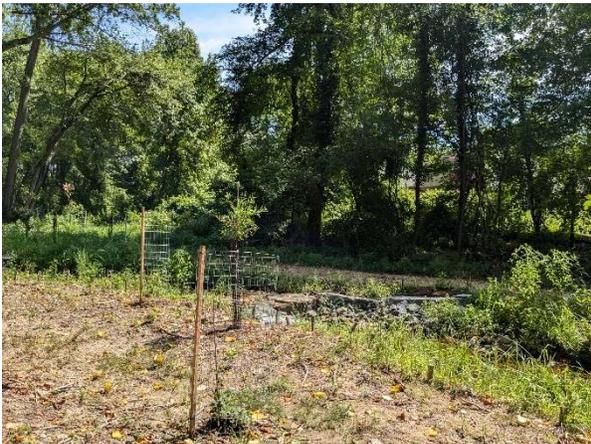
Photo Station 04 (2024): From the right bank looking across the stream. Existing forested wetlands remain on right bank floodplain. Potential forested wetland creation across stream on the left bank with evidence of past surface ponding.

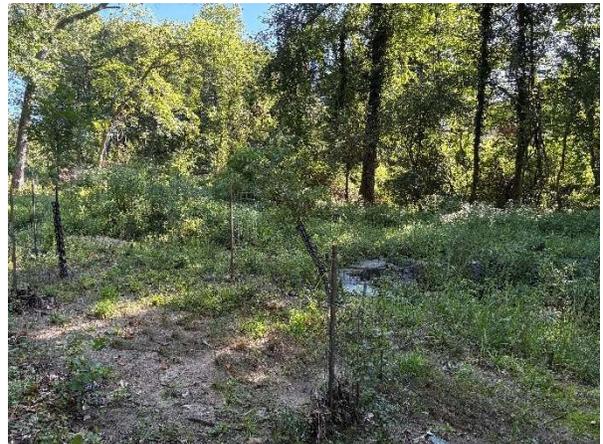
Photo Station 04 (2025): From the right bank looking across the stream. Evidence of drainage channels in right bank floodplain/wetland. Potential forested wetland creation across stream on the left bank with evidence of past surface ponding.

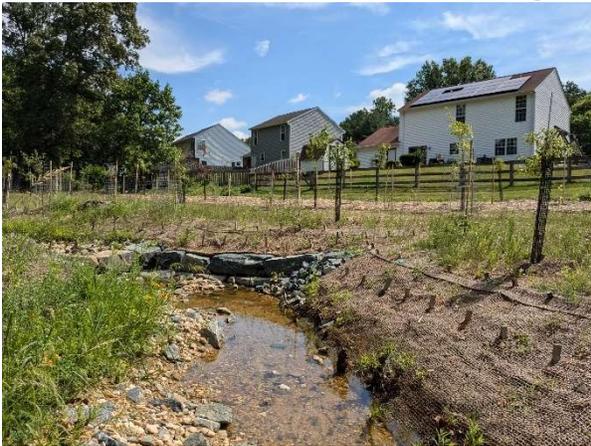
Photo Station 05 (2024): From the right bank, close to the channel looking upstream. Low vegetative establishment on the left bank, with a mulch construction path in the background.

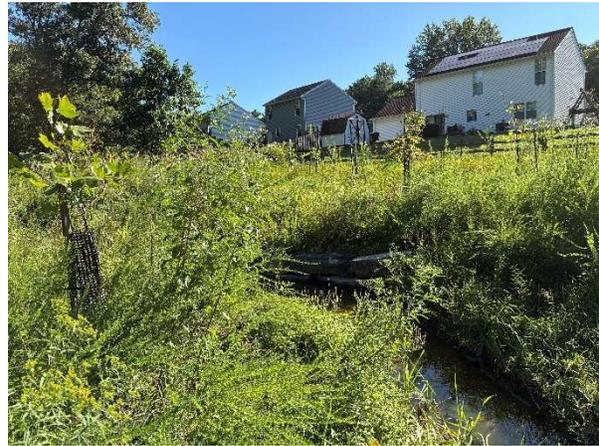
Photo Station 05 (2025): From the right bank, close to the channel looking upstream. Mixed native and invasive herbaceous establishment on both banks.

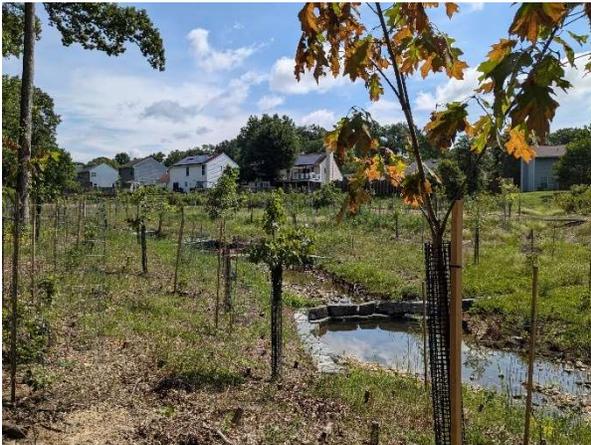
Photo Station 06 (2024): From top of right bank looking at stream, slightly upstream. Drainage channel still present on right of photo on the left bank but is repaired and vegetated. Houses on Declaration Circle in the background.

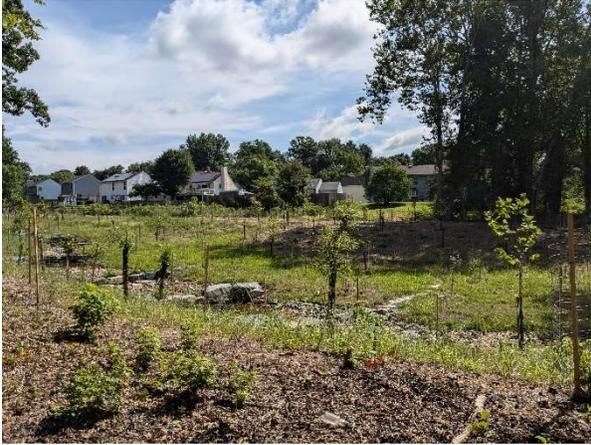
Photo Station 07 (2024): From right bank looking at channel. Wide floodplain bench on the left bank. Vegetative establishing but some bare patches near tree plantings; near forested wetland on right bank. Drainage channel on the left hillslope is causing some erosion.

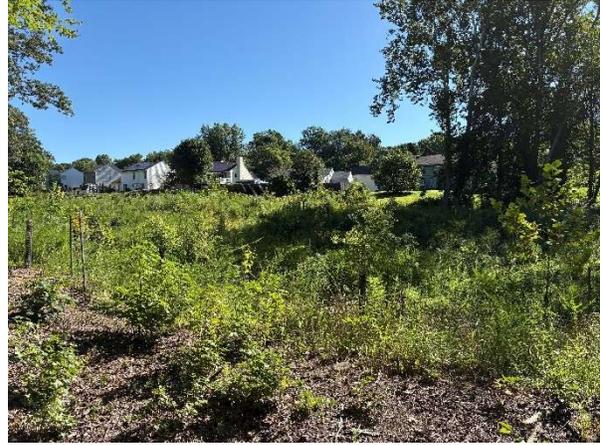
Photo Station 07 (2025): From right bank looking at channel. Wide floodplain bench on the left bank. Mixed native and invasive vegetative establishment; near forested wetland on right bank. Drainage channel on the left hillslope is causing erosion.

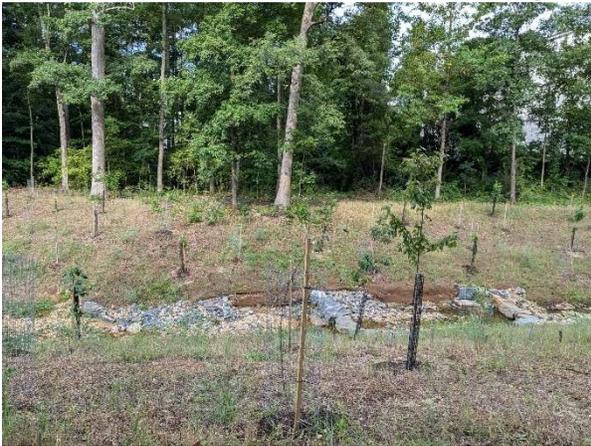
Photo Station 09 (2024): From top of left bank looking down at step pool structures and realigned channel.

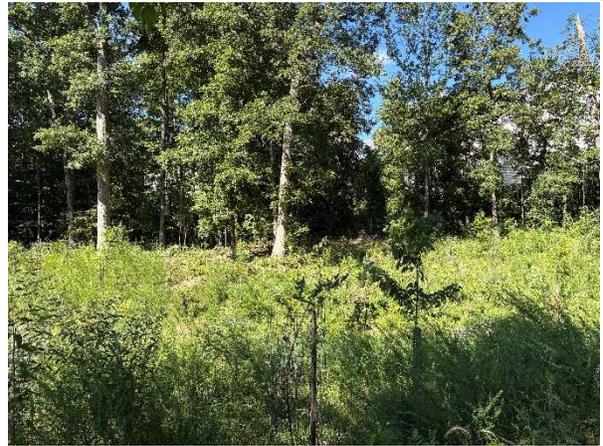
Photo Station 09 (2025): From top of left bank looking down at step pool structures and realigned channel. Structures obscured by Japanese clover (*Lespedeza striata*).

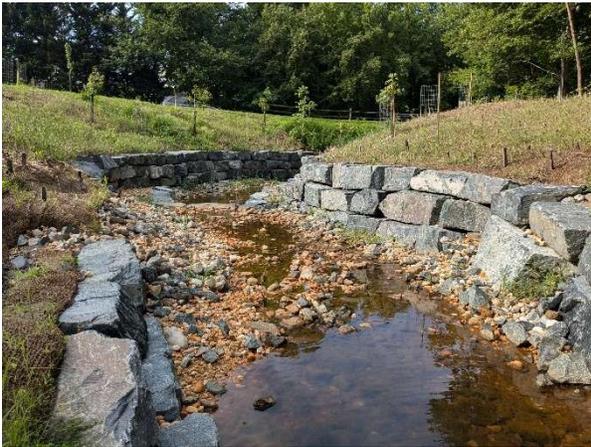
Photo Station 10 (2024): At last structure looking downstream. Imbricated boulder wall on either side of the channel. A cobble lined drainage channel is entering from the right bank (labelled as a wetland on plans).

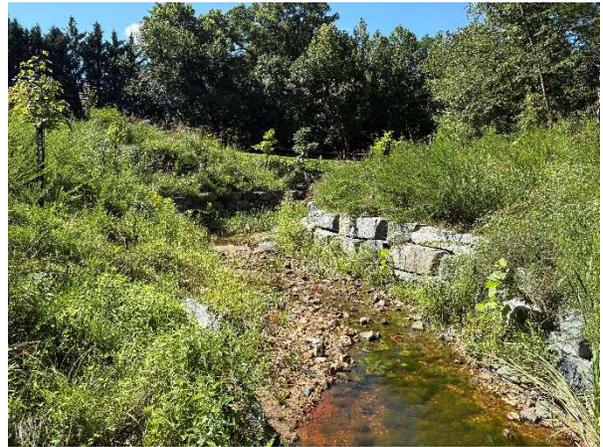
Photo Station 10 (2025): From last structure looking downstream. Imbricated boulder wall on either side of the channel. A cobble lined drainage channel is entering from the right bank (labelled as a wetland on plans). Low flow in stream with high algae and iron flocculant growth. Finer deposition near culvert.

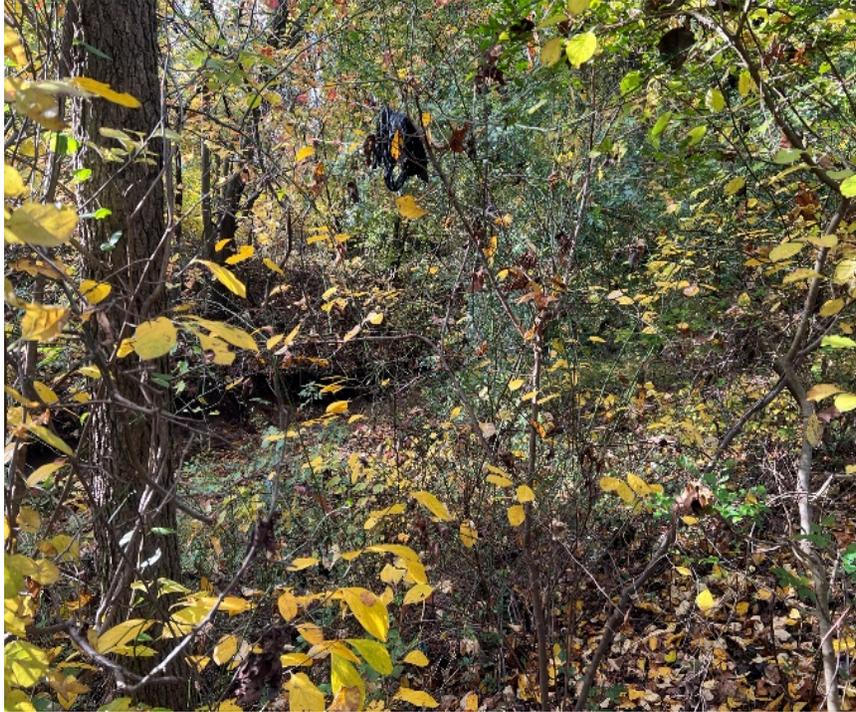
01_Overview Photo: Incised and eroded, intermittent stream channel. Channel has top widths ranging from 13-16 feet and a bottom width ranging 7-11 feet.

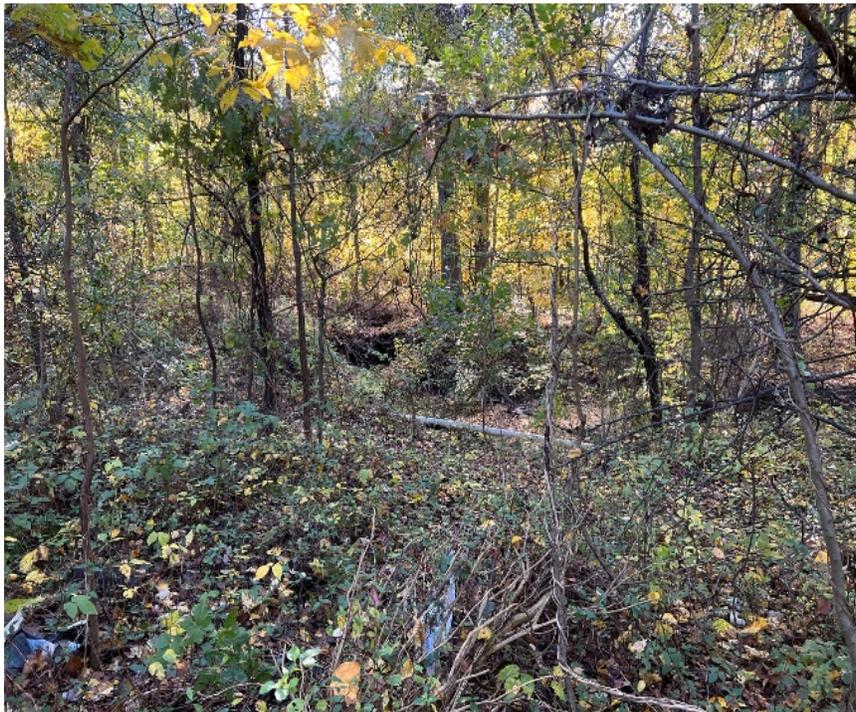
02_Overview Photo: Incised and eroded, intermittent stream channel. Channel has top widths ranging from 13-16 feet and a bottom width ranging 7-11 feet. A remnant 8" PVC pipe is in the channel, and a drainage channel is entering from the left bank causing erosion at the confluence.

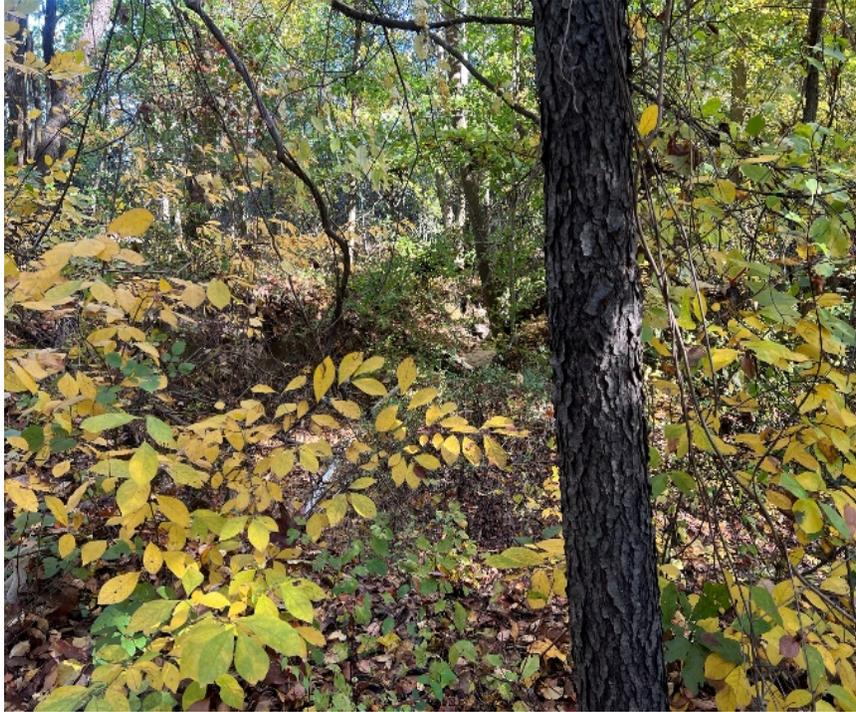
03_Overview Photo: At a meander of the incised and eroded intermittent stream channel. At the meander, channel has top widths ranging from 20-30 feet and bottom width ranging 10-15 feet.

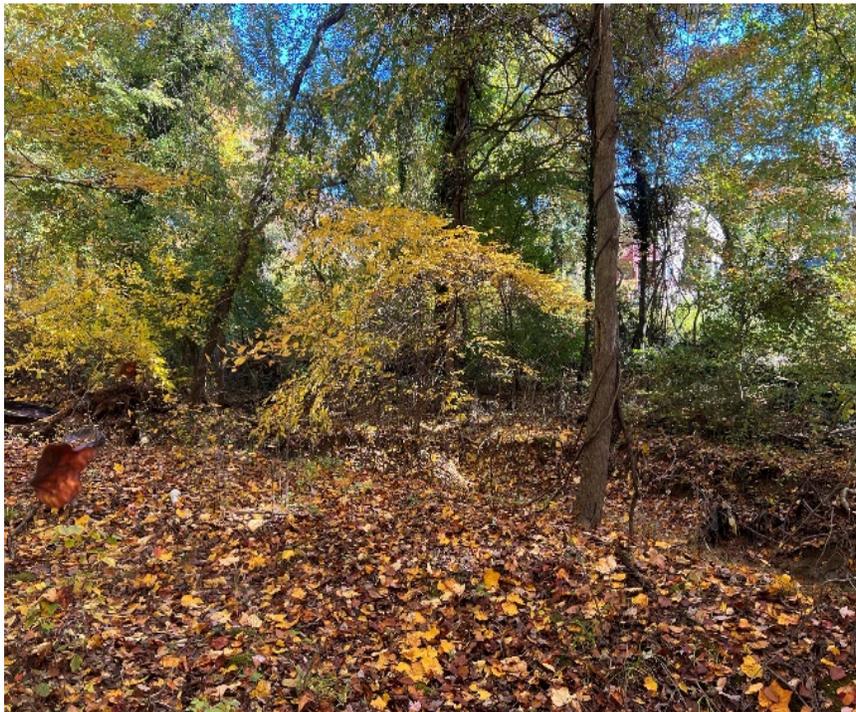
04_Overview Photo: Relatively less incised and eroded intermittent stream channel compared to entire restoration project limits. Forested wetland on right bank floodplain. Channel has top width ranging from 9 to 11 feet and bottom width of approximately 9 feet.

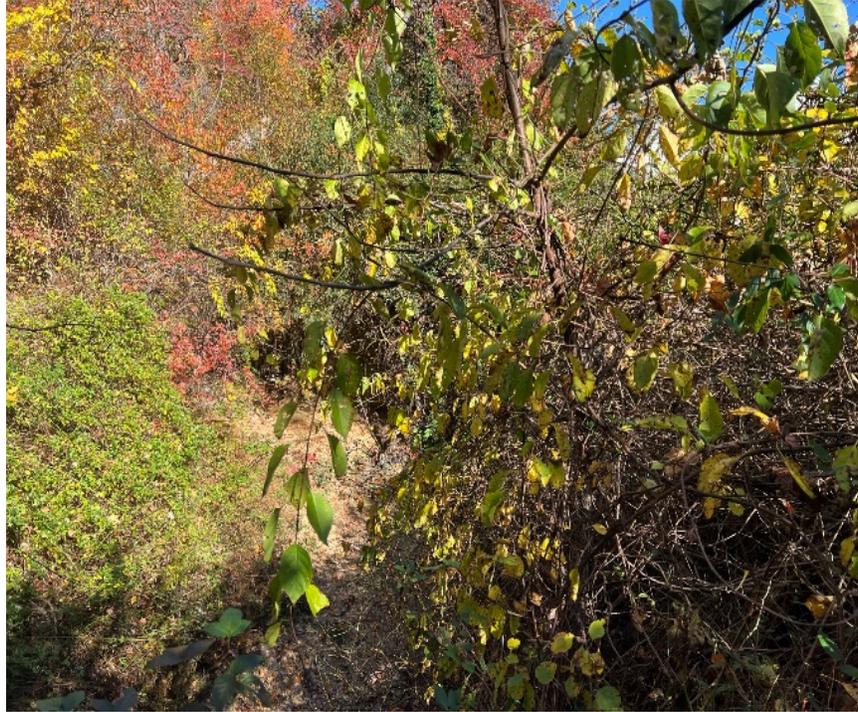
05_ Overview Photo: Deeply incised and actively eroding intermittent channel. Channel top width is approximately 36 feet and bottom width is approximately 15 feet. Total bank height averages 10 feet.

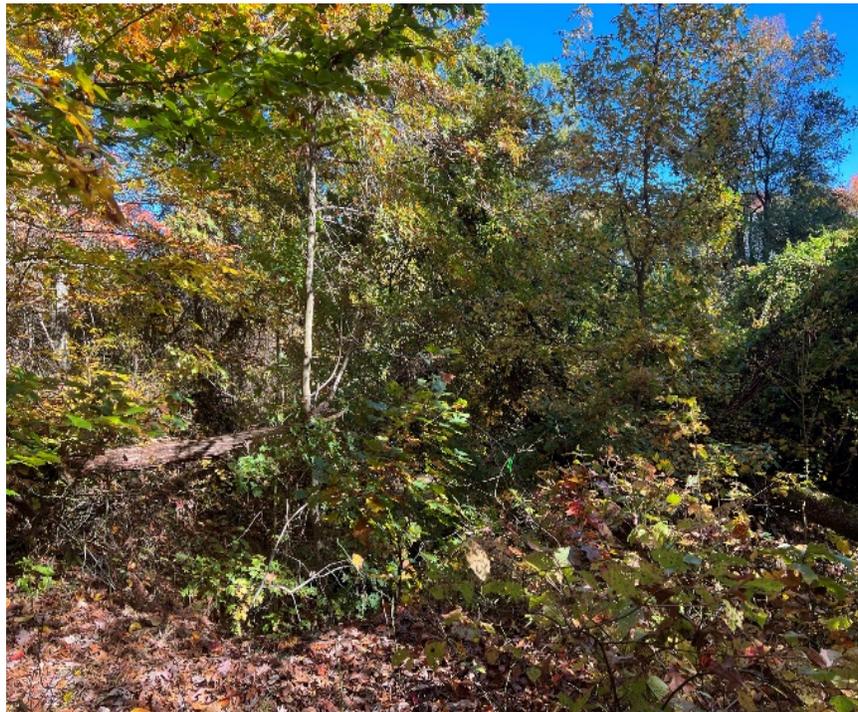
06_ Overview Photo: Deeply incised and actively eroding intermittent channel with two eroded drainages entering channel from the left bank. Channel top width is approximately 36 feet and bottom width is approximately 15 feet. Total bank height averages 10 feet.

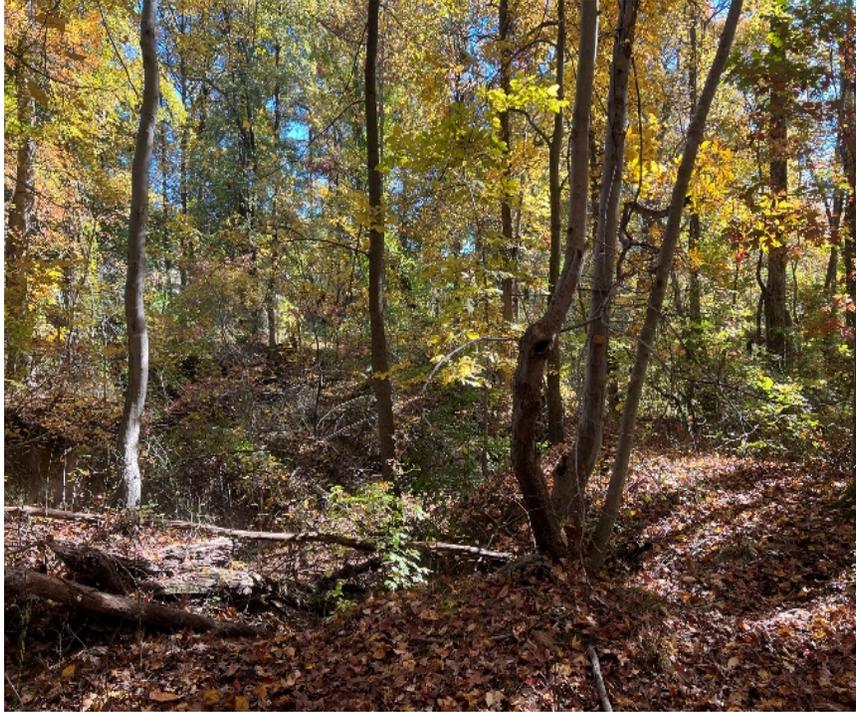
07_Overview Photo: Two meander bends along a deeply incised and actively eroding intermittent channel. Channel top width is approximately 36 feet and bottom width is approximately 15 feet. Total bank height averages 10 feet. Forested wetland on right bank at upstream meander. Erosion occurring at interface of wetland with stream bank.

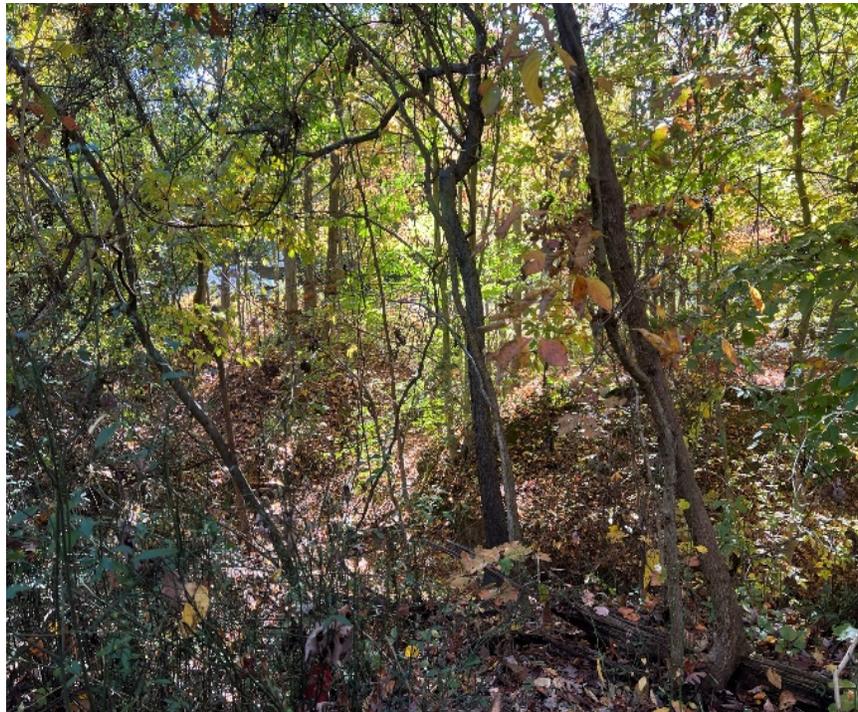
10_Overview Photo: Deeply incised and eroded intermittent channel with eroded drainage entering from left bank and forested wetland on right bank. Channel has widened and deposition is occurring along the margins of the channel. Channel top width is approximately 42 feet and bottom width is approximately 12 feet. Stream banks are often vertical, exceeding 10 feet in height.
