Appendix E2 - Stormwater Restoration (Restoration Inspections)

MEMORANDUM

Date: December 3, 2024
To: Danielle Hankins – Harford County Department of Public Works
From: Heaven Aziz – RK&K
CC: Andrew Bodt – Harford County Department of Public Works
Kate Gordon – RK&K
Re: Harford County Fall 2024 Gunpowder Valley Conservancy Tree Planting Site Inspections

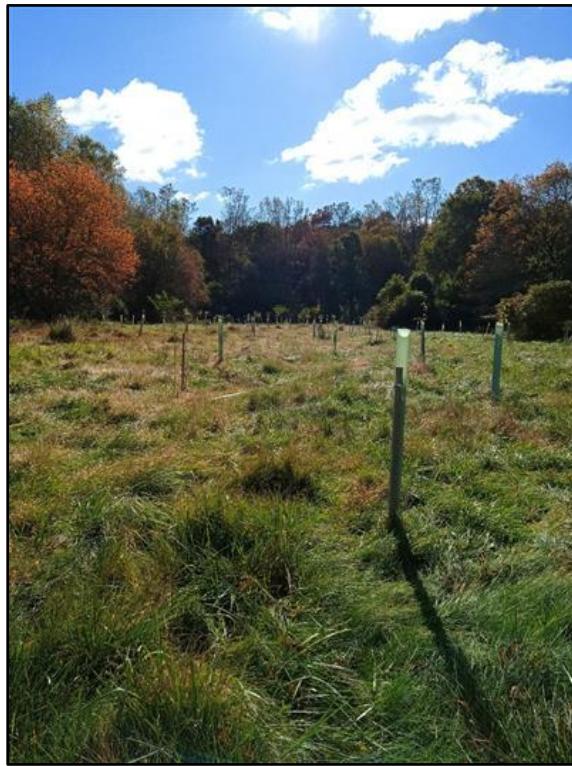
Photo 5: Overview photo of Klein B (HA22APY000098) looking southeast.

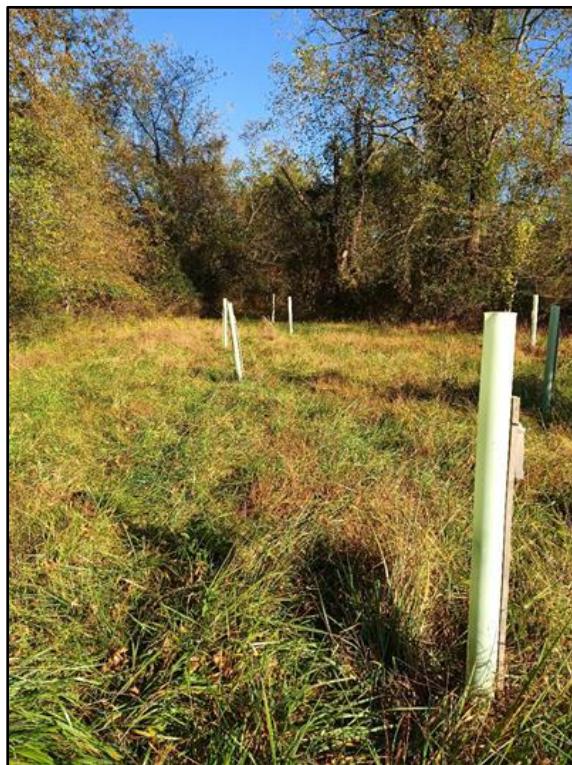
Photo 9: Interior of Klein A (HA22APY000097) site looking west.

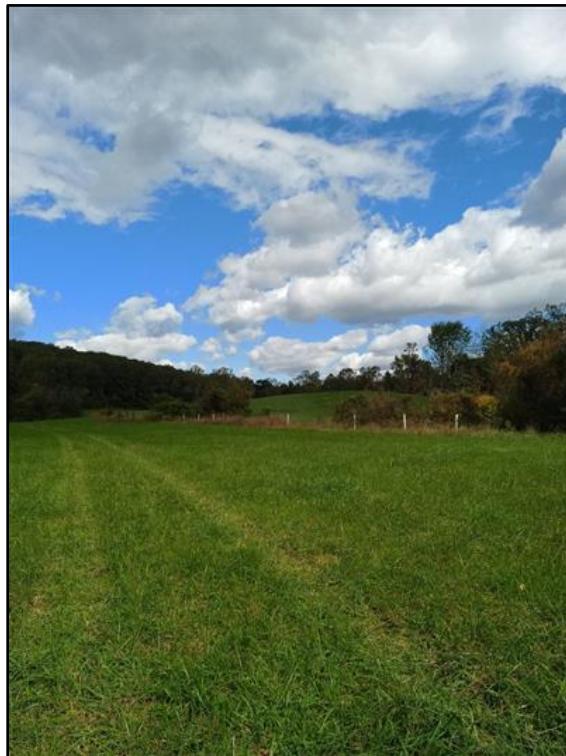
Photo 2: Overview photo looking north.

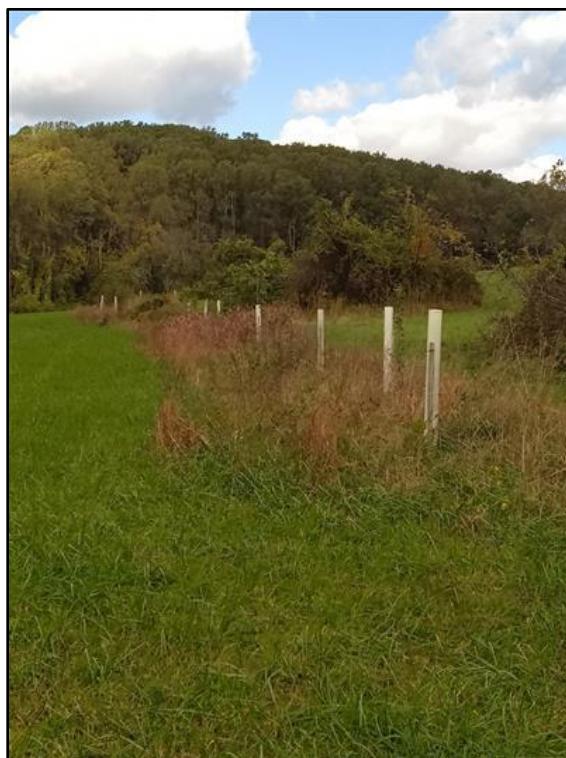
Photo 3: Overview of planting strip looking northwest.

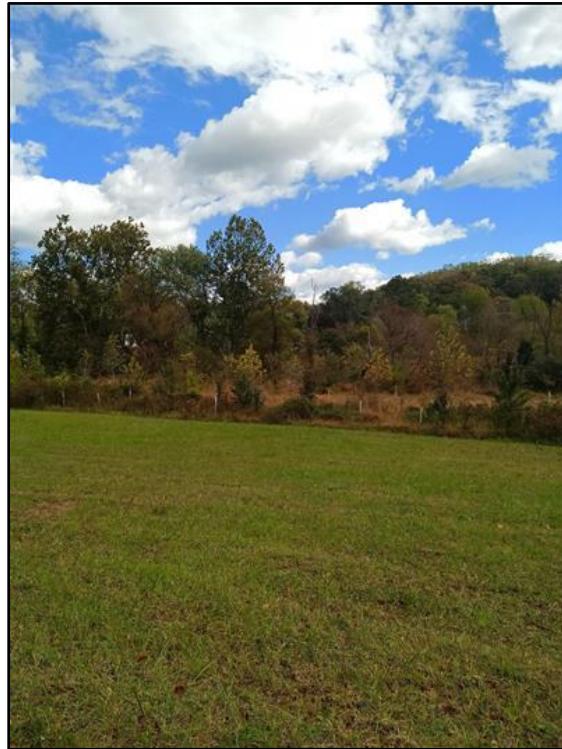
Photo 1: Overview photo looking northeast.

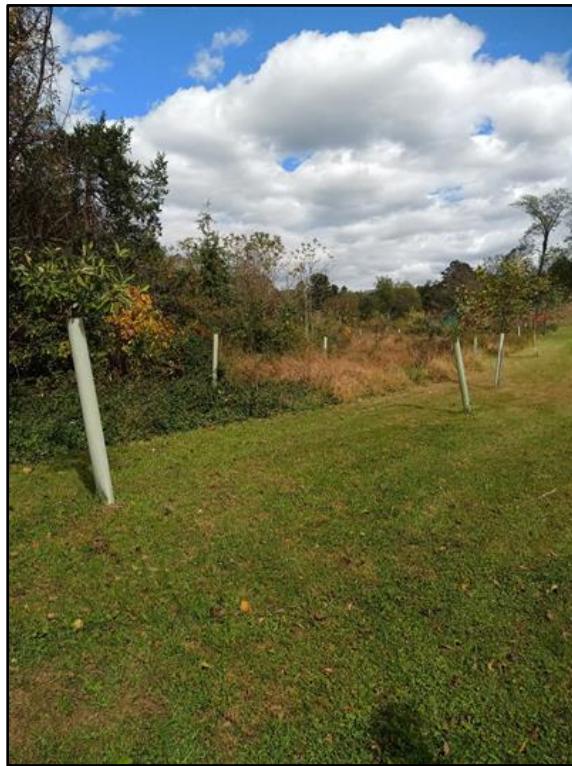
Photo 278: Overview photo looking northeast.

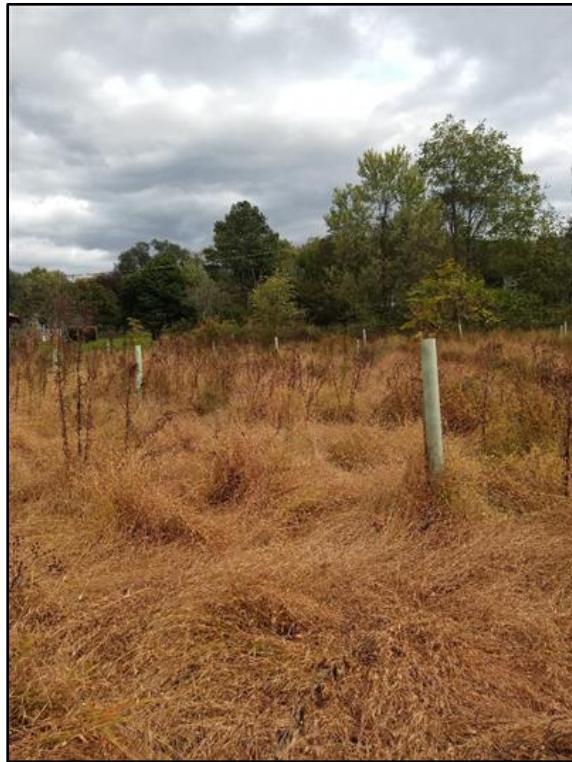
Photo 275: Interior of site, healthy tree plantings.

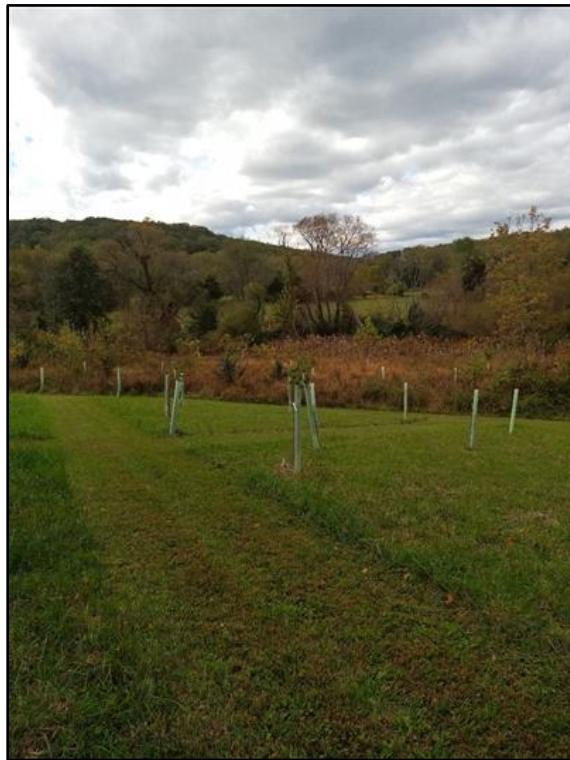
Photo 281: Overview photo looking north.

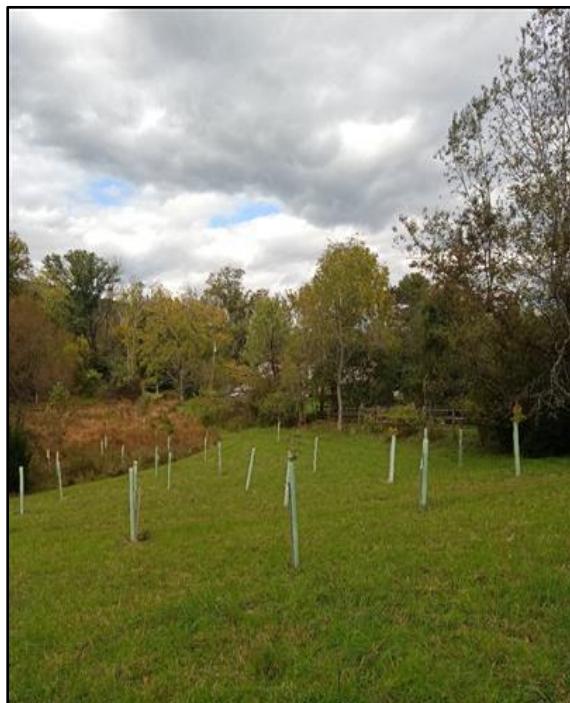
Photo 283: Interior of site, healthy tree plantings uphill of wetland.

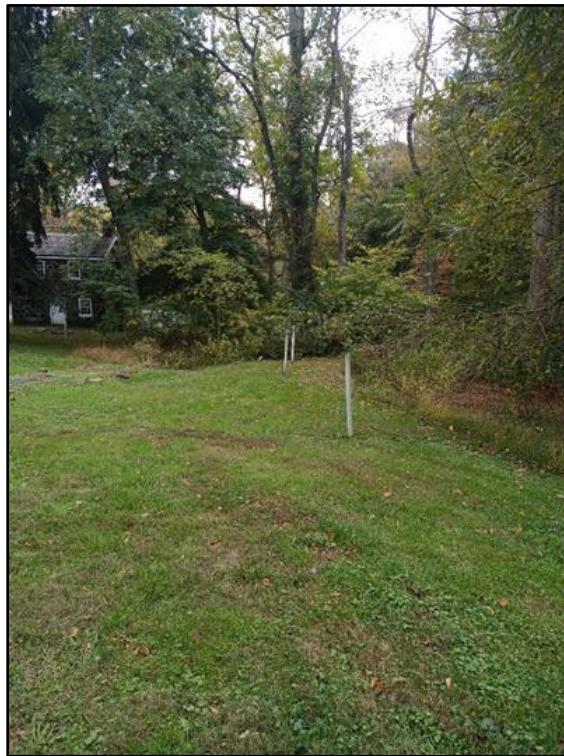
Photo 1: Six individual trees looking southwest.

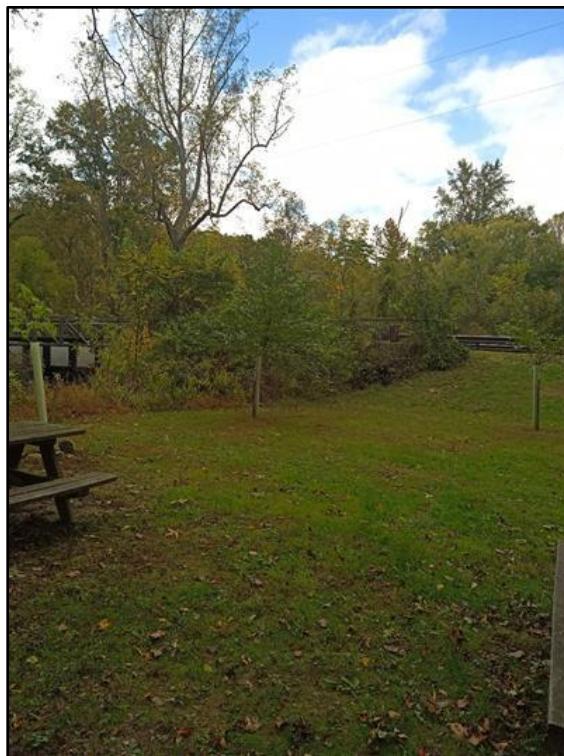
Photo 3: Three individual trees looking north.

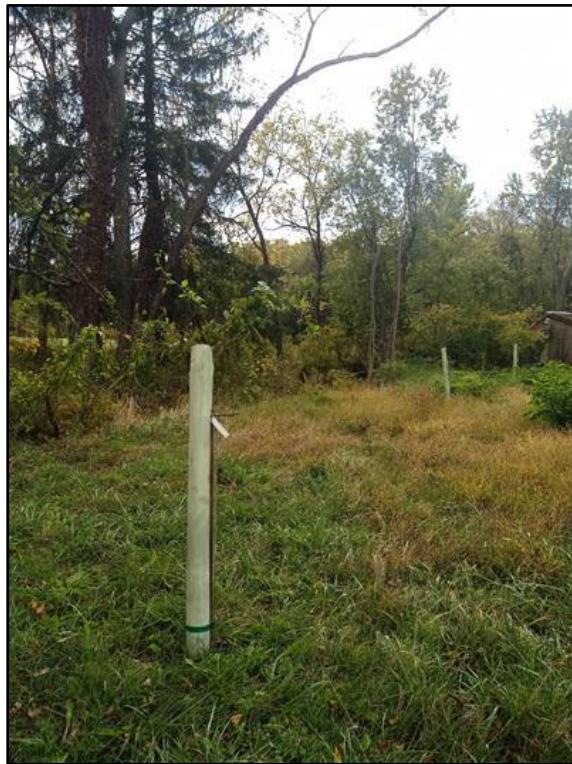
Photo 1: Overview photo looking southwest.

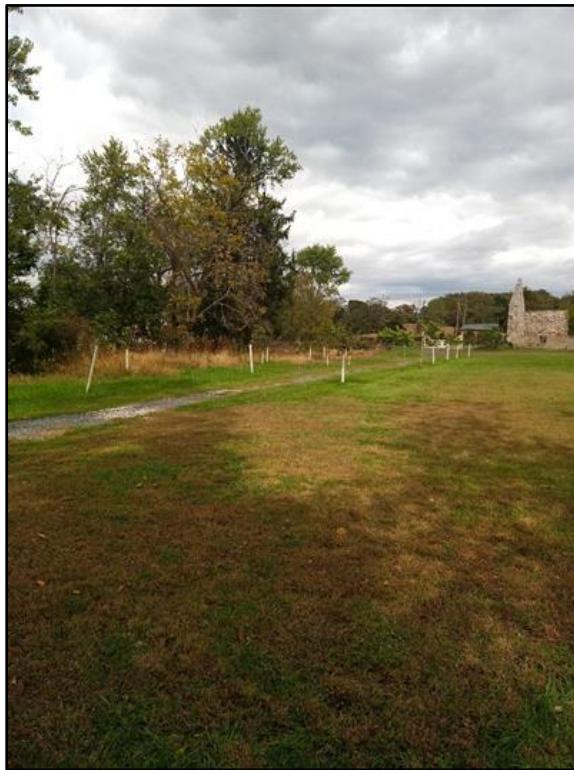
Photo 1: Overview photo looking east.

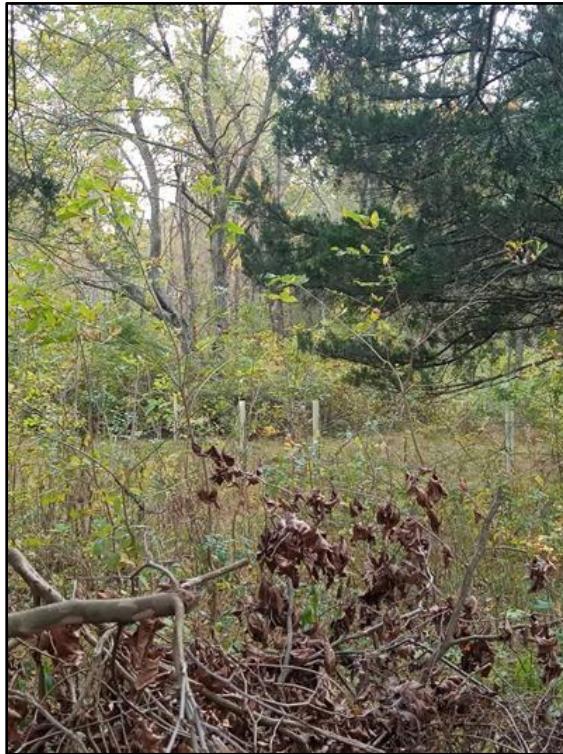
Photo 4: Overview photo looking south.

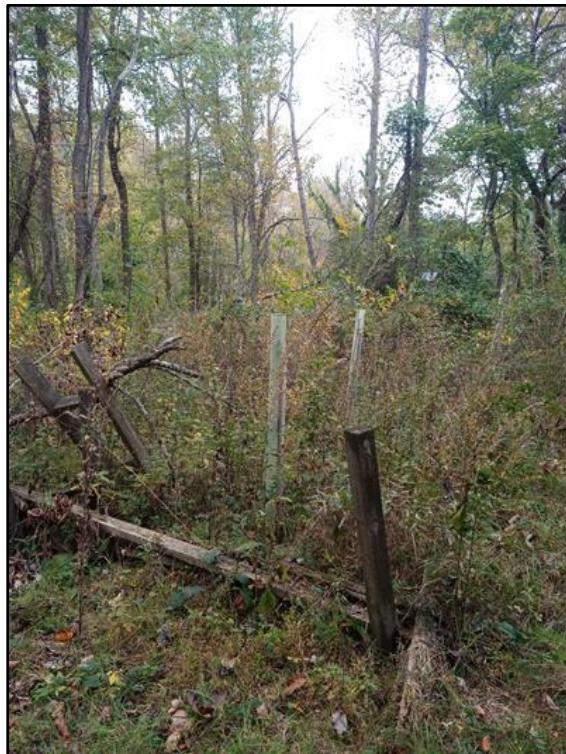
Photo 2: Interior of site, thick brush in understory.

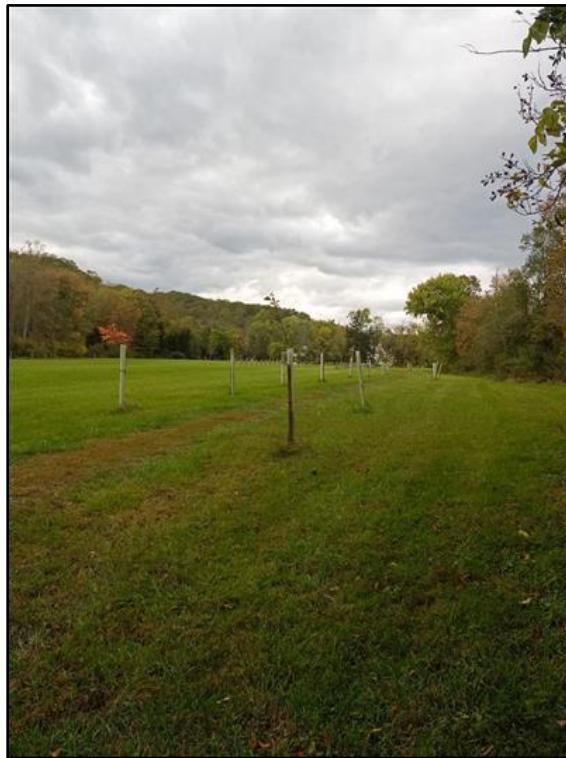
Photo 408: Overview photo looking north.

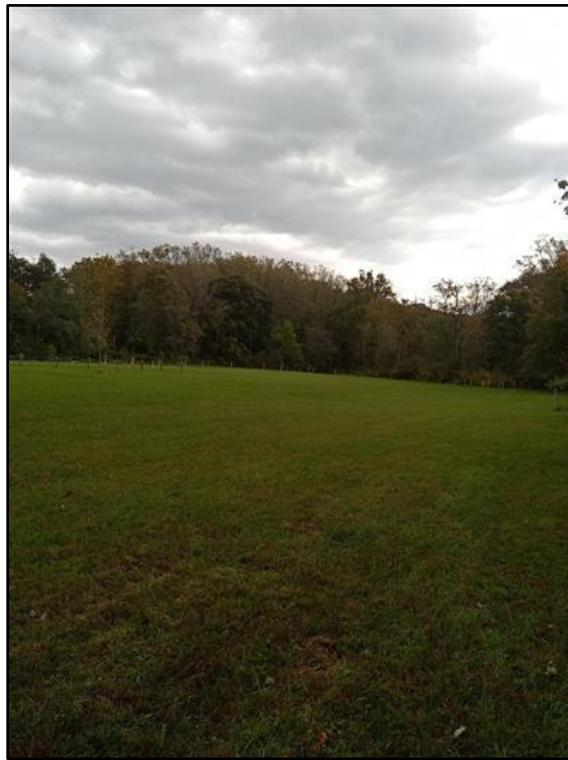
Photo 2: Overview photo looking east.

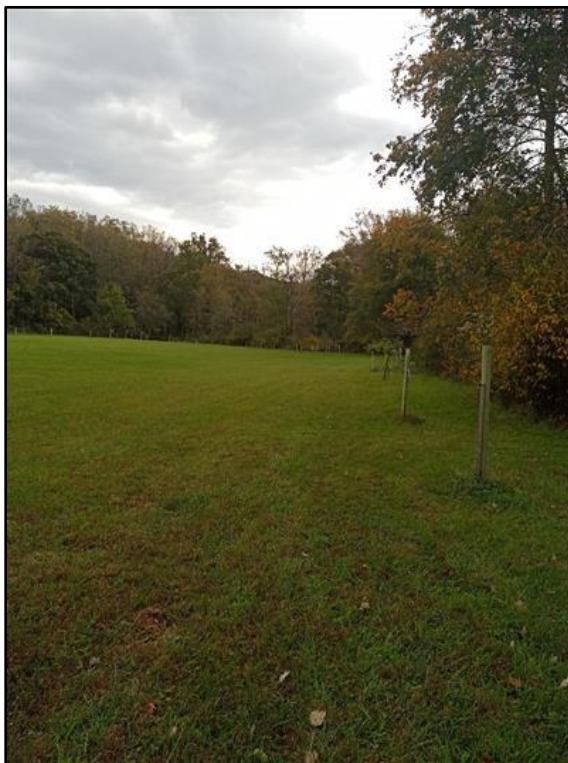
Photo 1: Interior of site, healthy tree plantings.

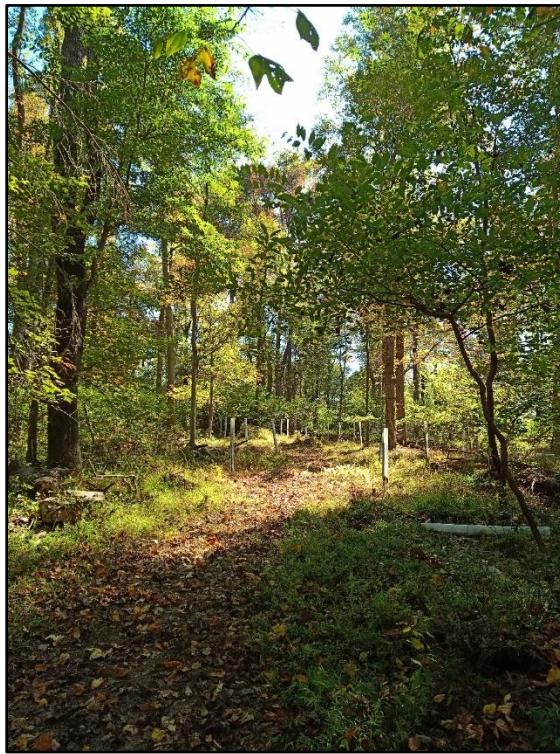
Photo 7: Overview photo of Chris Murk A (HA21APY000033) facing southeast.

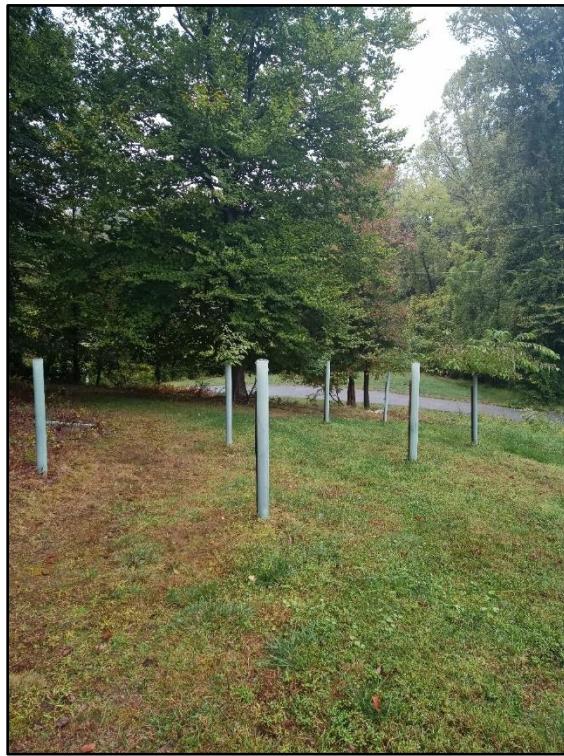
Photo 4: Overview photo facing northwest.

General Comments: Site was originally mowed by Alliance but is no longer receiving maintenance. Establishment is generally strong but maintenance is recommended. Some small gaps for infill, but replanting is not required based on density.

Maintenance Comments: Recommend mowing or brushhog, shelter repair and removal, cut stump herbicide application for large multiflora. Flag or re-shelter leaning trees prior to mowing.

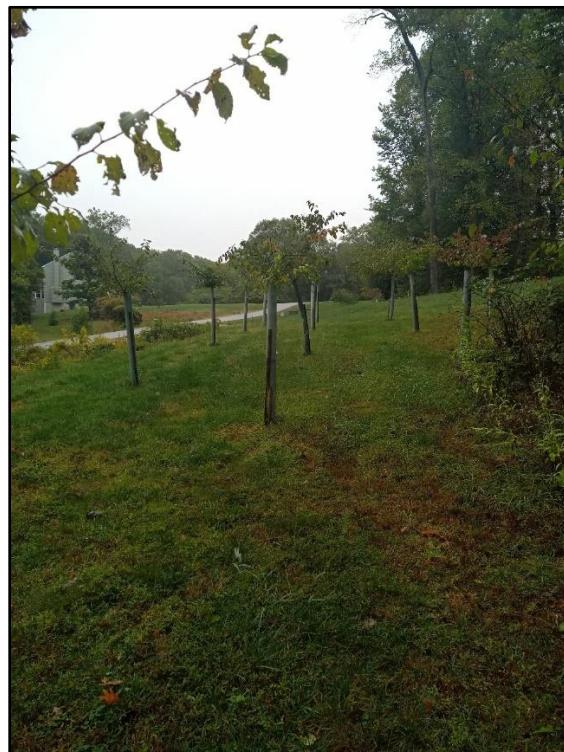
Photo 3: Overview photo facing southeast.

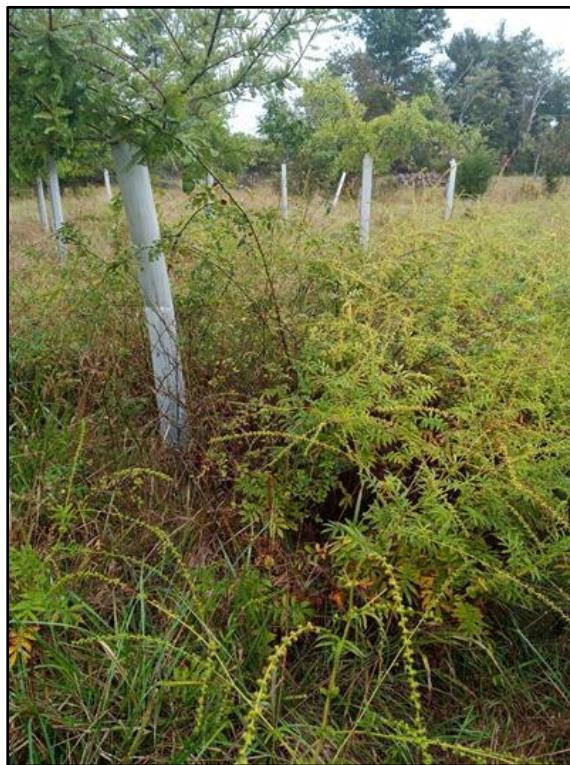
Photo 12: Interior of site and understory.

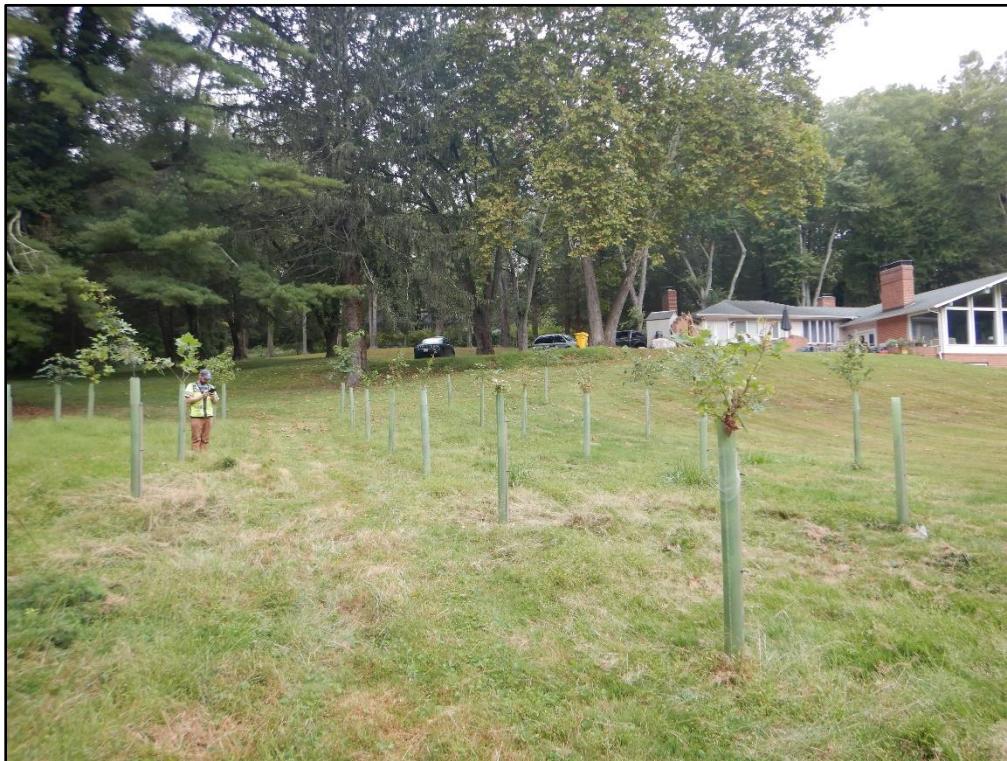
Photo 5: Interior of site, healthy tree plantings.

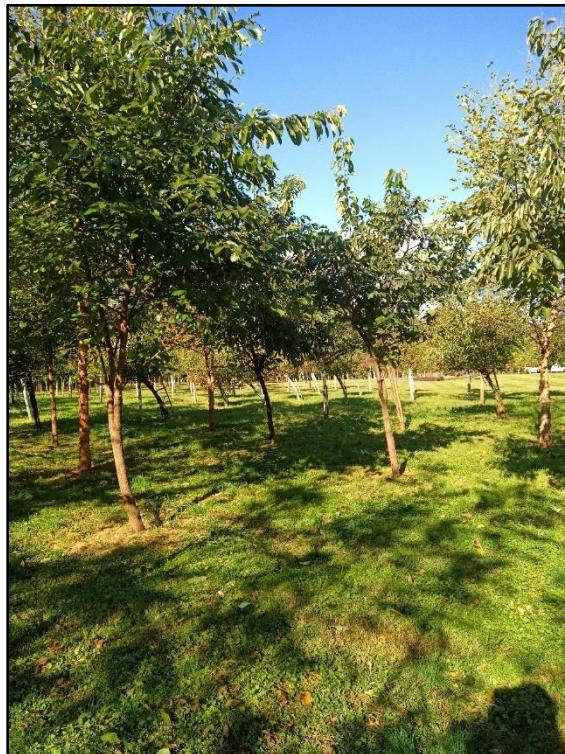
Photo 1: Overview photo facing west.

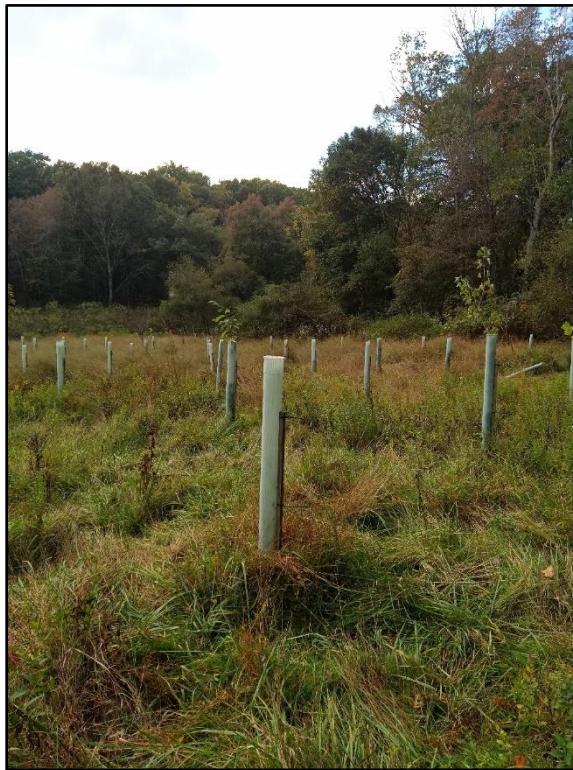
Photo 1: Interior of site Kahl A (HA19APY000052) looking southwest, healthy tree plantings.

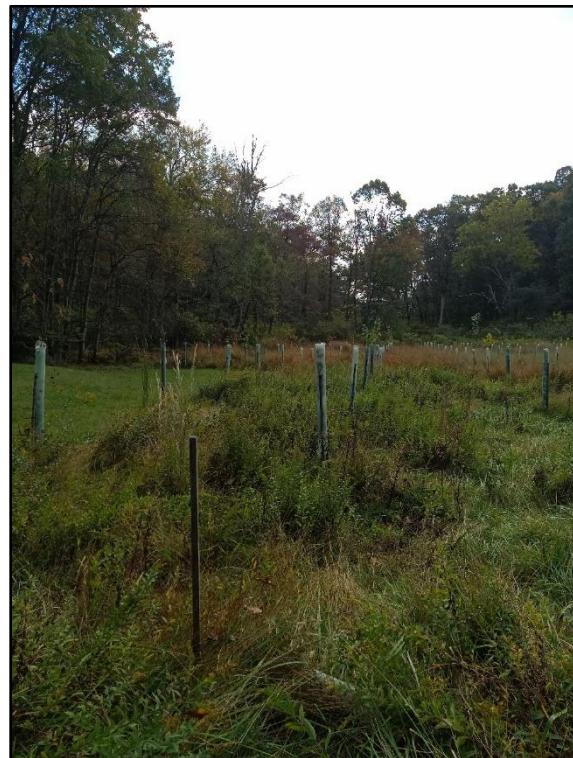
Photo 2: Interior of site Kahl A (HA19APY000052) looking south, healthy tree plantings.

General Comments: Large areas of failure, mowers have knocked down most trees and tubes. Almost entirely stilt grass in northern area

Maintenance Comments: Replanting, shelter repair/replacement

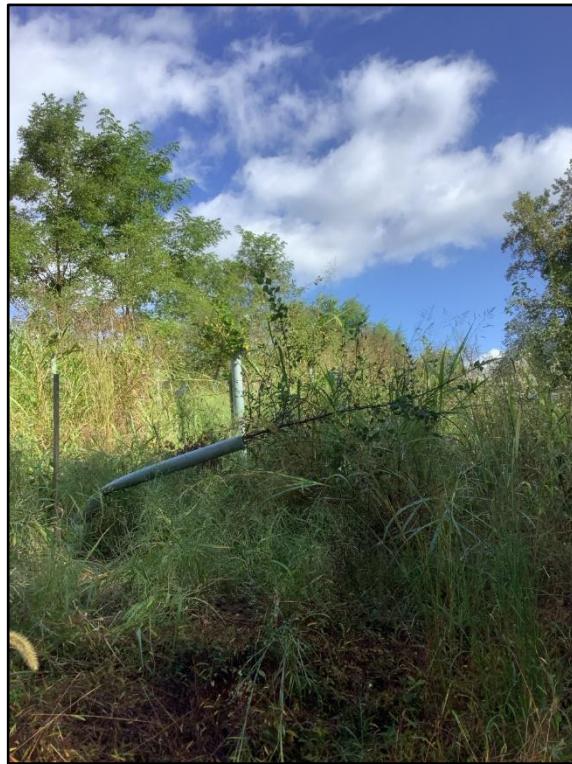
Photo 5: Overview photo facing northeast.

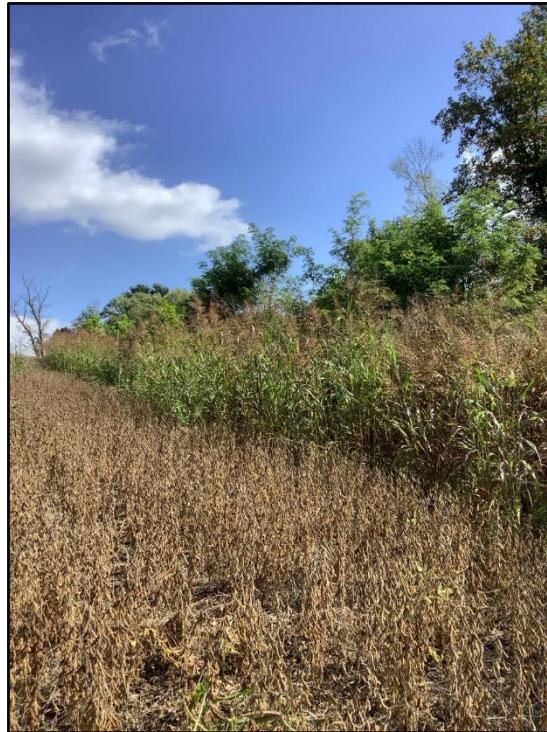
Photo 2: Overview of site, photo facing southeast.

General Comments: Plantings in good condition overall, low mortality

Maintenance Comments: Control Johnson grass and Oriental bittersweet with hand tools and chemical treatment. Replace damaged shelters and remove shelters on larger trees.

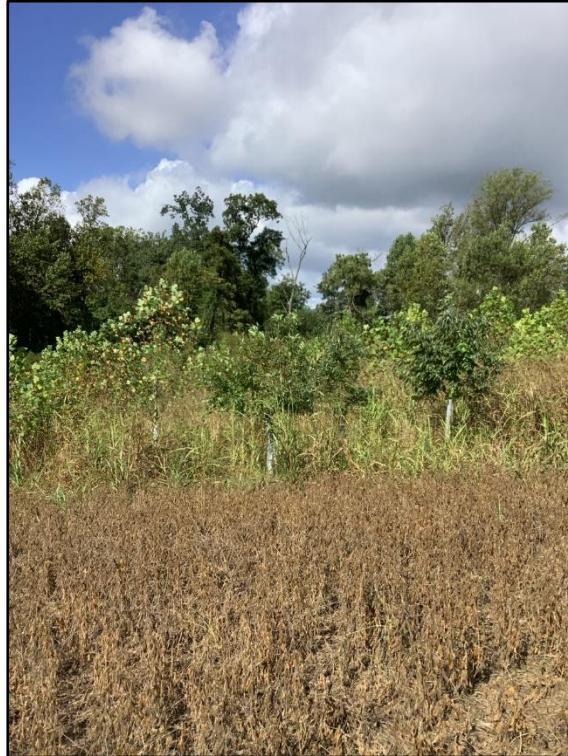
Photo 1: Overview photo facing west.

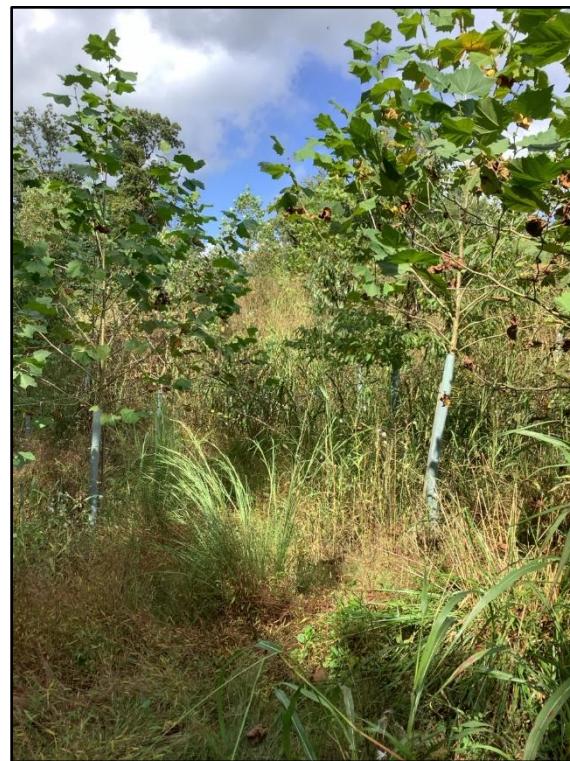
Photo 3: Overview photo facing northwest.

General Comments: Goldenrod prevalent in herbaceous layer, competing with Johnsongrass. Plantings in good condition overall, mostly taller than Johnsongrass.

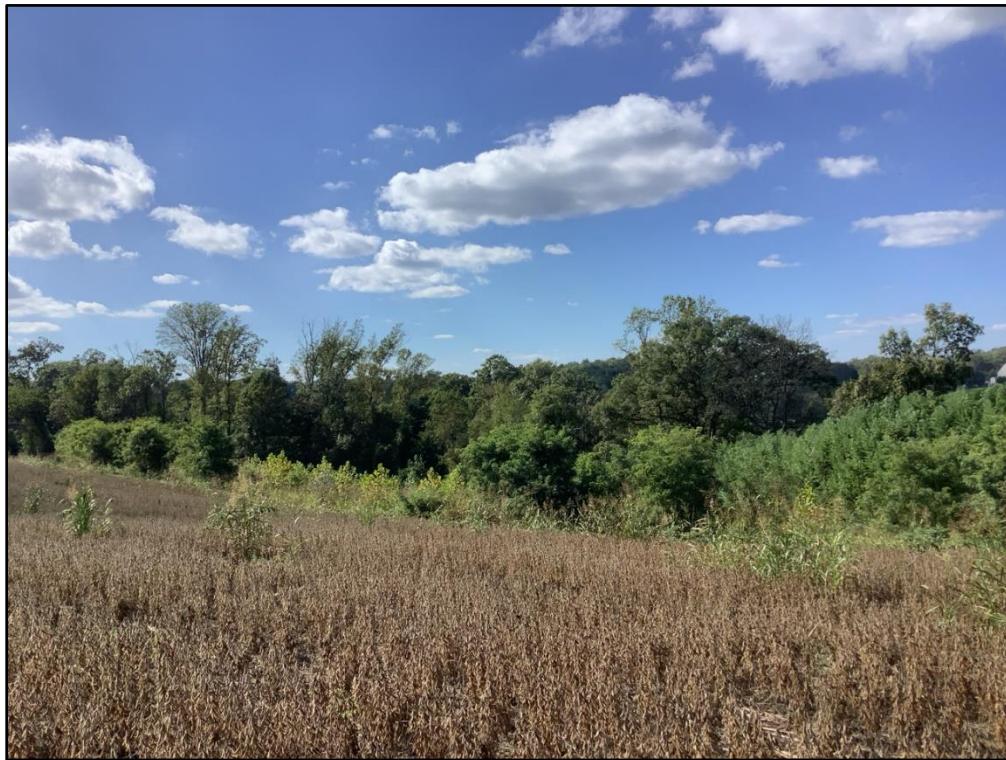
Photo 1: Overview of planted area, facing northwest.

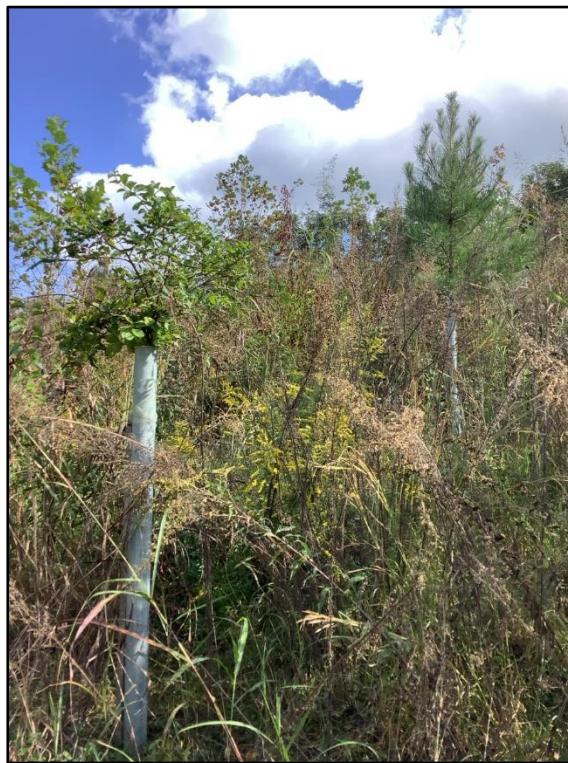
Photo 6: Interior of site, healthy tree plantings.

General Comments: Site looks good overall and is well maintained by landowner. A few shelters missing but trees are large enough that they don't need them. Portion along the stream has an unmanaged understory with ATV trails throughout. All species are doing well for the most part with low mortality.

Maintenance Comments: Some oriental bittersweet climbing plantings. Invasive species control with hand tools and chemical treatment is recommended for the portion along the stream.

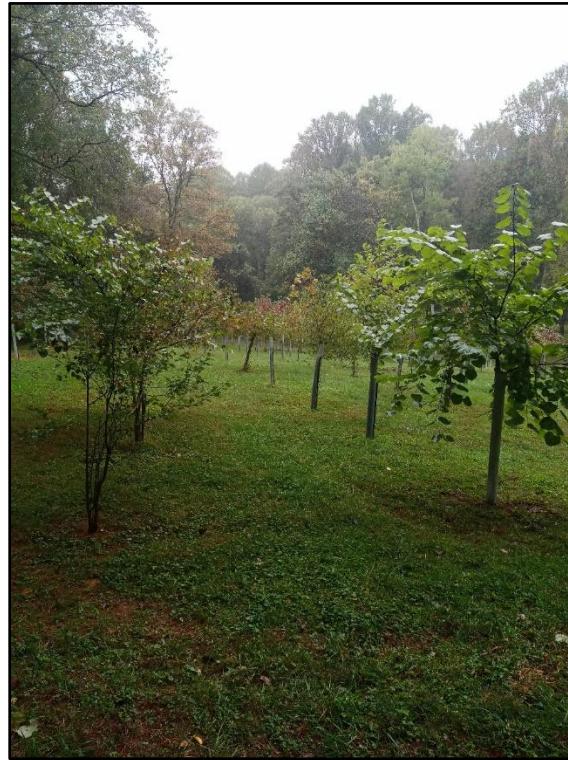
Photo 1: Overview photo facing west.

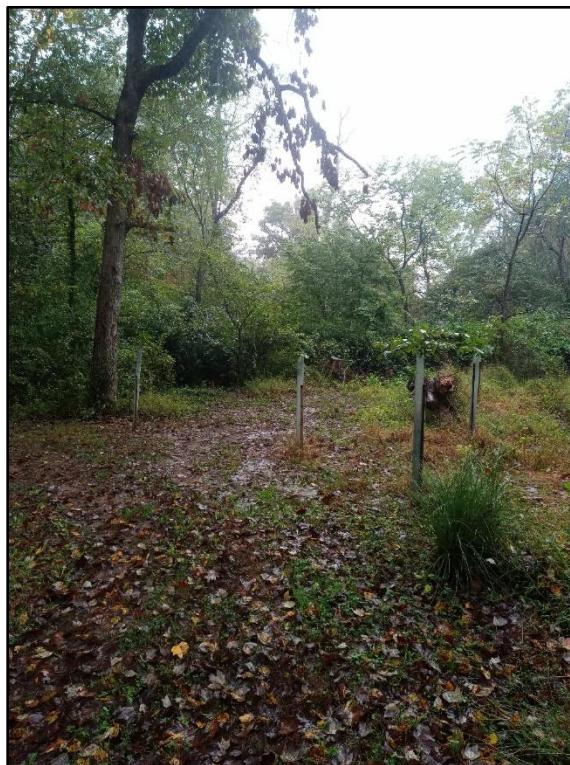
Photo 2: Overview photo facing southwest.

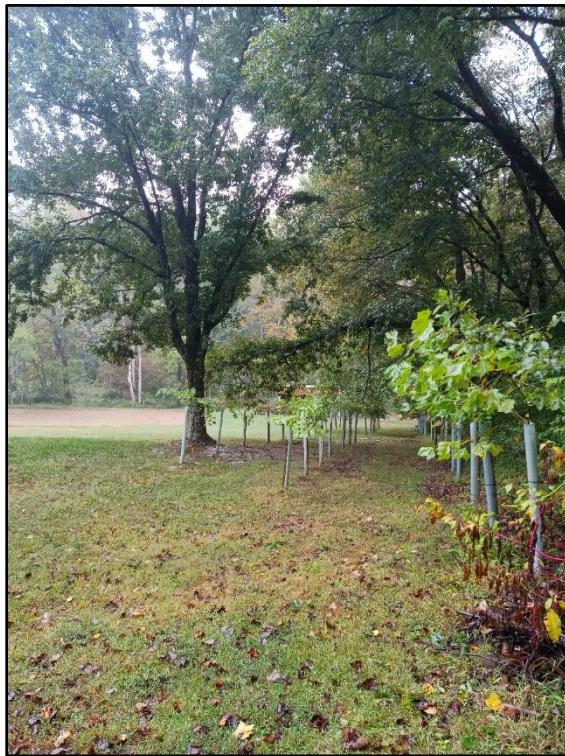
Photo 3: Overview photo facing northwest.

General Comments: Planting is on border of small field of fescue. Some shelters look damaged by mower. Overall plantings look healthy.

Maintenance Comments: Some shelters need to be removed or repaired. Continue mowing a couple times a year to control encroaching honeysuckle.

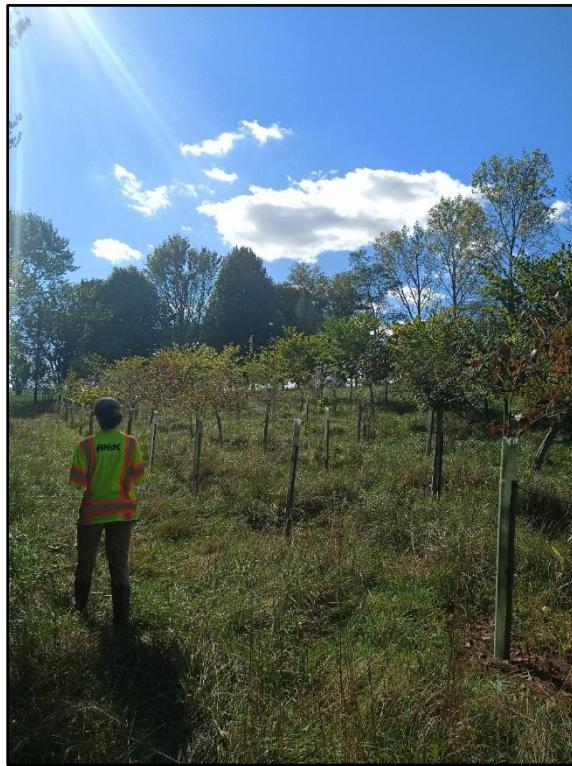
Photo 1: Overview photo facing west.

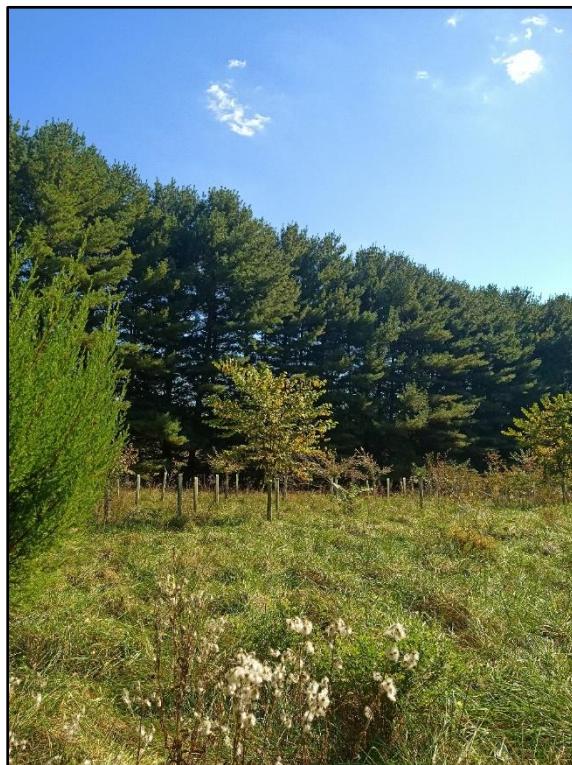
Photo 3: Overview photo facing southeast.

Maintenance Comments: Continue mowing a couple times a year. Monitor Japanese honeysuckle and microstegium. Shelters should be removed from larger trees.

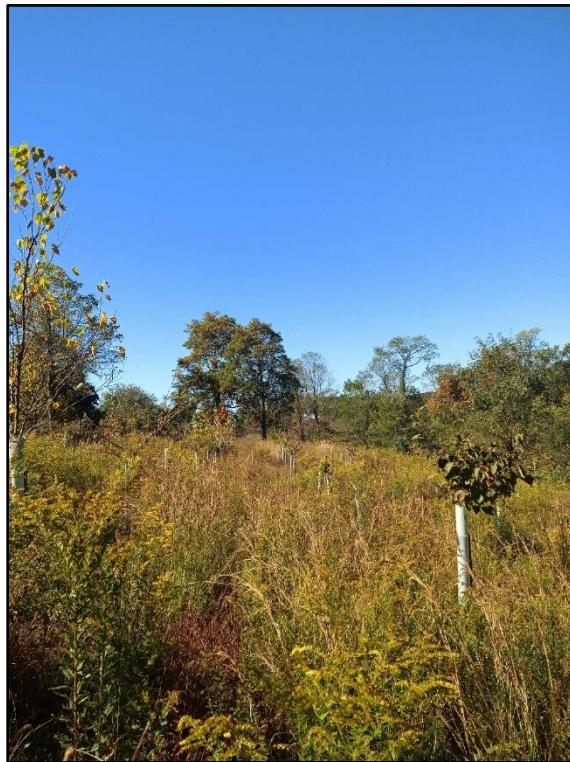
Photo 1: Overview of site, looking west.

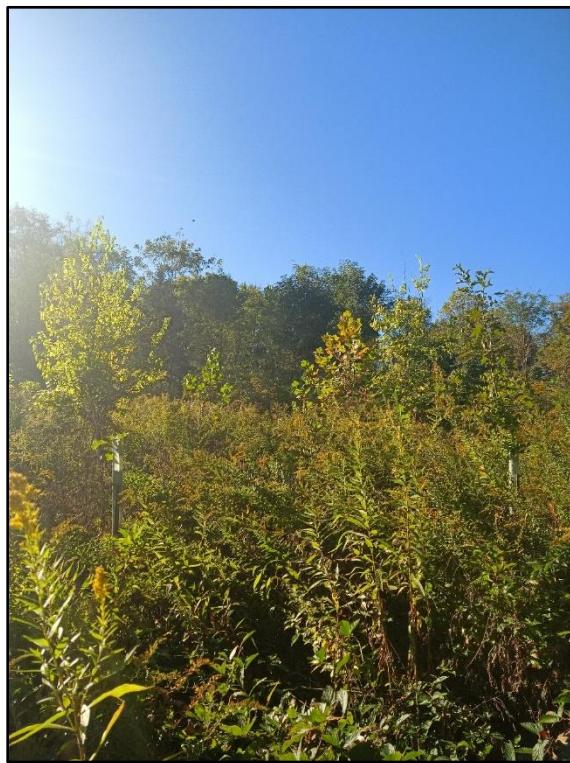
Photo 5: Interior of site and established understory, facing northeast.

General Comments: Species typically more vigorous higher up slope. Plantings almost entirely understory trees. Understory includes foxtail, stiltgrass, little bluestem, and patches of goldenrod. Site appears to be mowed a 2-4x a year. High deer activity, generally site is in good/fair condition.

Maintenance Comments: Continue mowing 2-4x a year to control microstegium. Some shelters could be removed/replaced. Could infill some empty shelters - but replanting is currently not necessary due to density.

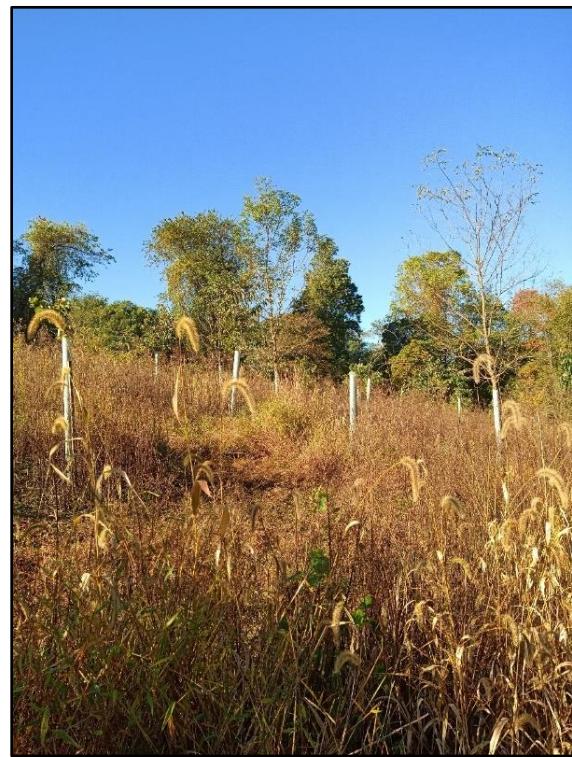
Photo 3: Interior of site with established understory and healthy tree plantings.

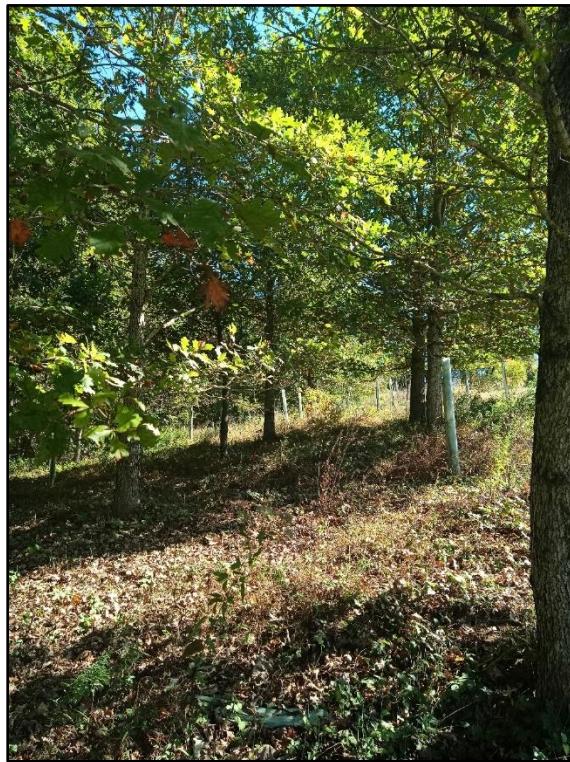
Photo 1: Overview of site, facing southeast.

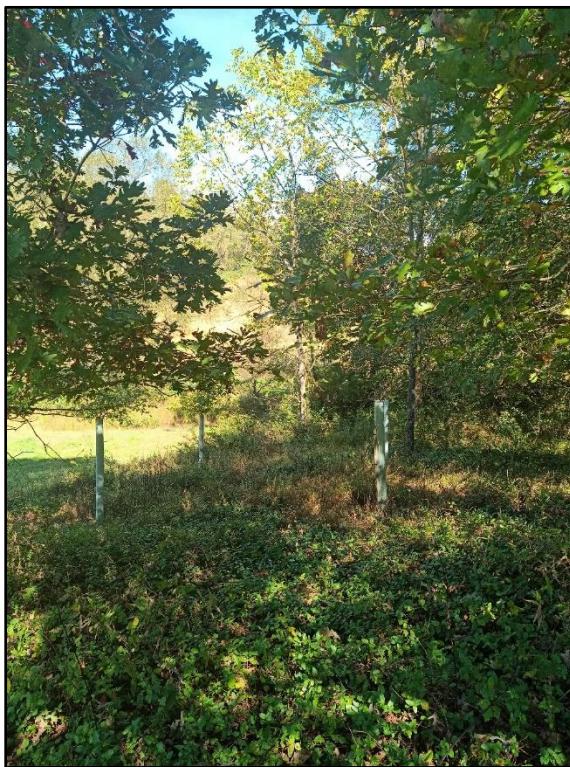
Photo 2: Overview of site, facing northeast.

Site Condition: Not Functioning

Maintenance Comments: Replace infill plantings that died. Control multiflora patches.

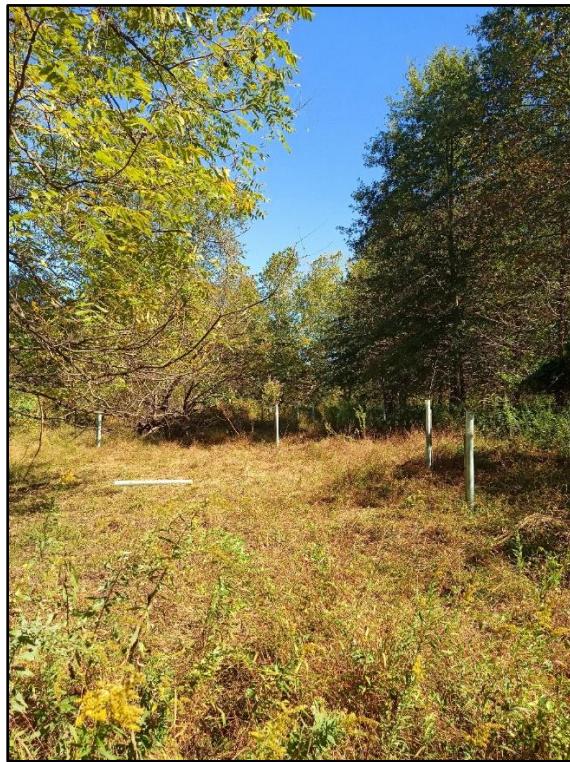
Photo 1: Overview photo facing east.

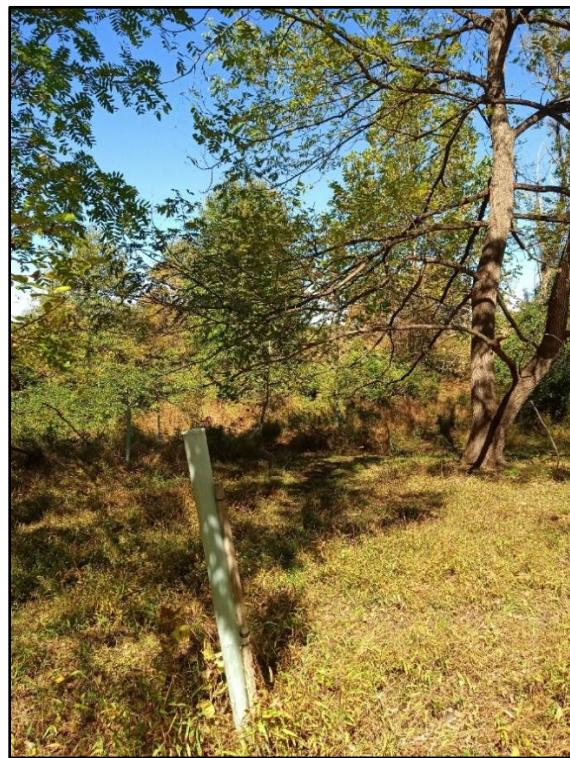
Photo 2: Overview photo facing north.

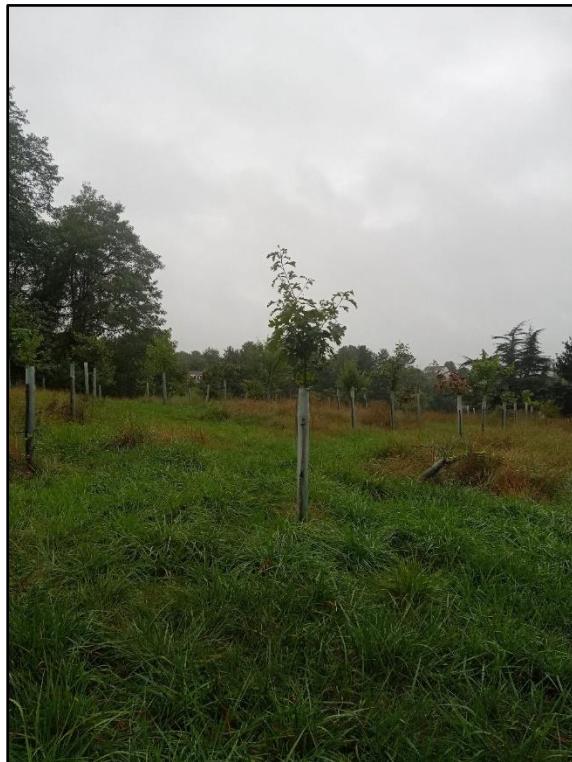
Photo 1: Overview photo facing northwest.

Maintenance Comments: Shelter replacement and removal recommended. Corrective pruning and NNI control with handtools is recommended.

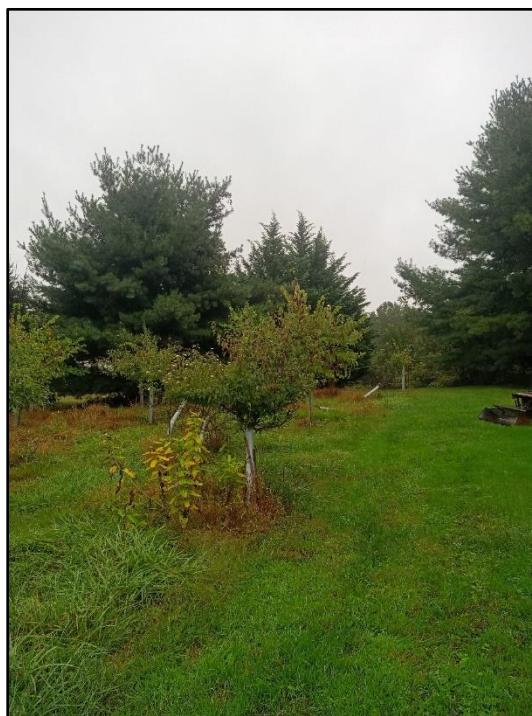
Photo 2: Overview photo facing west.

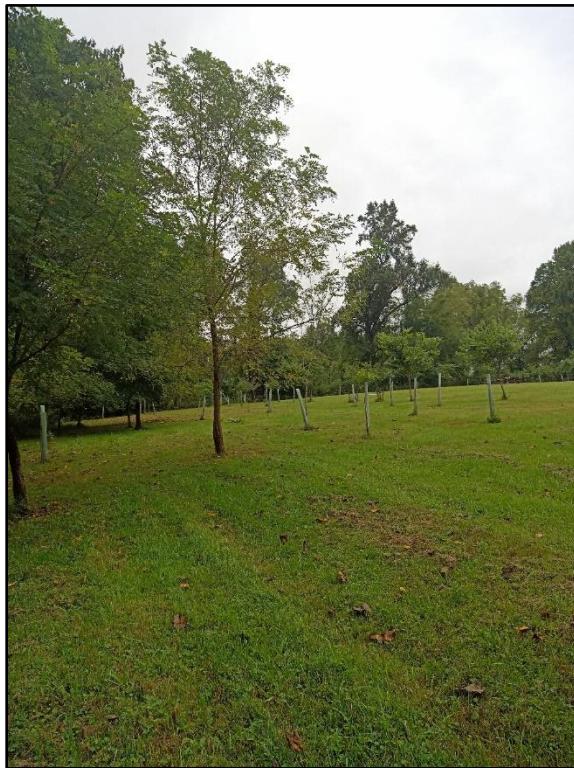
Photo 1: Overview photo facing south.

General Comments: Site is establishing very well overall, strong survival and growth. Site is being well maintained via low mow, some wind damage evident. Homeowner inquired about future maintenance and mowing support

Maintenance Comments: Continue low mow regime, stake and guy trees damaged by wind. Chemical control of thistle recommended. Thistle is present throughout site but large notable stand identified on notes line. Replace zip ties to re-attach shelters to the wooden stakes.

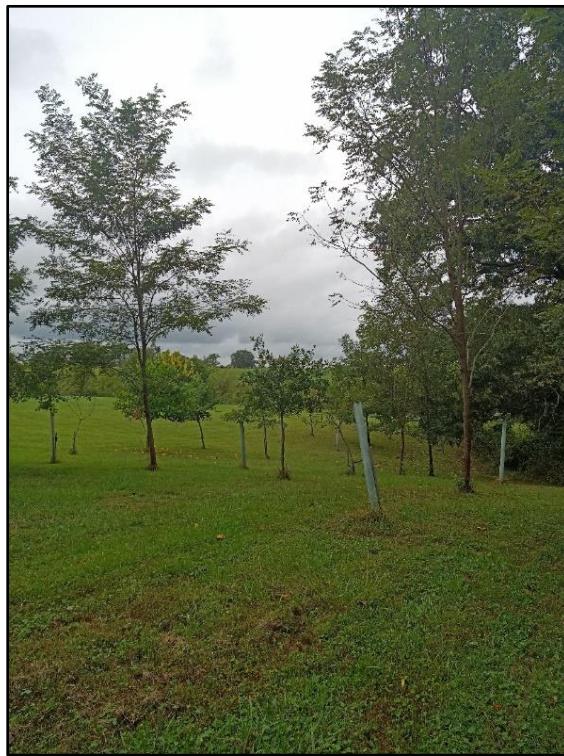
Photo 2: Overview photo facing north.
