Appendix E2 - Stormwater Restoration (Restoration Inspections)

MEMORANDUM

Date: December 3, 2024
To: Danielle Hankins – Harford County Department of Public Works
From: Heaven Aziz – RK&K
CC: Andrew Bodt – Harford County Department of Public Works
Kate Gordon – RK&K
Re: Harford County Fall 2024 Gunpowder Valley Conservancy Tree Planting Site Inspections

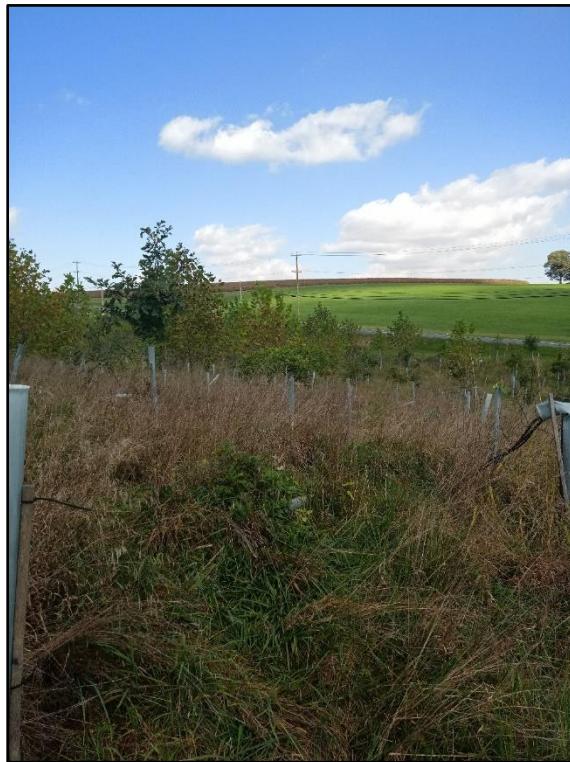
Photo 1: Interior of site looking south, healthy tree plantings and understory.

Maintenance Comments: Clear bittersweet within tubes, chemical control for thistle sp., shelter repair

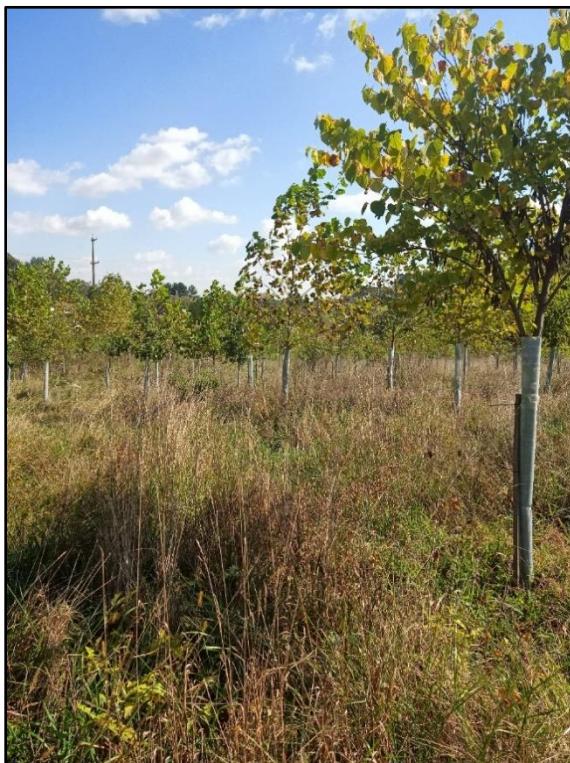
Photo 5: Interior of site looking south, healthy tree plantings and understory.

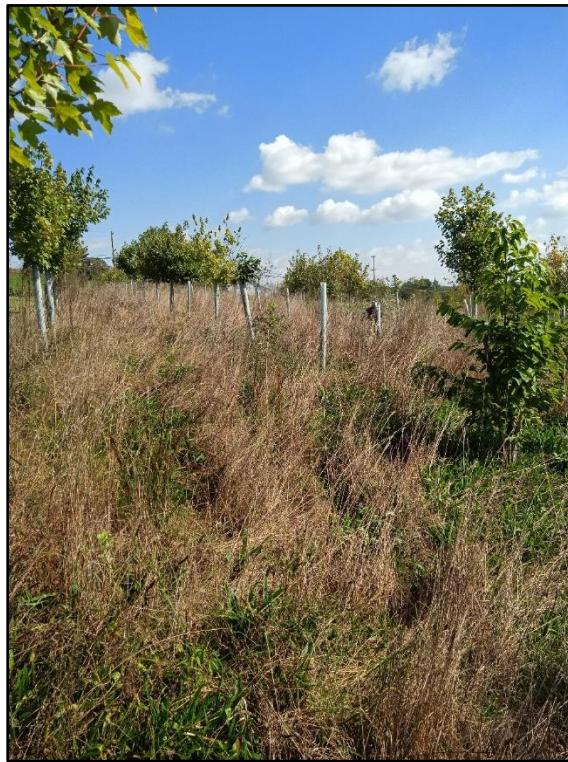
Photo 1: Overview photo facing south.

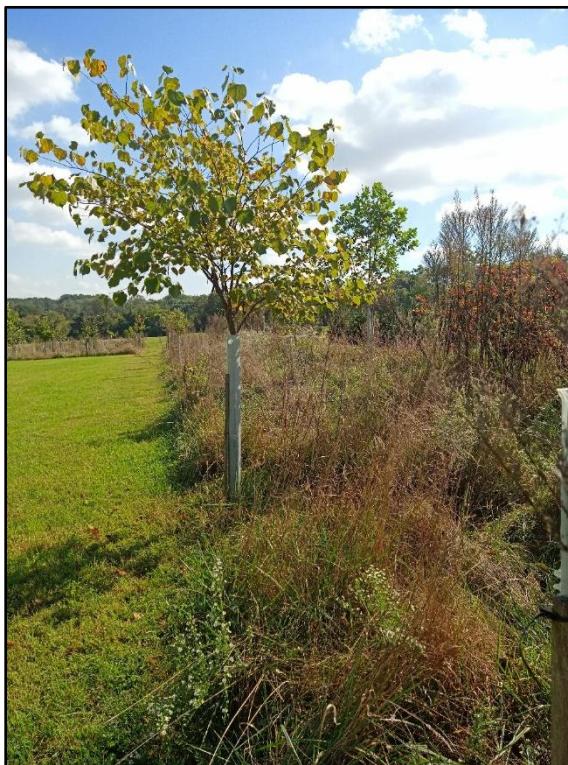
Photo 8: Overview photo facing east.

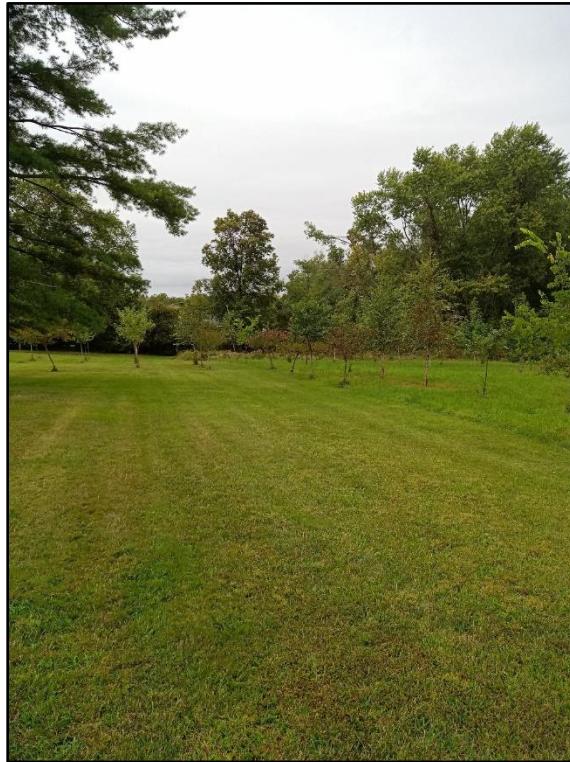
Photo 1: Overview photo facing southwest.

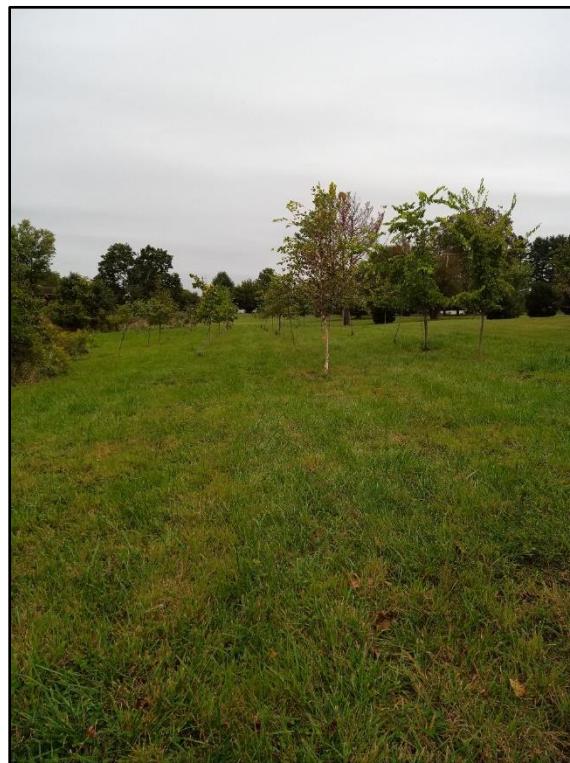
Photo 6: Interior of site, facing northeast.

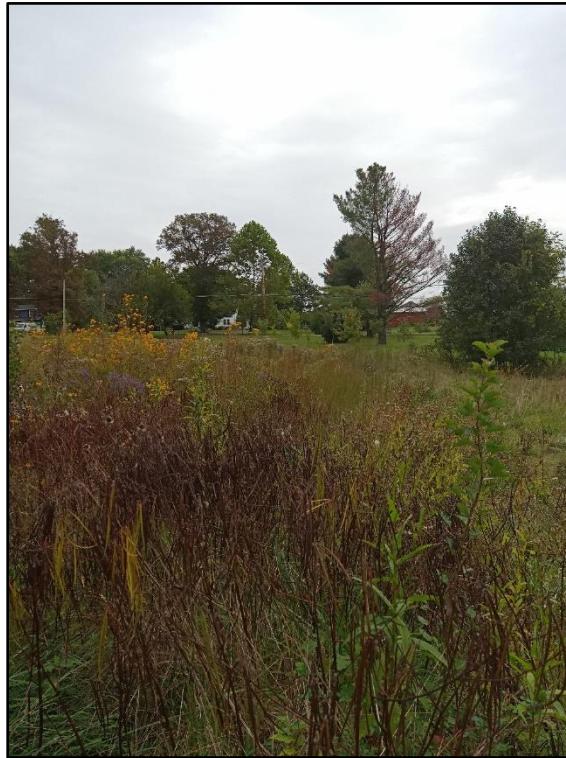
Photo 1: Overview photo facing southwest.

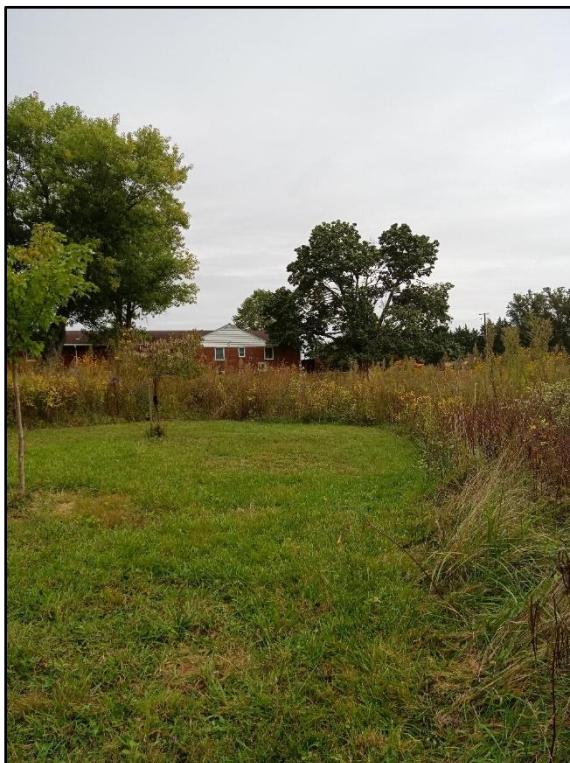
Photo 2: Overview photo facing west.

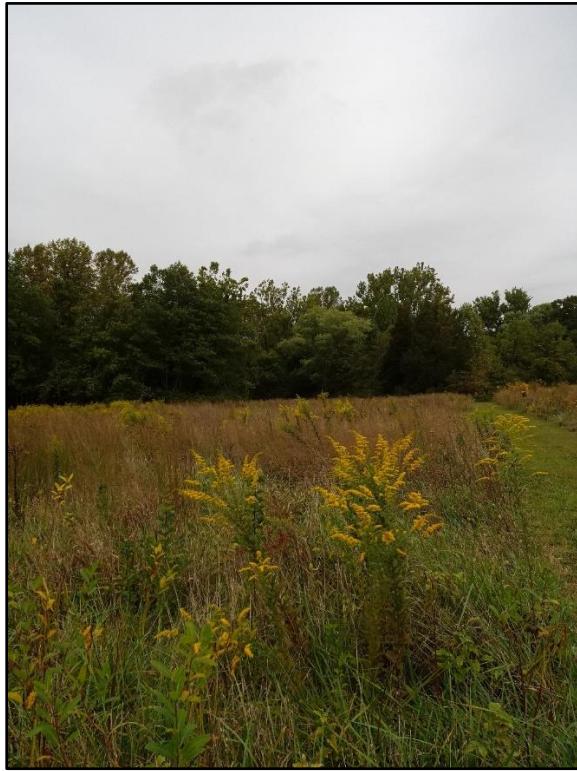
Photo 1: Overview photo of meadow facing north.

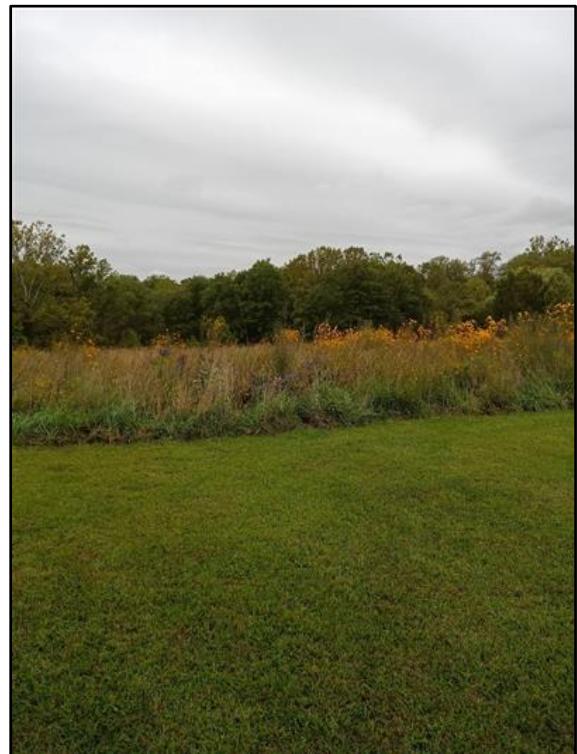
Photo 8: Overview photo of meadow facing southwest.

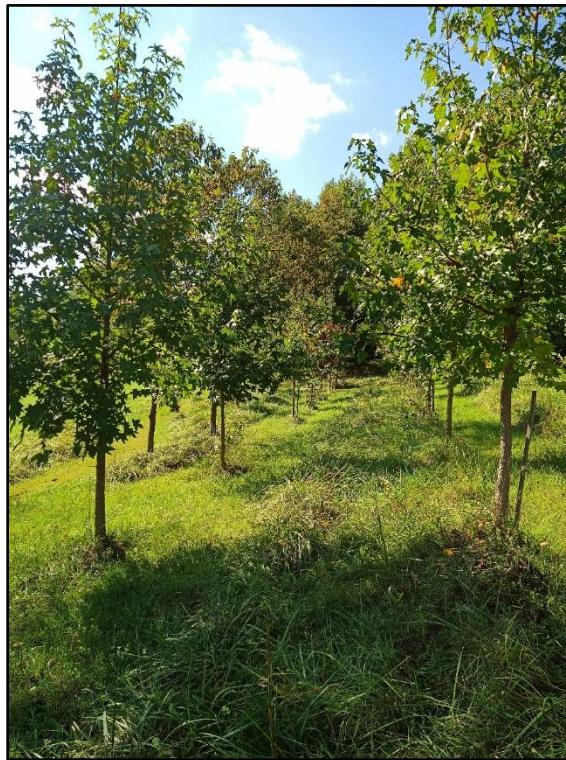
Photo 5: Overview photo facing west.

BMP Type: Forest Planting
Total Trees: 3
Trees per Acre: 60
Planted Acres: 1.24
Total IA Credit: 1.37
Site Condition: Not Functioning
Inspection Method: 0.05 Acre Plots
Understory: Unmanaged
General Comments: Active floodplain with wetland conditions beginning at toe of slope. Appears to be maintained due to lack of invasive woody species. Entire site could use infill with wetland species like sycamore, river birch, black willow, willow oak, and swamp white oak.
Maintenance Comments: Conduct infill planting throughout. Clear plant debris as needed for access.
Owner Type: Homeowner

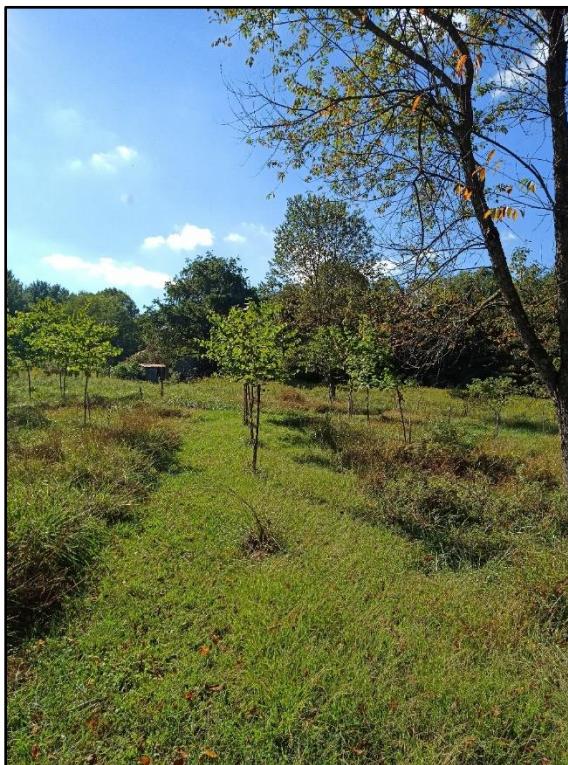
Photo 3: Overview photo facing east.

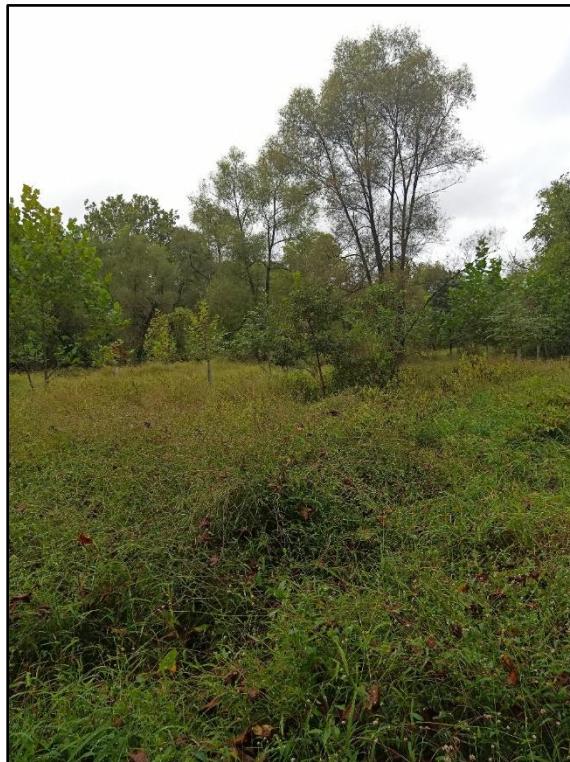
Photo 2: Overview photo facing north.

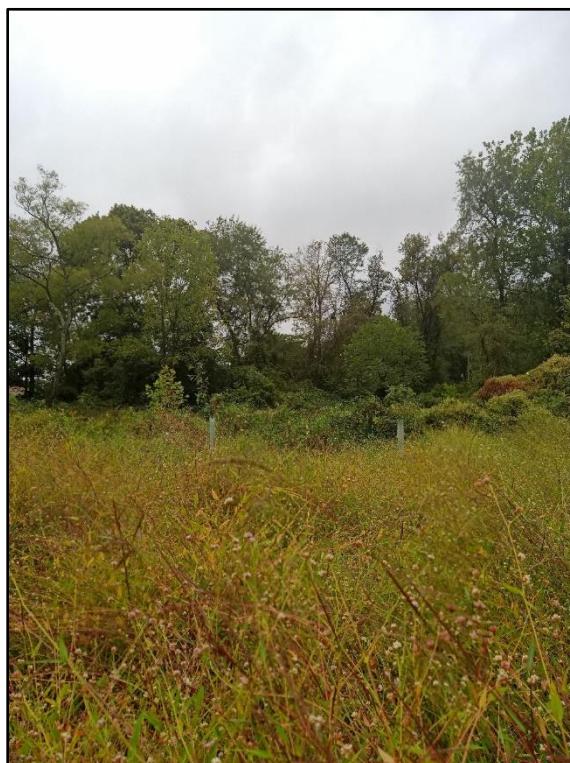
Photo 4: Overview photo facing west.

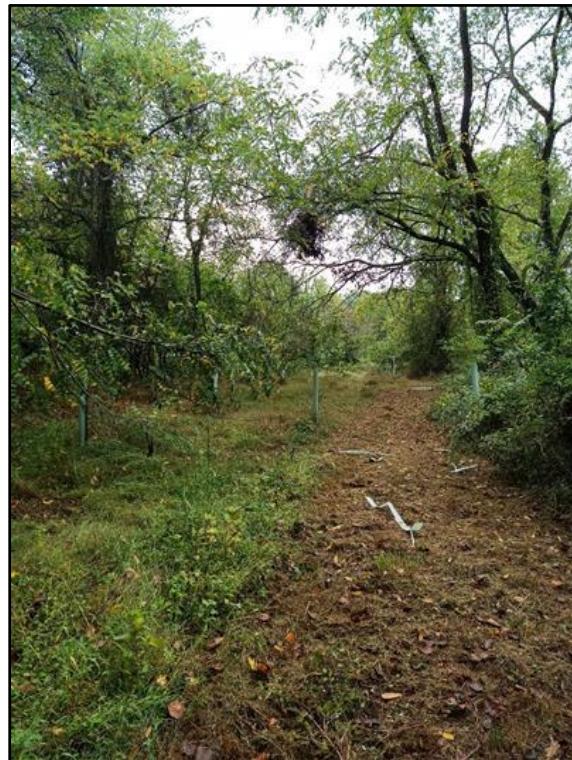
Photo 2: Overview photo facing southeast.

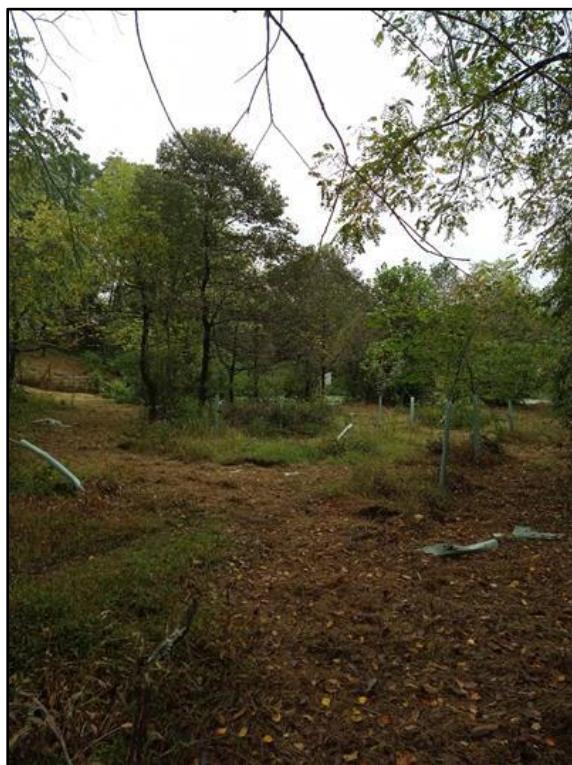
Photo 4: Overview photo facing southeast.

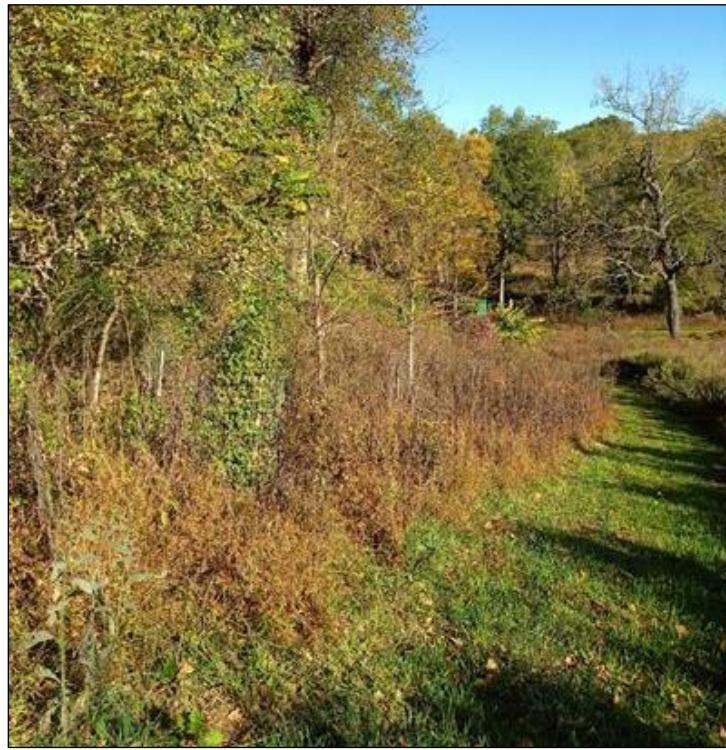
Photo 014: Overview photo looking northwest.

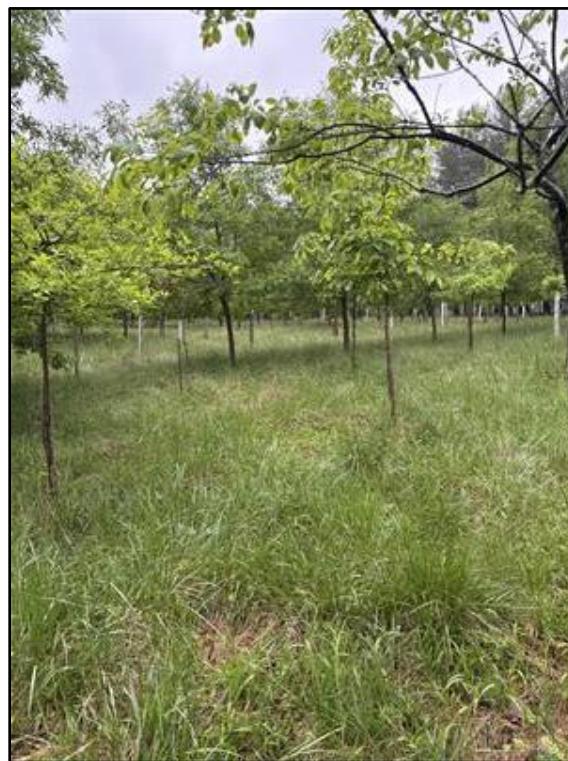
Photo 1: Interior of site, healthy tree plantings.

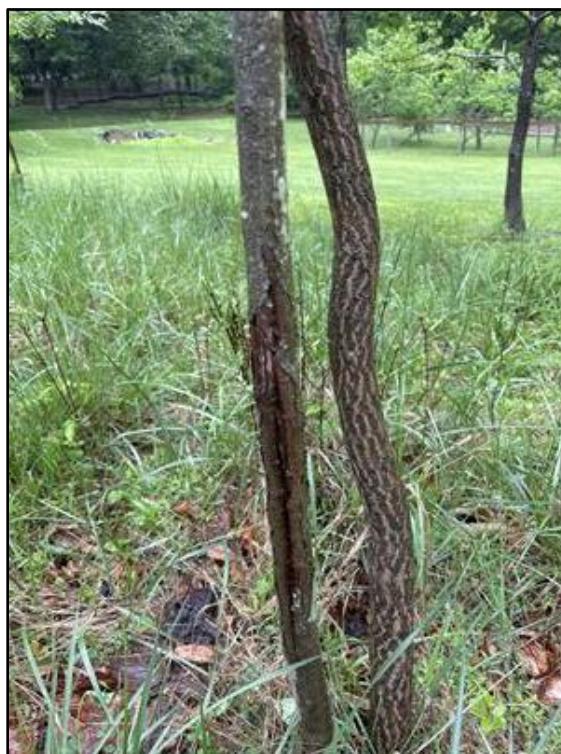
Special Concern Photo 2: Deer buck rub.

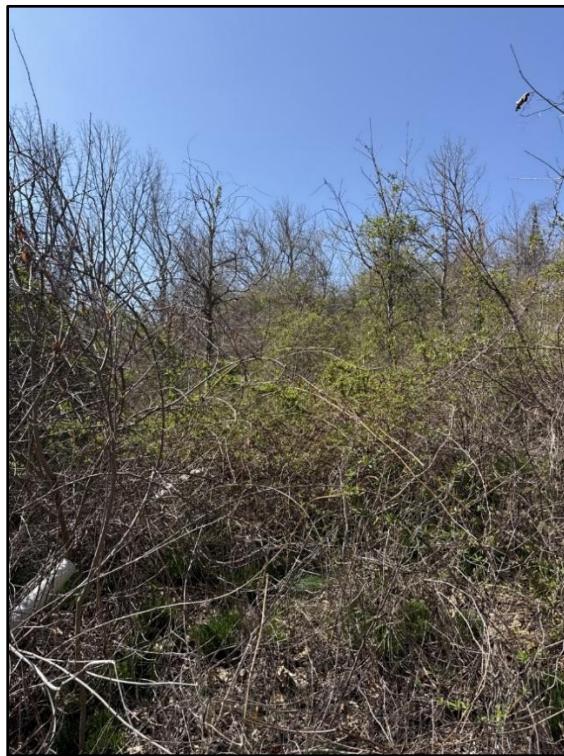
Photo 5: Special concern photo of high poison ivy.

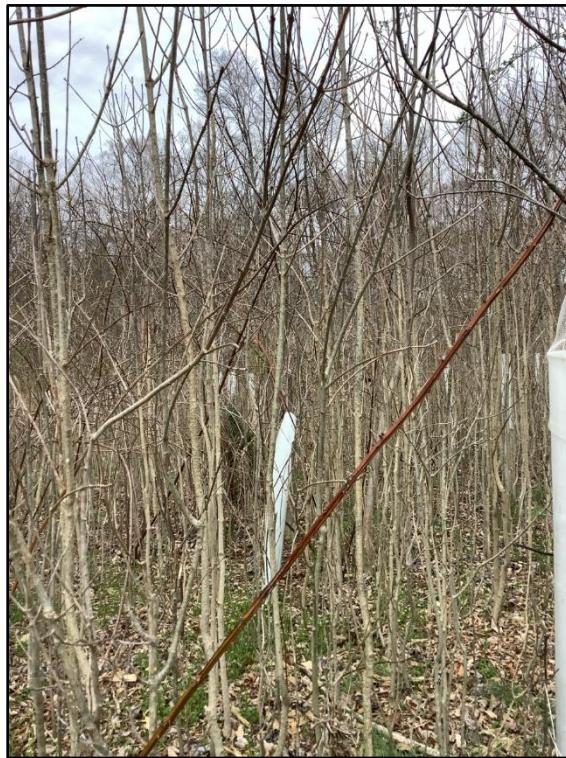
Photo 1: Overview photo of green ash regeneration.

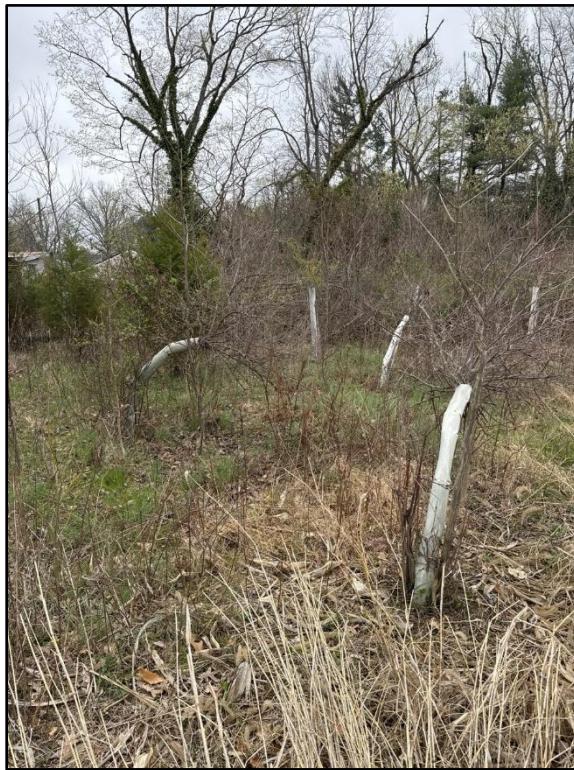
Special Concern Photo 2: Photo of tree shelters in need of maintenance.

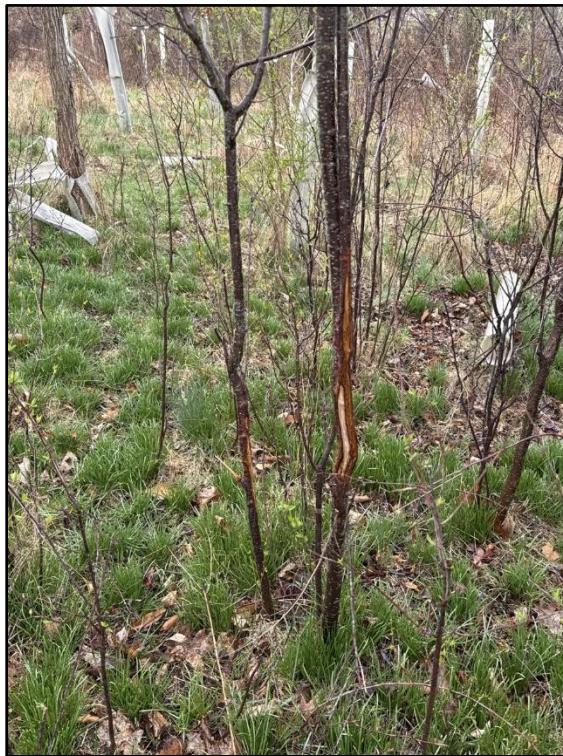
Special Concern Photo 1: Deer buck rub.

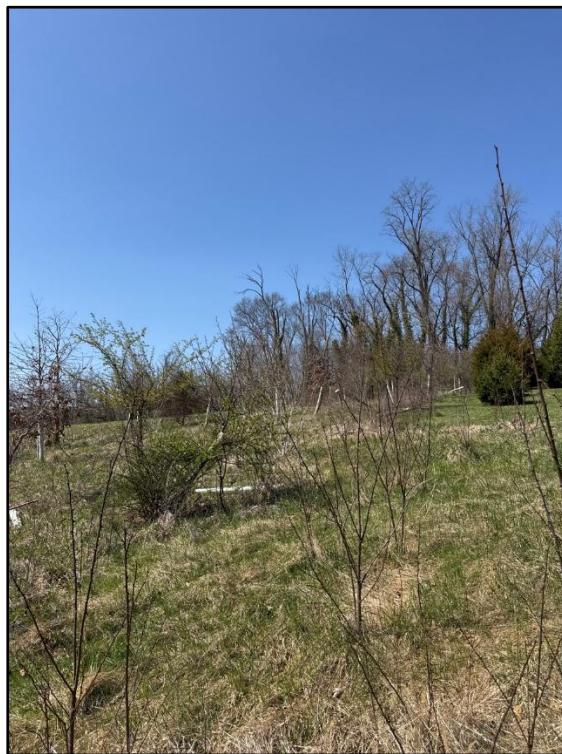
Photo 1: Overview photo facing northwest.

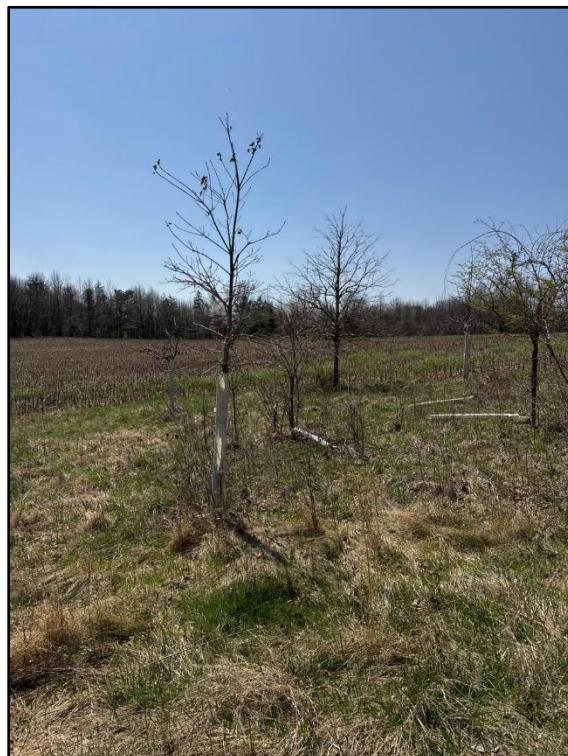
Photo 2: Overview photo facing west.

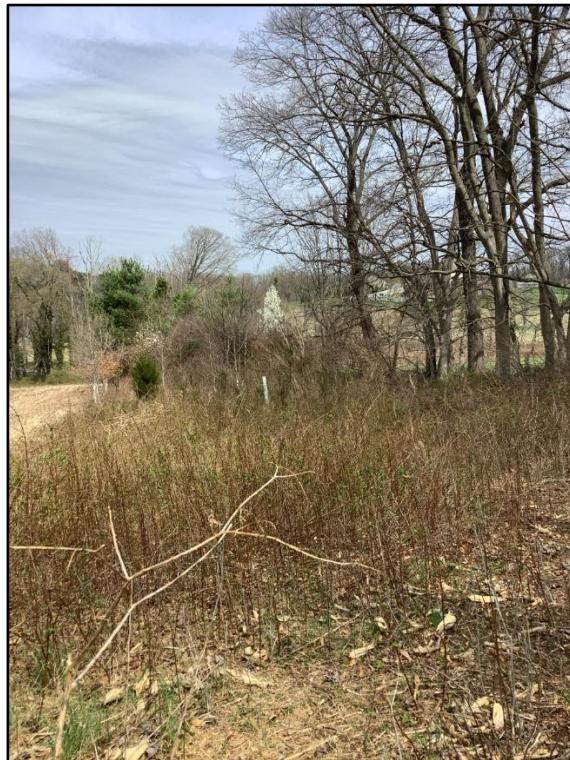
Photo 1: Overview photo facing southeast.

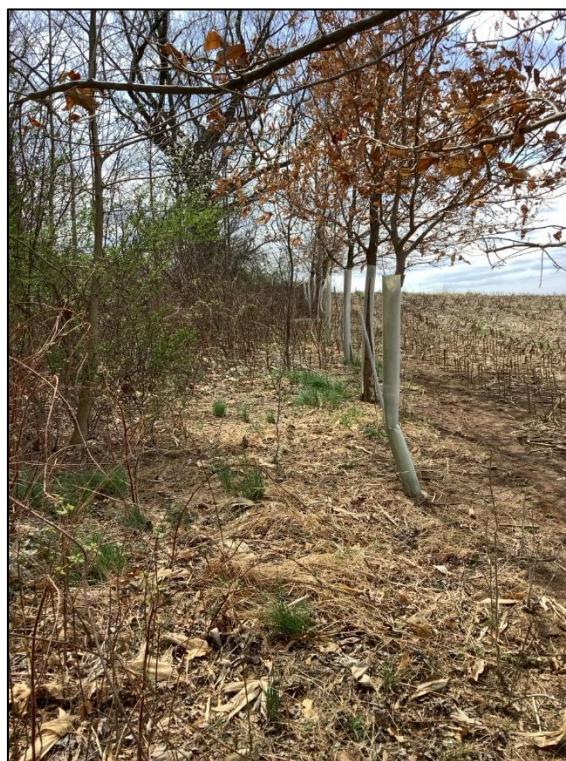
Photo 3: Overview photo facing north.

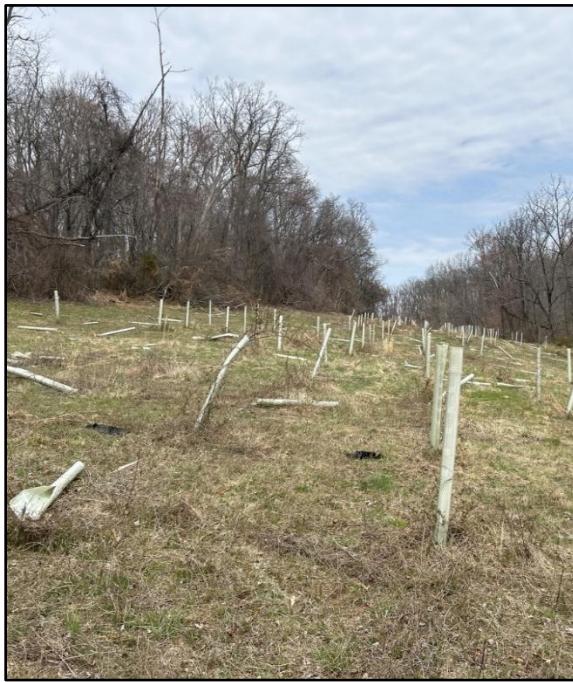
Photo 1: Overview photo facing northeast.

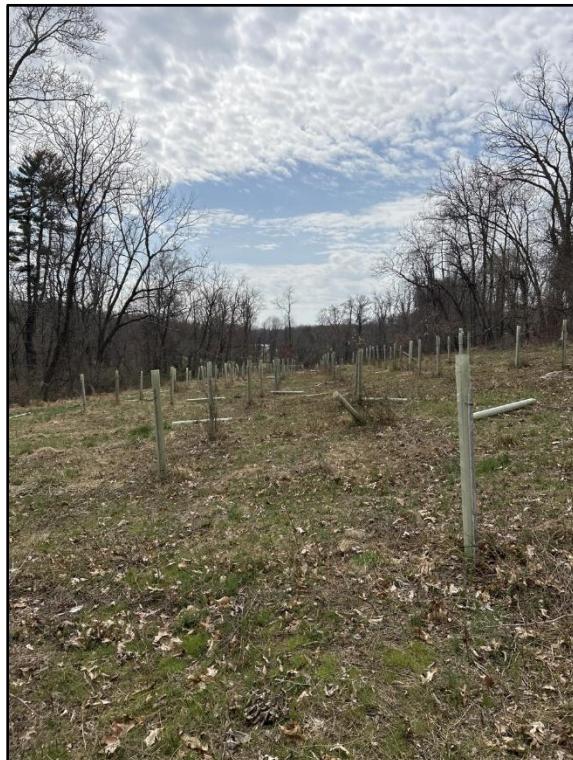
Photo 5: Overview photo facing northeast.

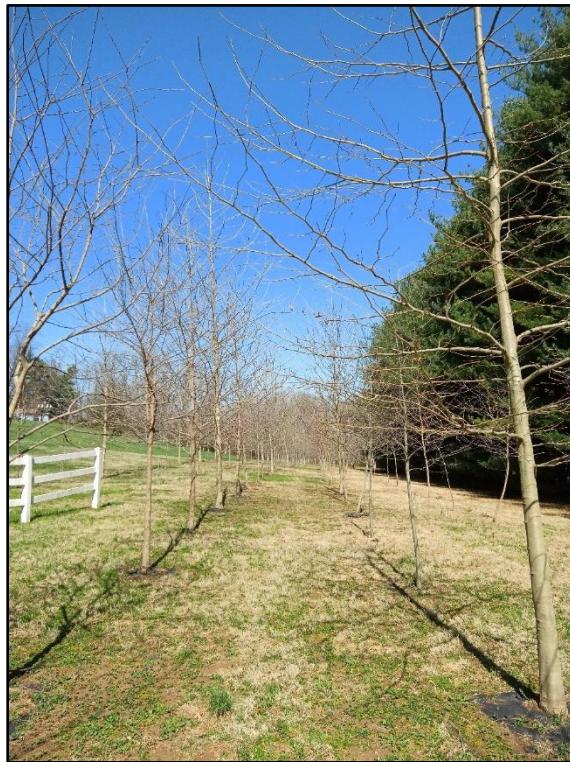
Photo 1: Overview photo facing northeast.

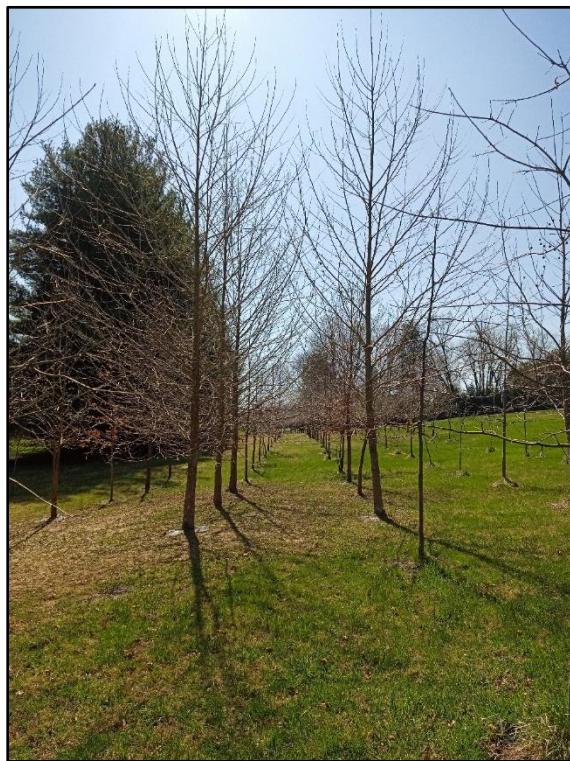
Photo 5: Overview photo facing southwest.

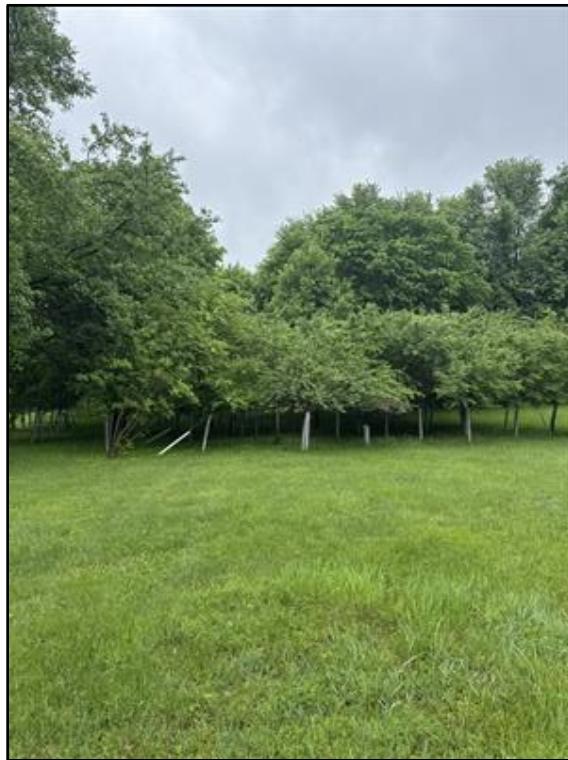
Photo 1: Overview photo facing east.

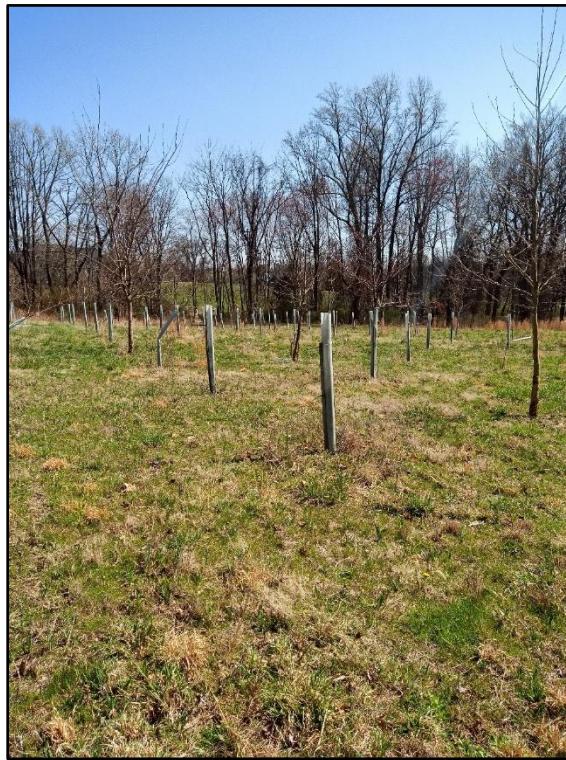
Photo 1: Overview photo facing southwest.

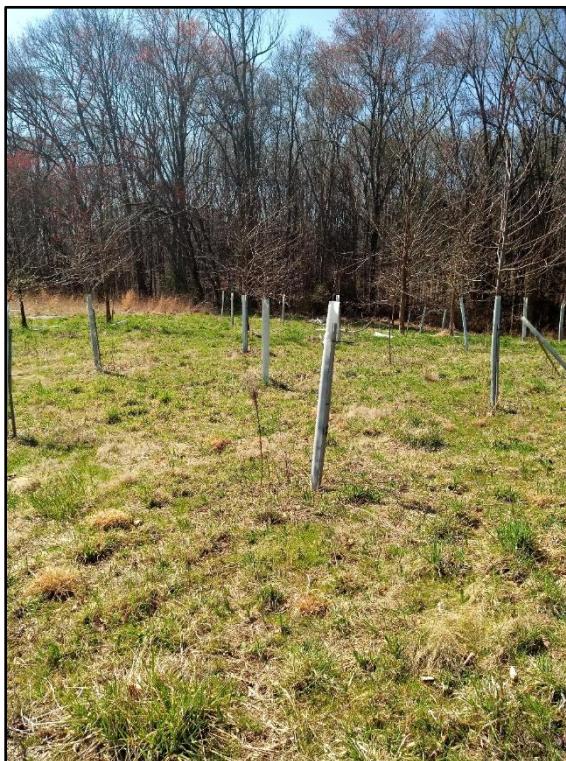
Photo 2: Overview photo facing northeast.

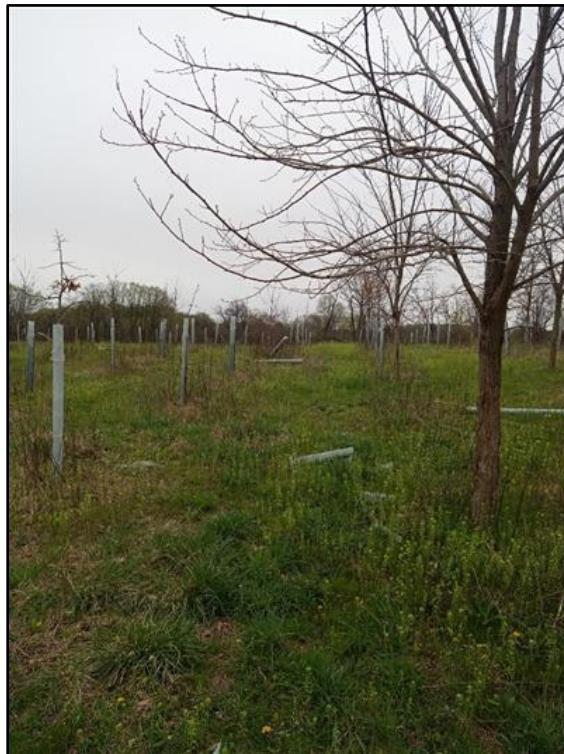
Photo 2: Overview photo facing southwest.

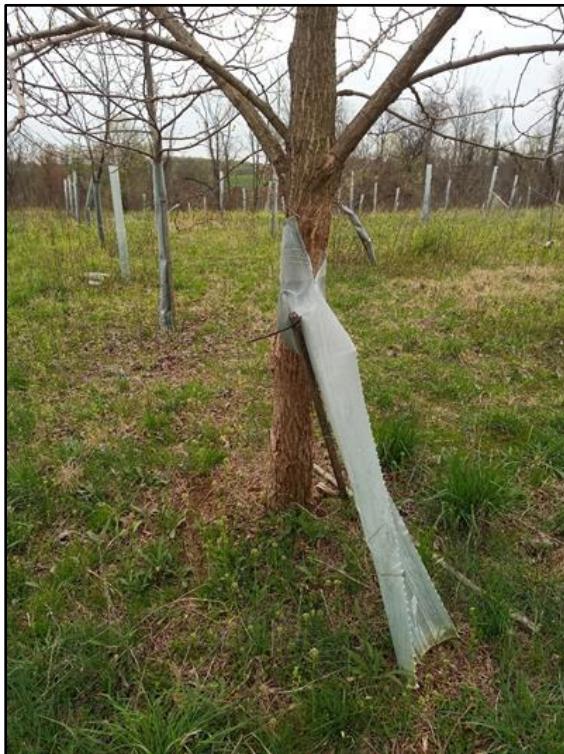
Special Concern Photo 3: Tree shelters in need of maintenance.

BMP Type: Urban Tree Canopy
Total Trees: 6
Trees per Acre: 12
Planted Acres: 0.48
Total IA Credit: 0.13
Site Condition: Not Functioning
Inspection Method: Total Site Count
Understory: Maintained Turf
General Comments: Site has largely failed, complete replanting needed. Landowner mentioned that the forestry board oversaw the initial plantings.
Maintenance Requested: Yes
Maintenance Comments: Removal of invasive honeysuckle needed, followed by replanting/infill of entire site.
Owner Type: Homeowner

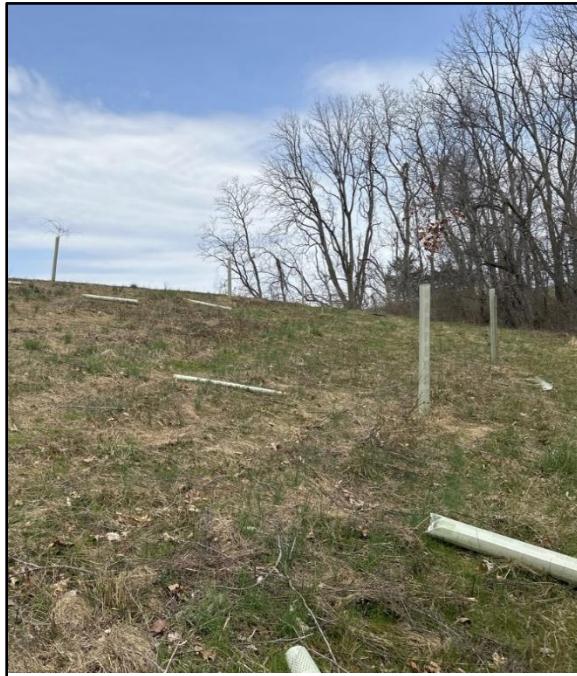
Photo 1: Overview photo facing northeast.

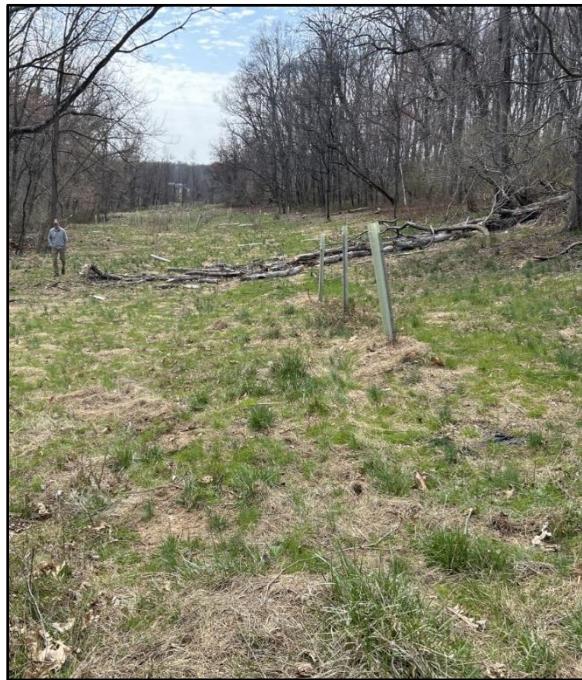
Photo 2: Overview photo facing southwest.

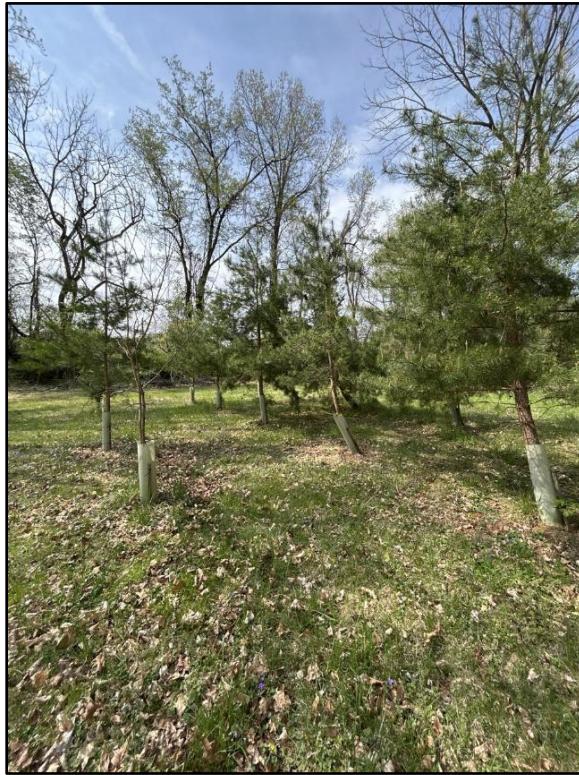
Photo 2: Overview photo facing south.

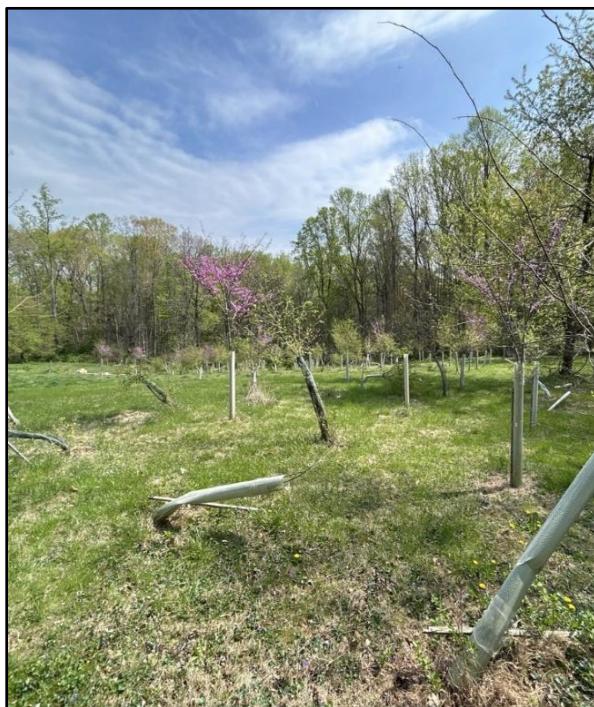
Photo 3: Overview photo facing northeast.

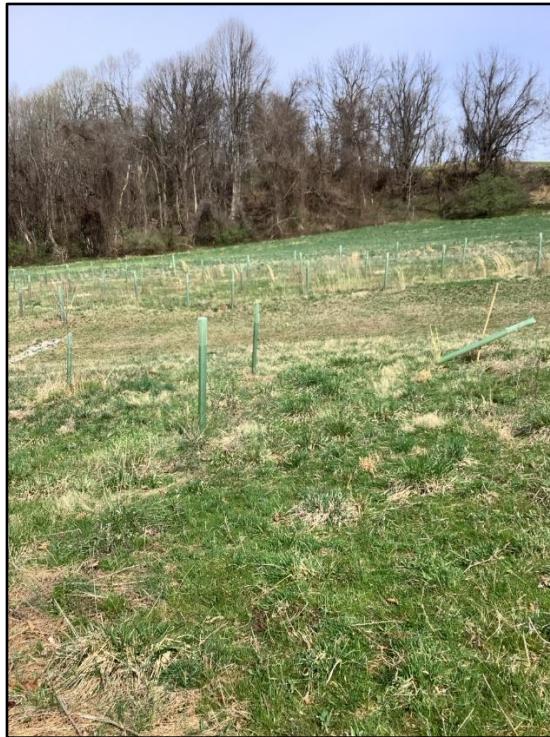
Photo 1: Overview photo facing west.

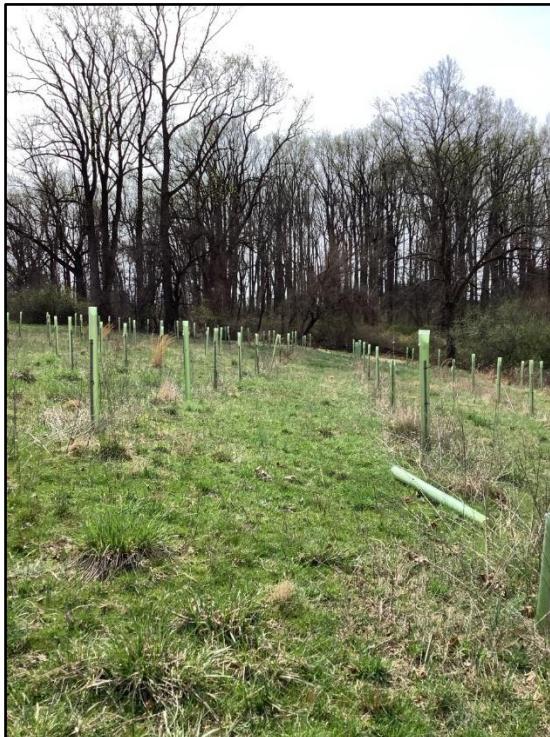
Photo 2: Plot photo facing northwest.

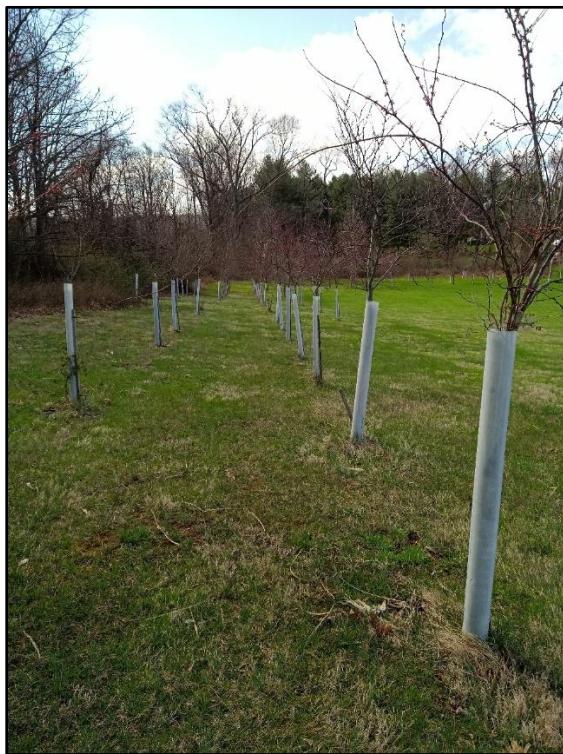
Photo 3: Overview photo facing south.

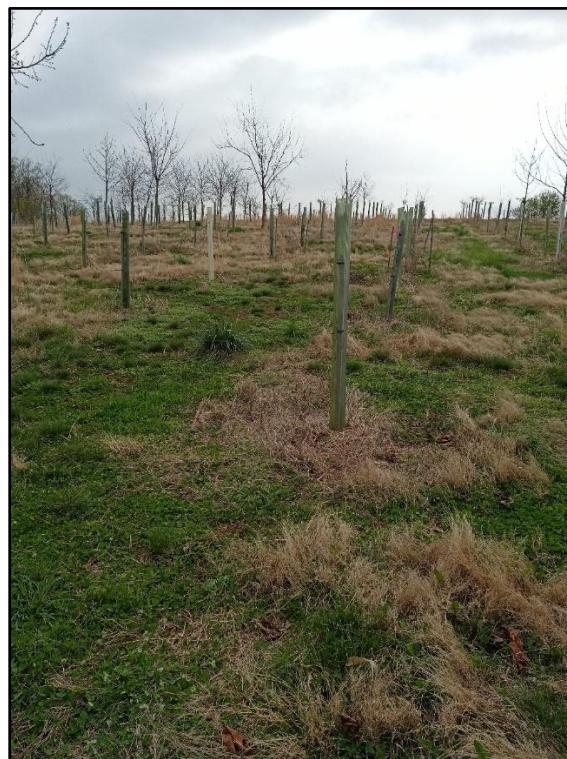
Plot Point Photo 2: Overview photo facing east.

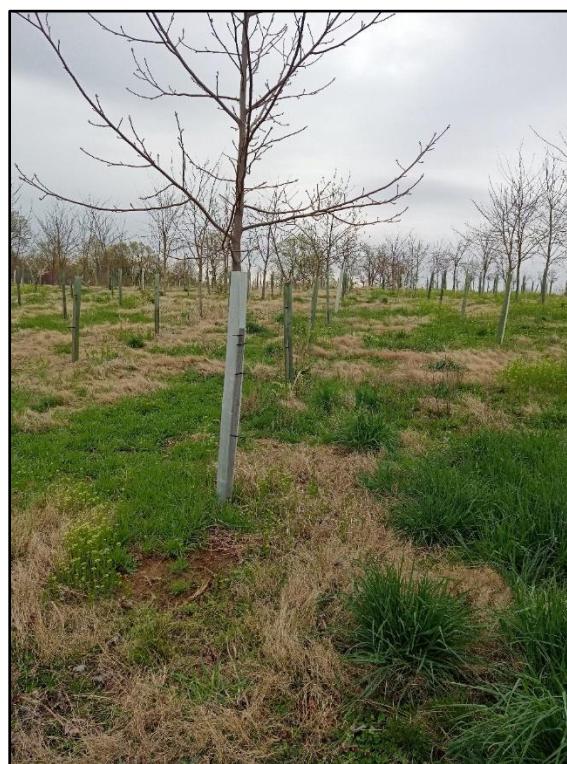
Plot Point Photo 4: Overview photo facing south.

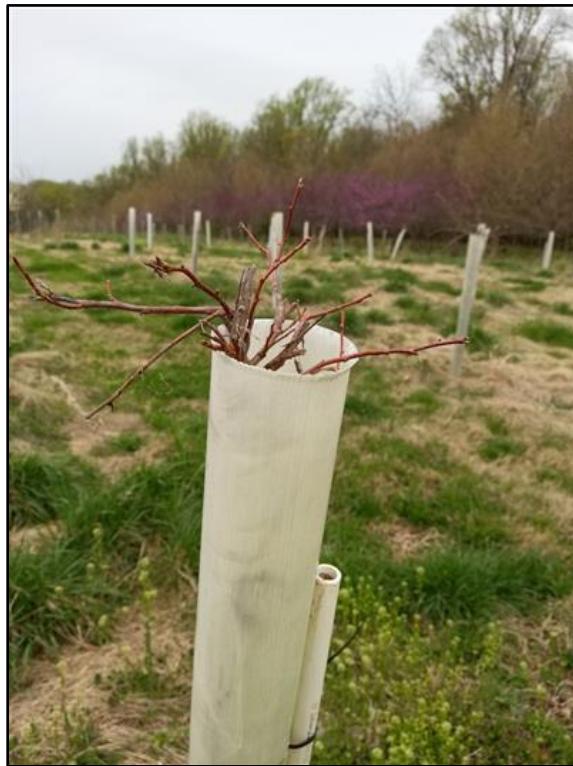
Special Concern Photo 1: Deer browse resulting in a deformed crown.

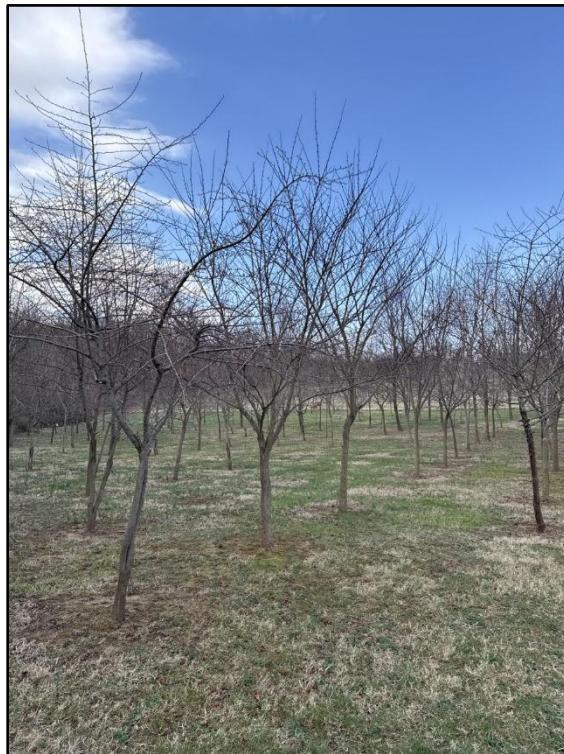
Photo 4: Overview photo facing southwest.

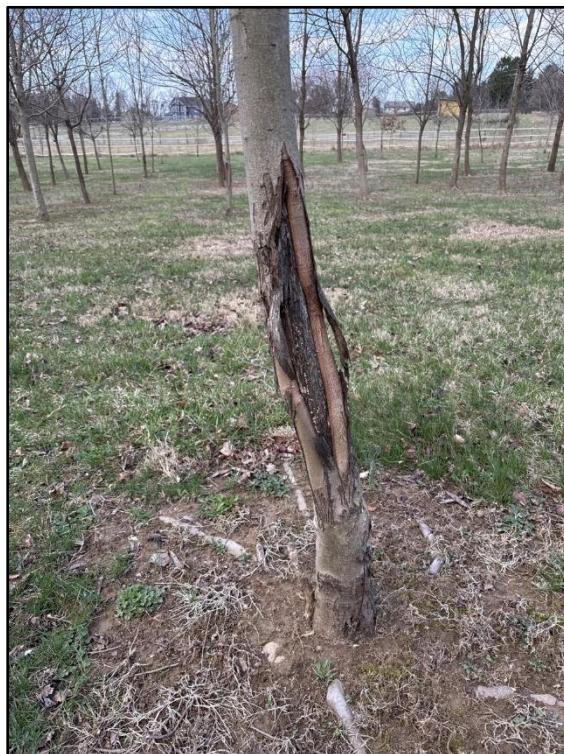
Special Concern Photo 1: Deer buck rub.

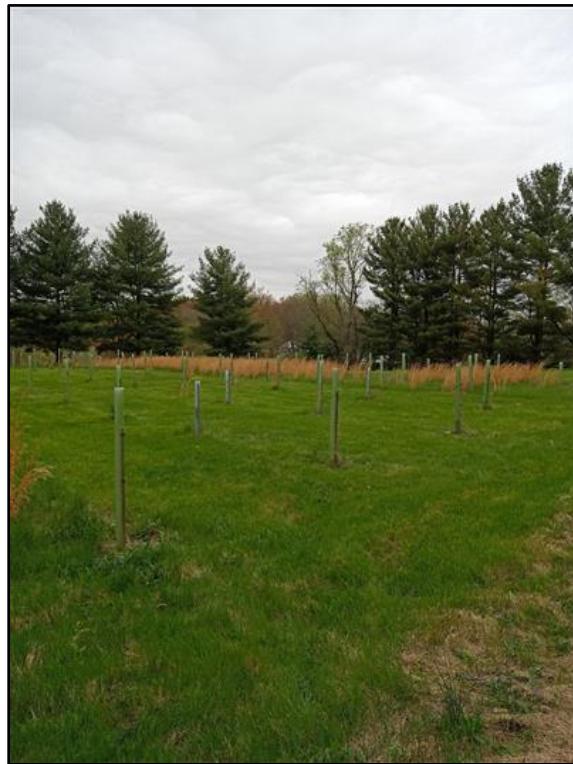
Photo 1: Overview photo facing northwest.

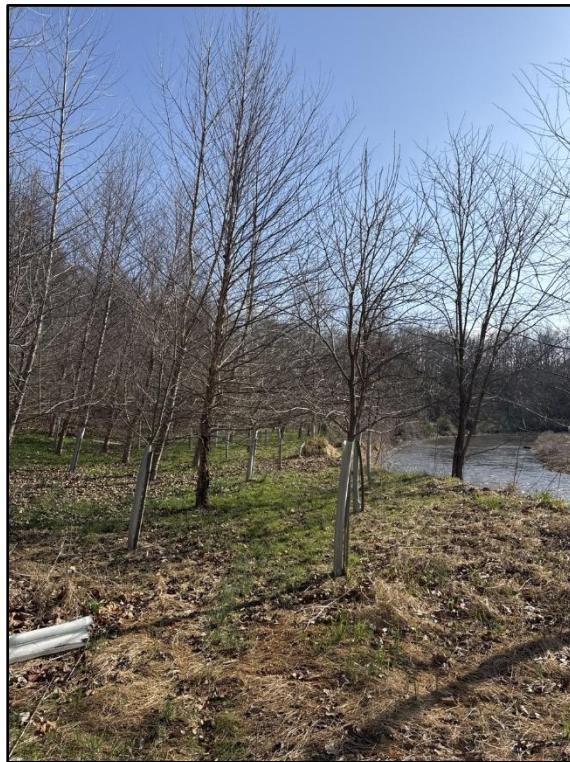
Photo 2: Overview photo facing north.

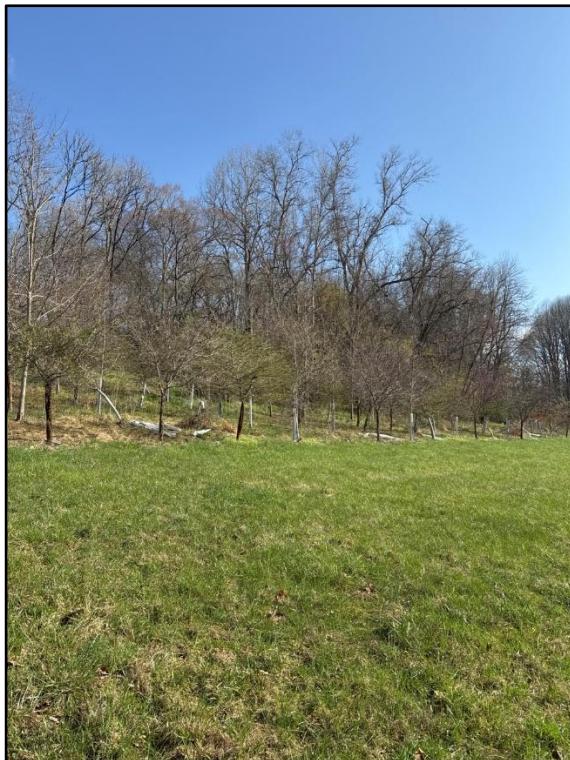
Photo 6: Overview photo facing west.
