Appendix E2 - Stormwater Restoration (Restoration Inspections)

MEMORANDUM

Date: December 3, 2024
To: Danielle Hankins – Harford County Department of Public Works
From: Heaven Aziz – RK&K
CC: Andrew Bodt – Harford County Department of Public Works
Kate Gordon – RK&K
Re: Harford County Fall 2024 Gunpowder Valley Conservancy Tree Planting Site Inspections

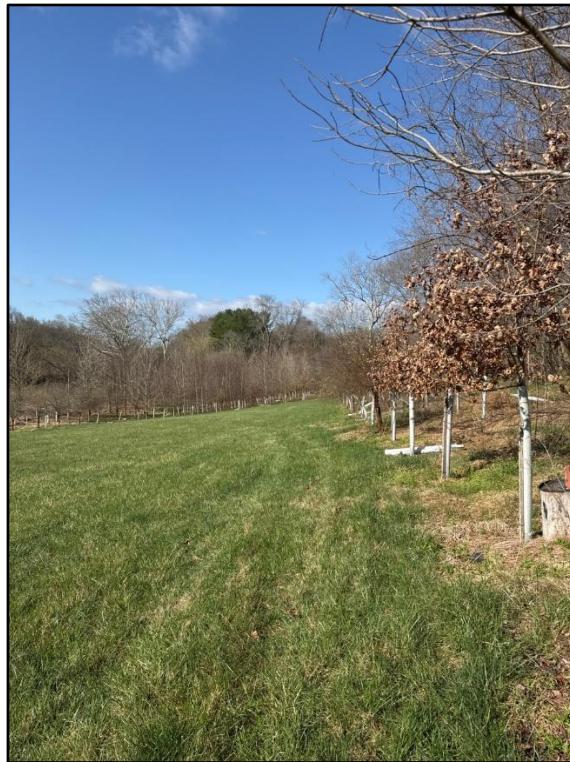
Photo 8: Overview photo facing southwest.

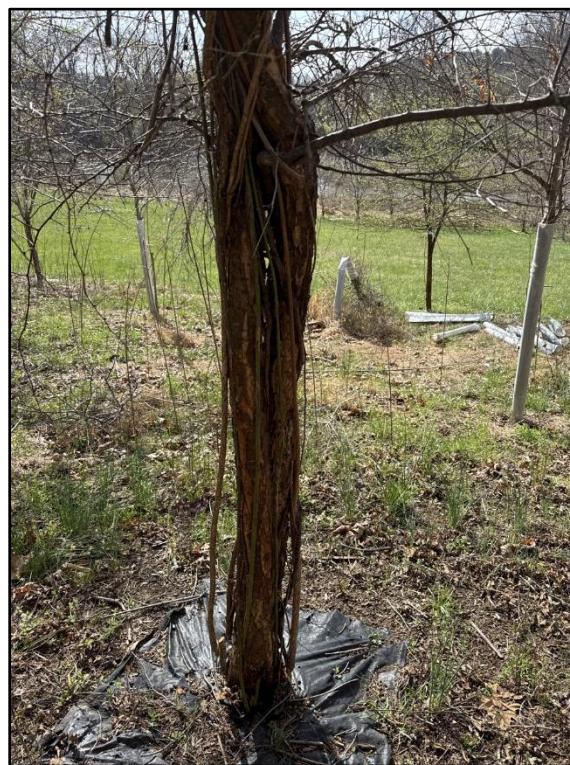
Special Concern Photo 3: Oriental bittersweet covering a planted tree.

General Comments: Site is establishing very well overall, trees are generally 6-20' tall, 1-6" caliper.
Maintenance Requested: Yes
Maintenance Comments: Removing invasive species from tubes and repairing shelters. Owner is actively maintaining site.

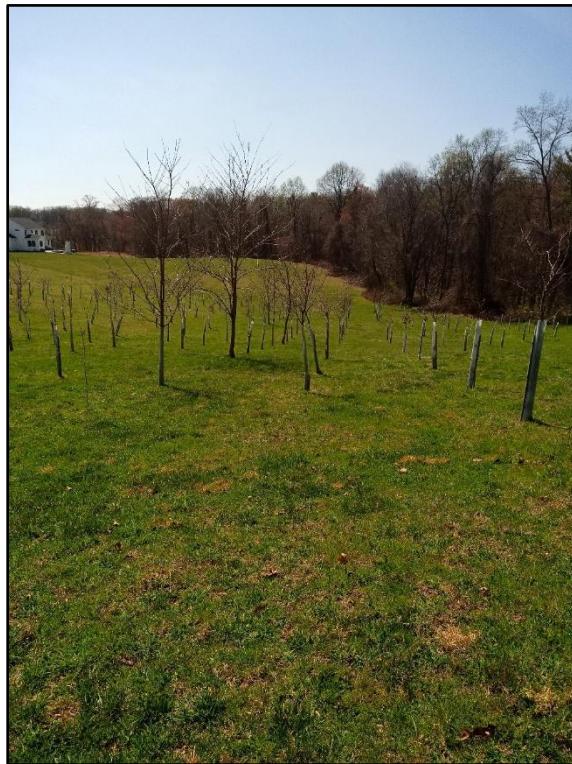
Photo 2: Overview photo facing southwest.

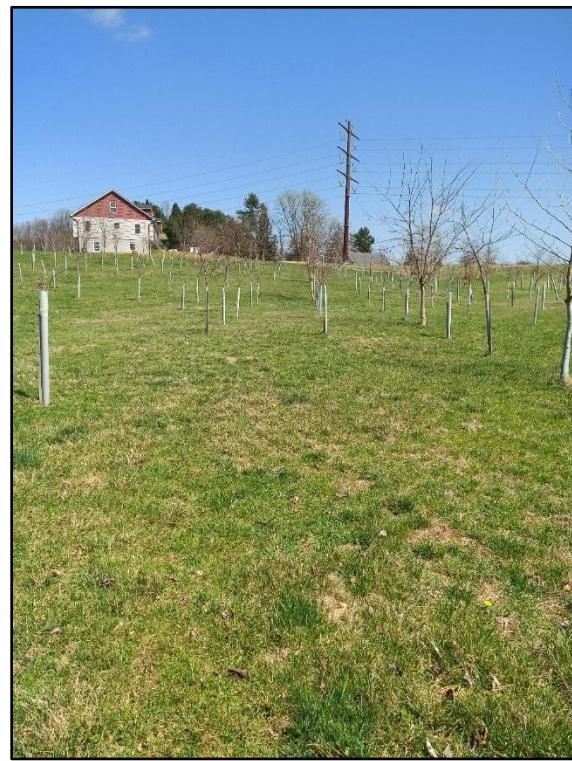
Plot Point Photo 2: Overview photo facing northeast.

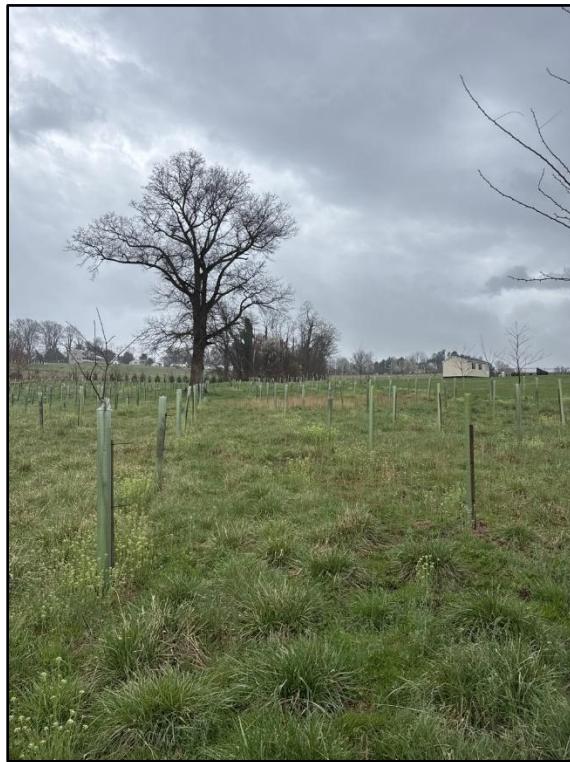
Photo 2: Overview photo facing east.

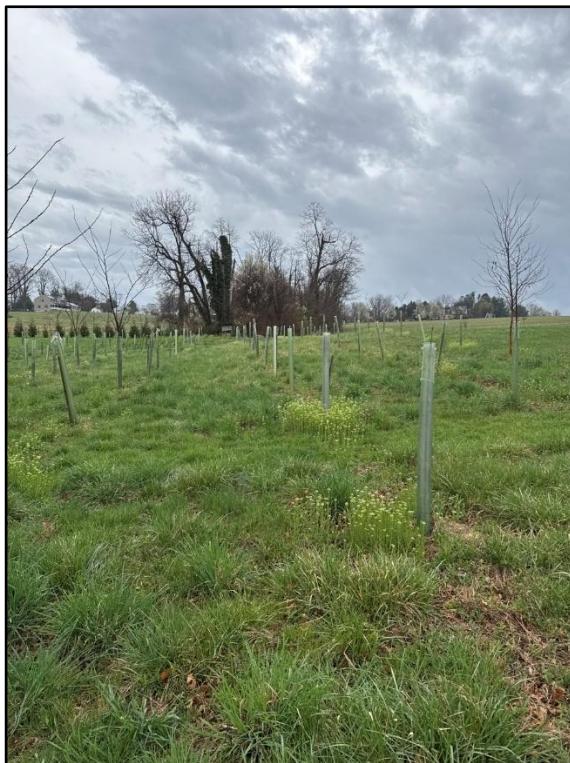
Photo 5: Overview photo facing east.

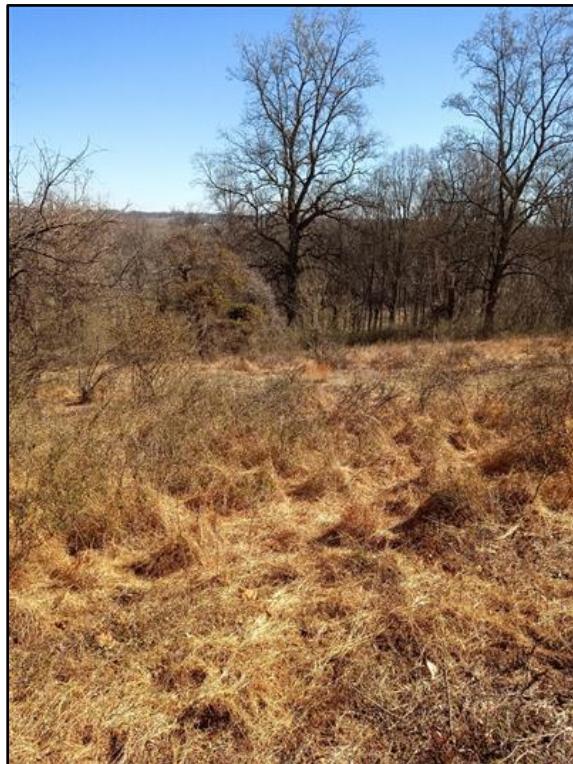
Photo 2: Overview photo facing east.

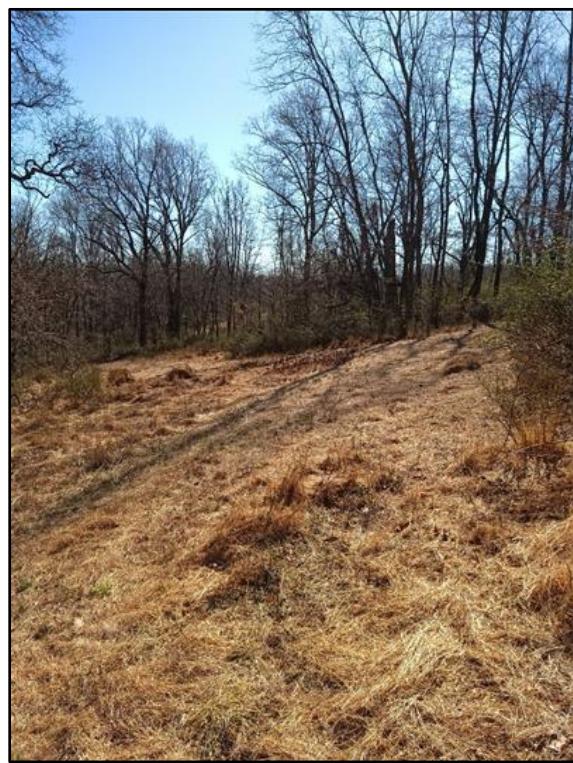
Photo 5: Overview photo facing south.

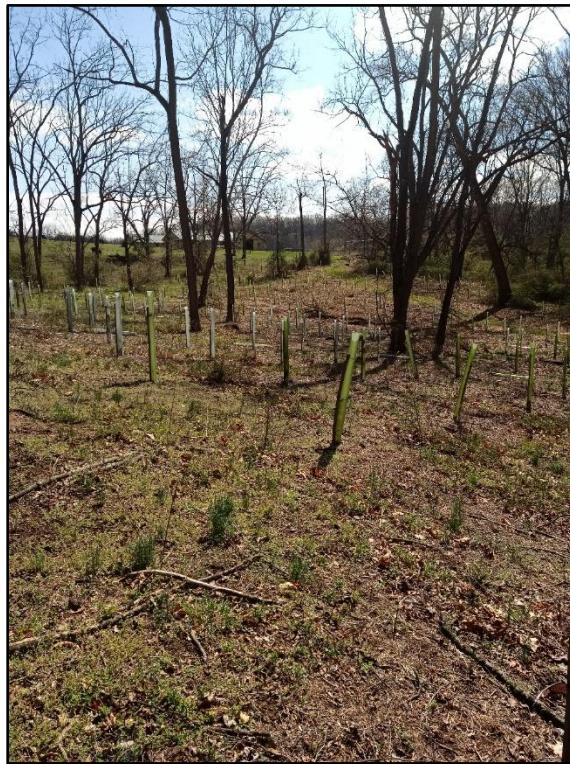
Photo 1: Overview photo facing southeast.

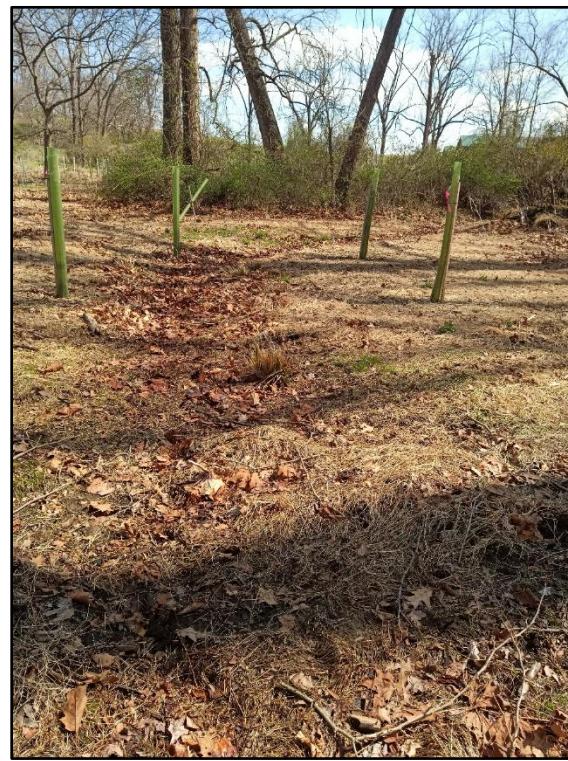
Special Concern Photo 1: Linear wetland, photo facing east.

Maintenance Comments: Brushhog in between rows and apply herbicides. Re-stake and repair shelters.

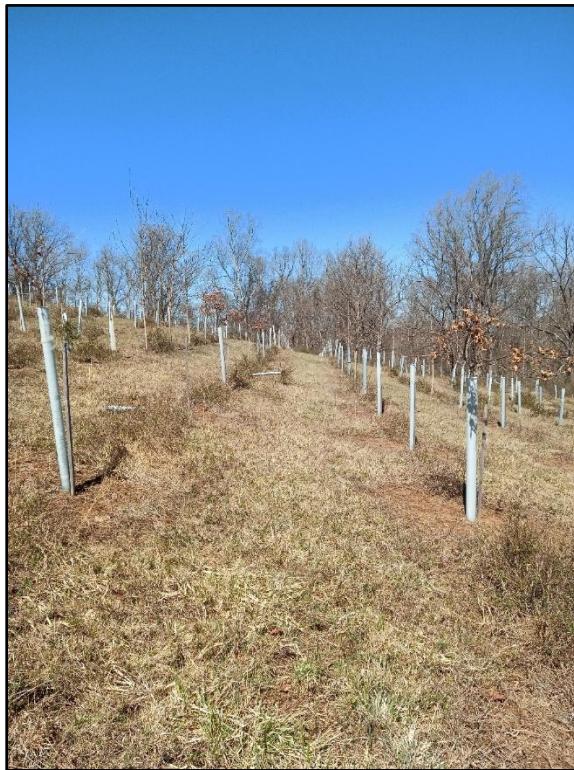
Photo 1: Overview photo facing west.

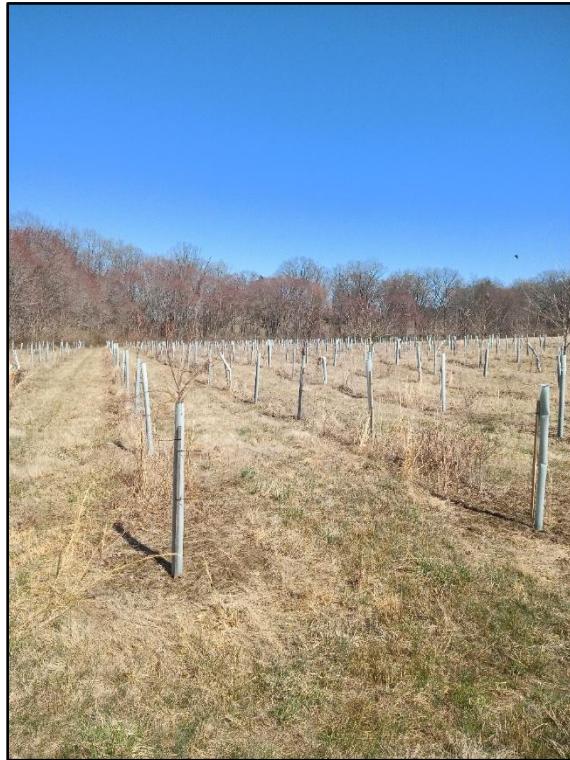
Photo 1: Overview photo facing east.

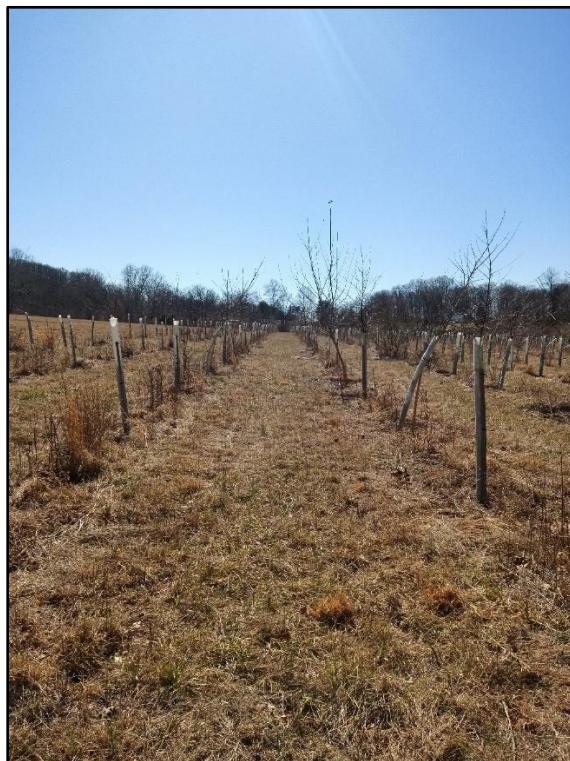
Photo 2: Overview photo facing southwest.

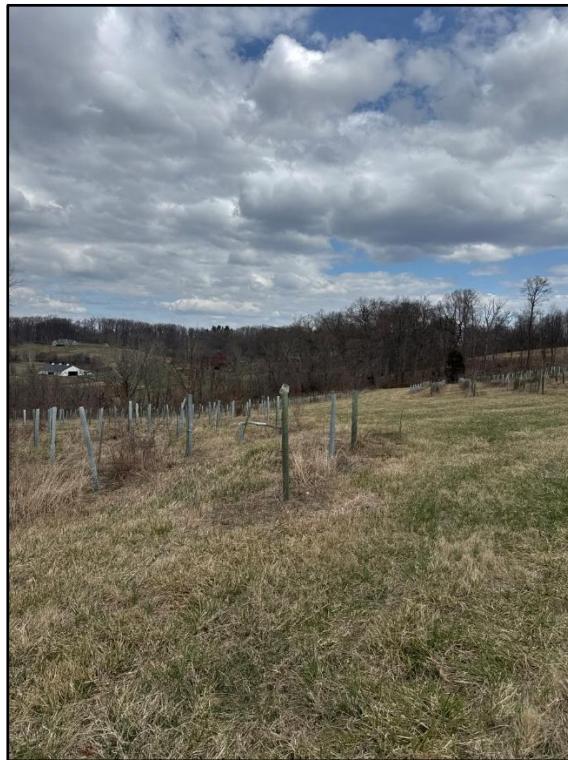
Photo 2: Overview photo facing east.

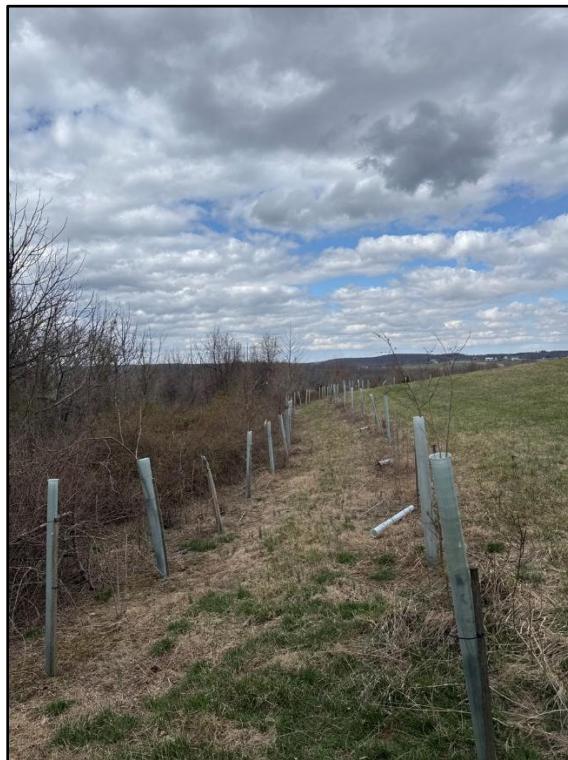
Photo 5: Overview photo facing northwest.

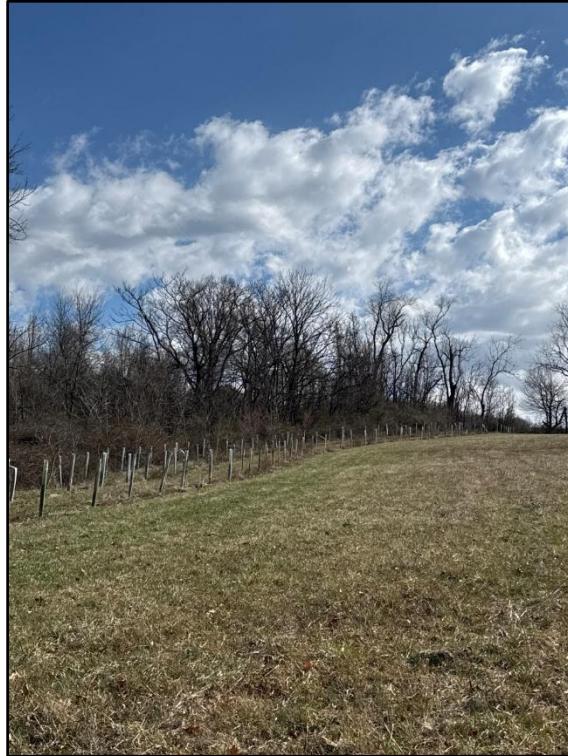
Photo 4: Overview photo facing east.

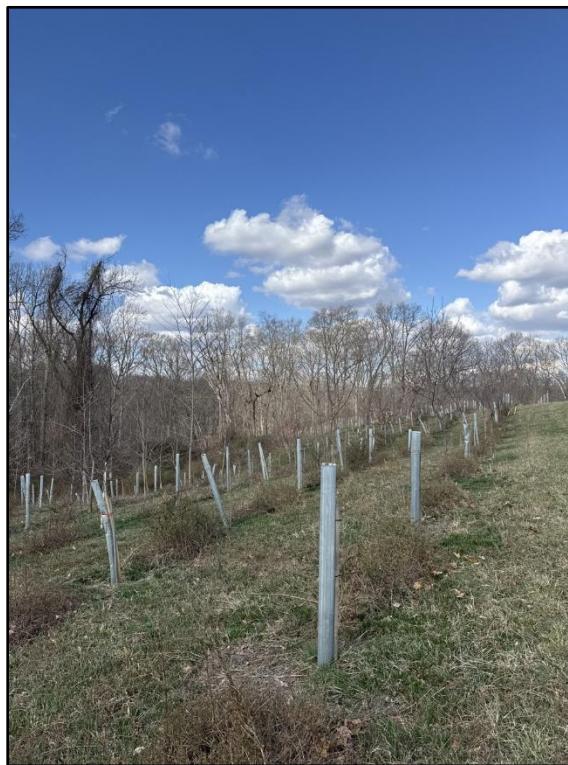
Photo 8: Overview photo facing southwest.

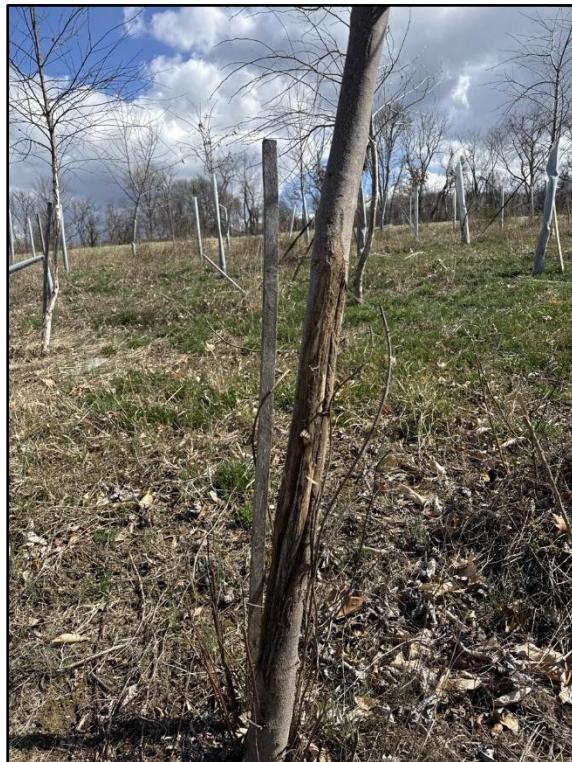
Special Concern Photo 1: Deer buck rub.

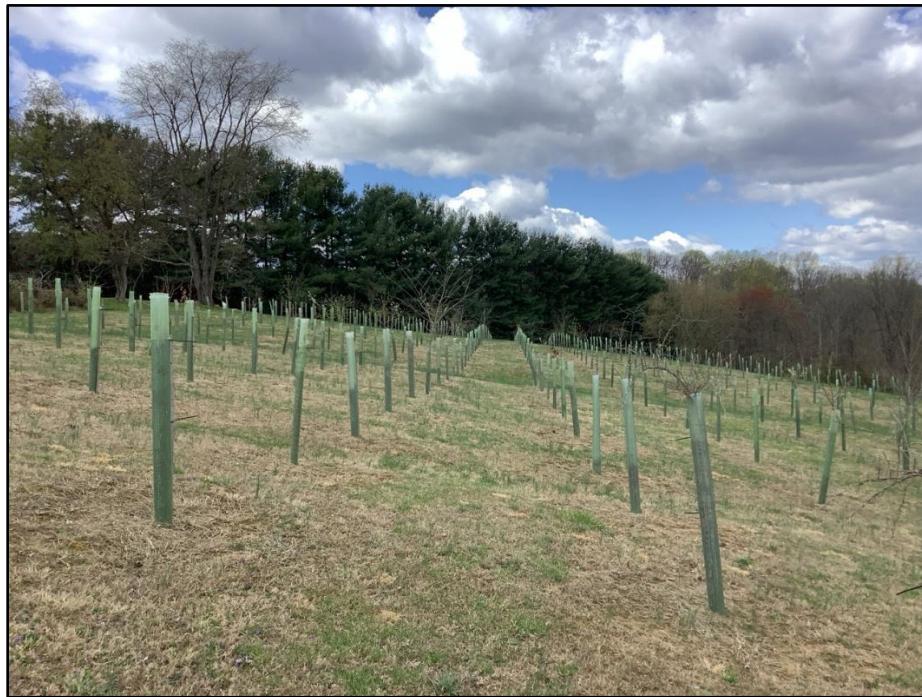
Photo 1: Overview photo facing west.

General Comments: Majority of the site failed, owner said that many trees died, site is essentially a monoculture of Norway spruce. Most trees do not have shelters anymore, high deer and groundhog activity, surviving trees are 2-5' tall.

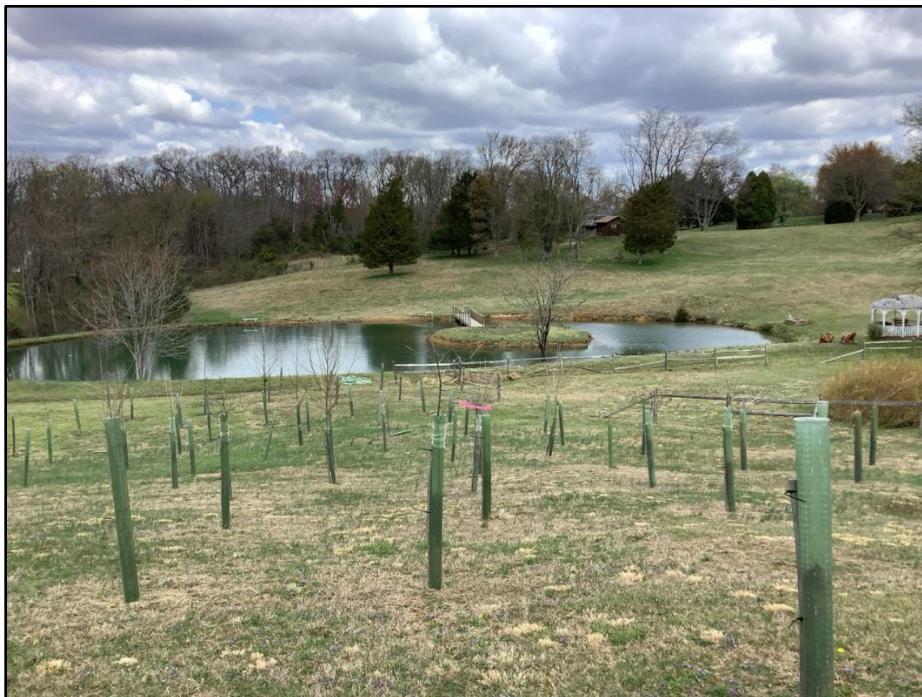
Plot Photo 13: Plot photo facing north.

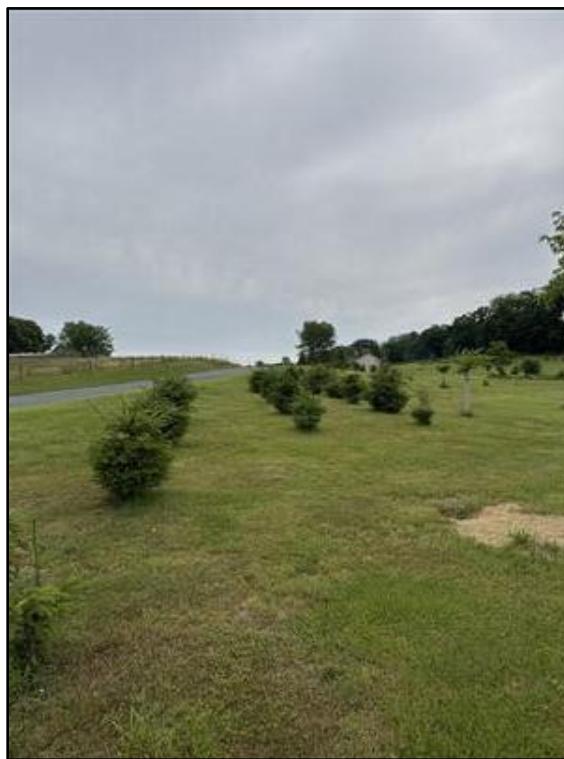
Photo 9: Overview photo facing east.

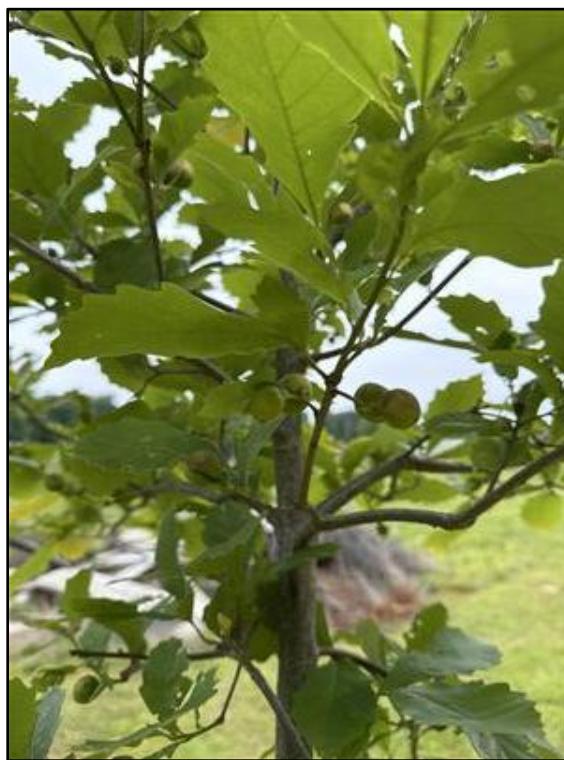
Special Concern Photo 2: Swamp white oak with oak gall.

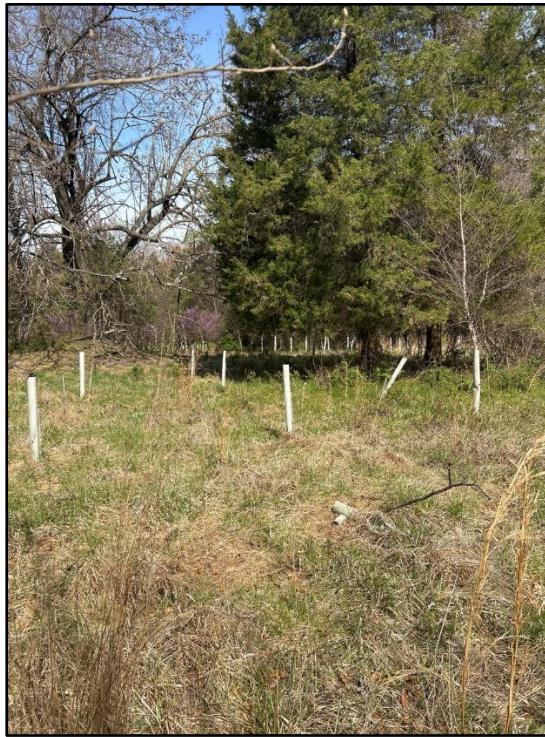
Plot Point Photo 4: Overview photo facing northeast.

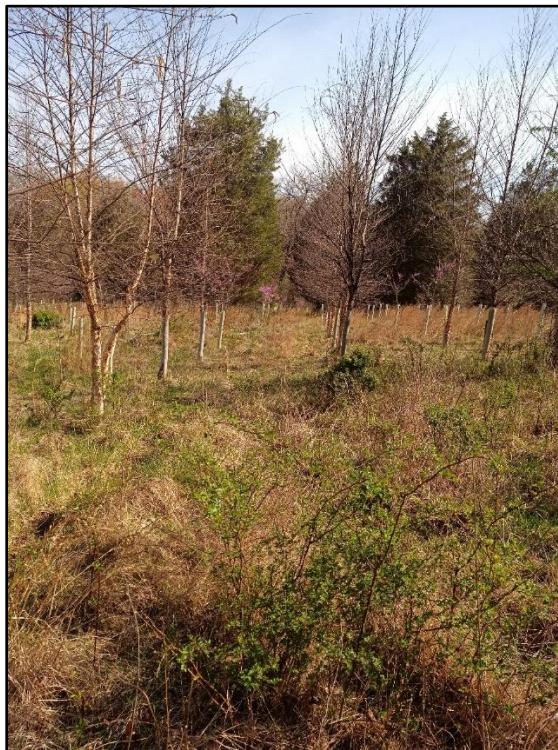
Plot Point 8: Overview photo facing southwest.

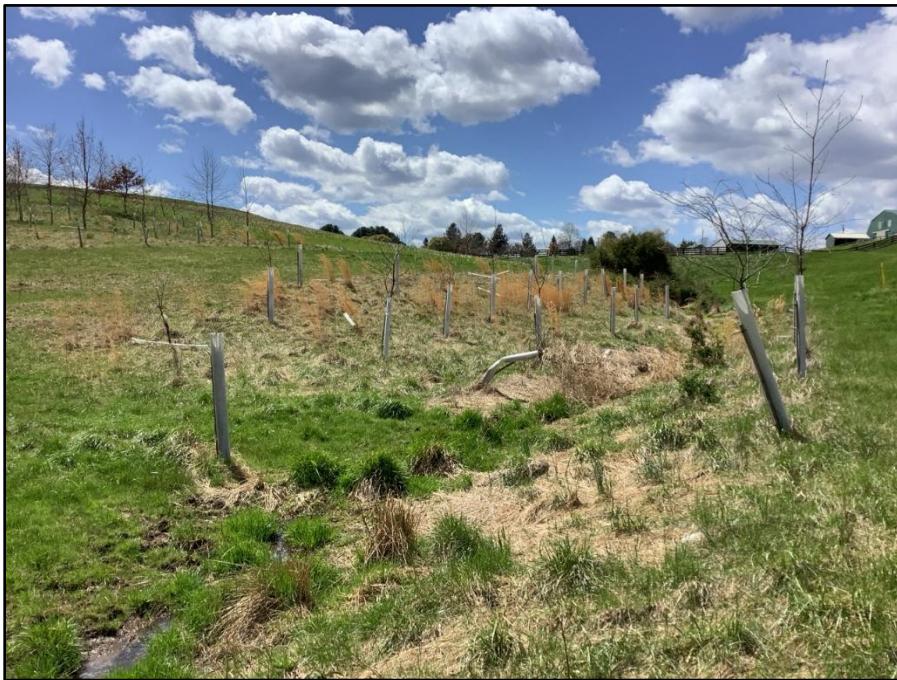
Photo 1: Overview photo facing west.

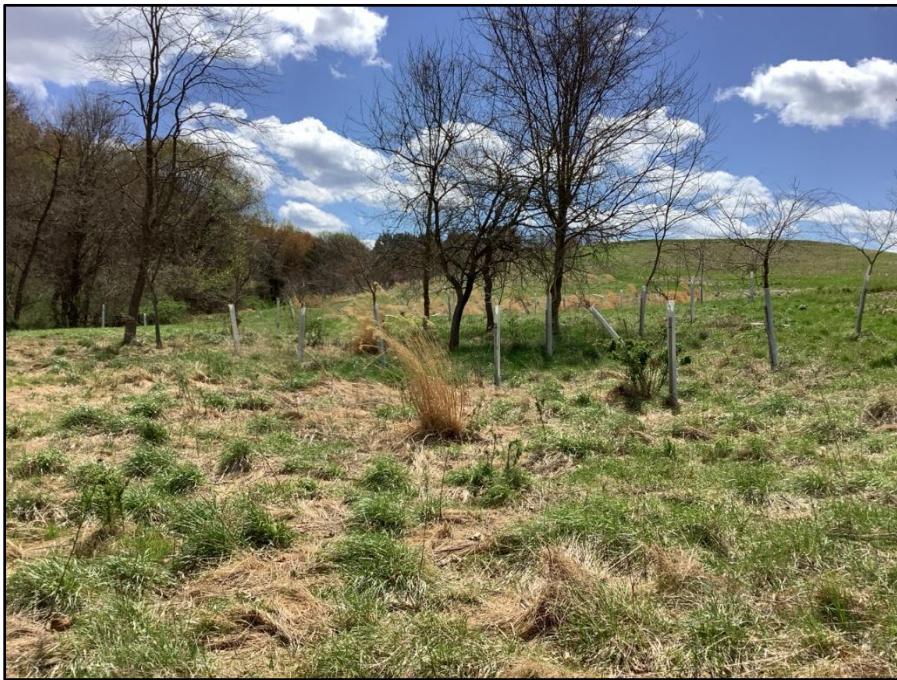
Plot Point Photo 36: Overview photo facing north. (Plot point was dropped during post-processing due to site boundary revisions and low survival)

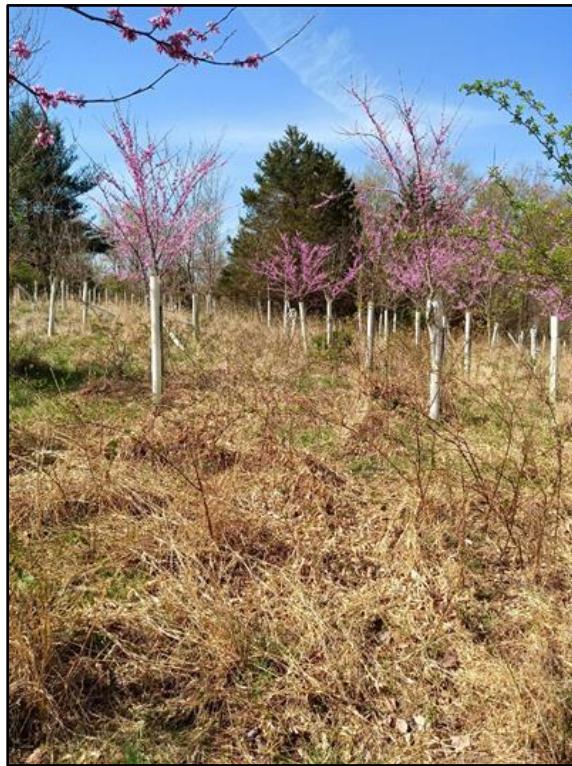
Photo 2: Overview photo facing west.

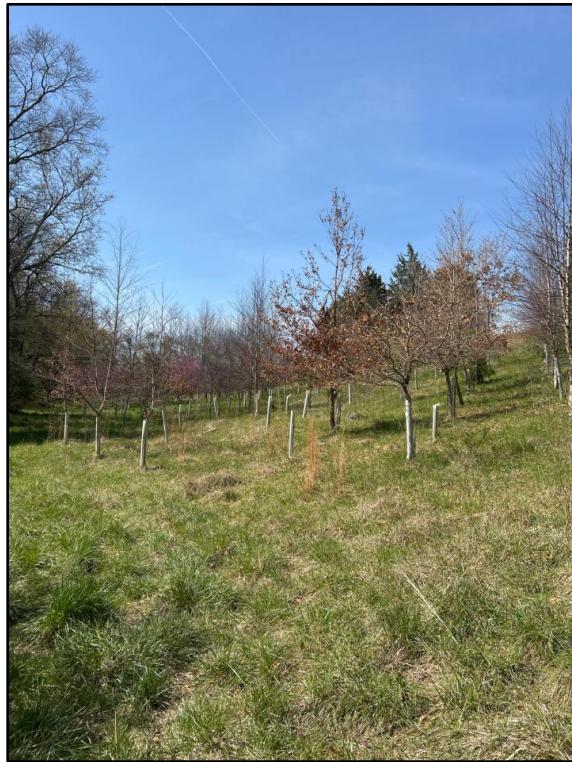
Photo 4: Overview photo facing southwest.

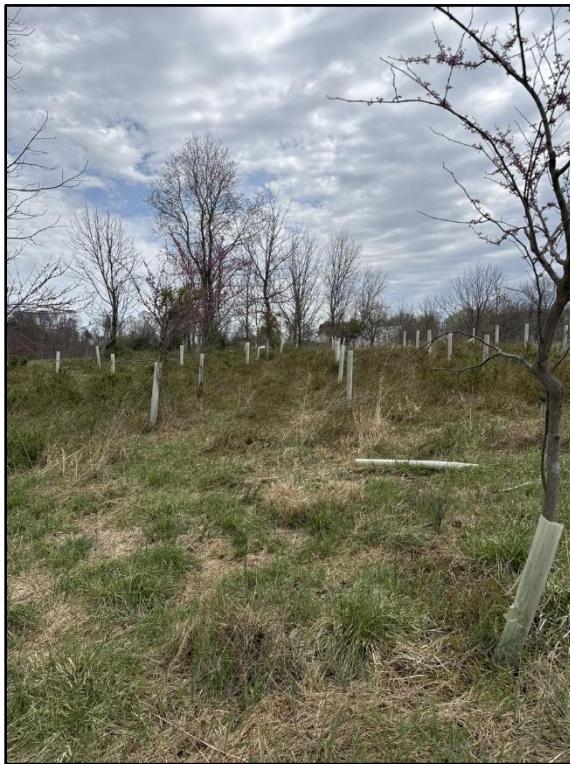
Photo 1: Overview photo facing north.

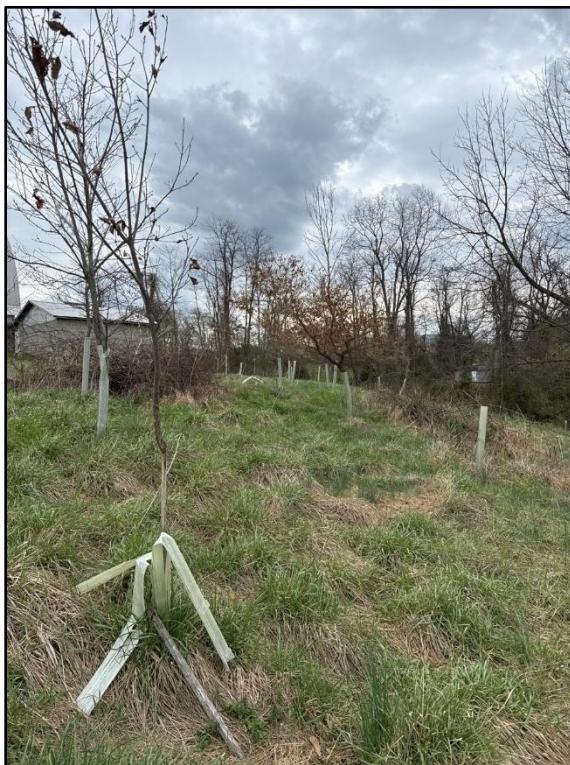
Photo 8: Overview photo facing south.

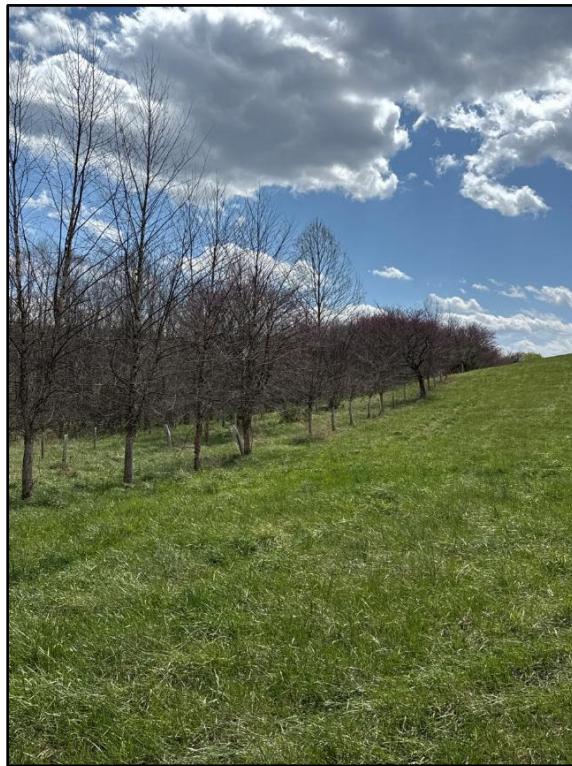
Photo 1: Overview photo facing south.

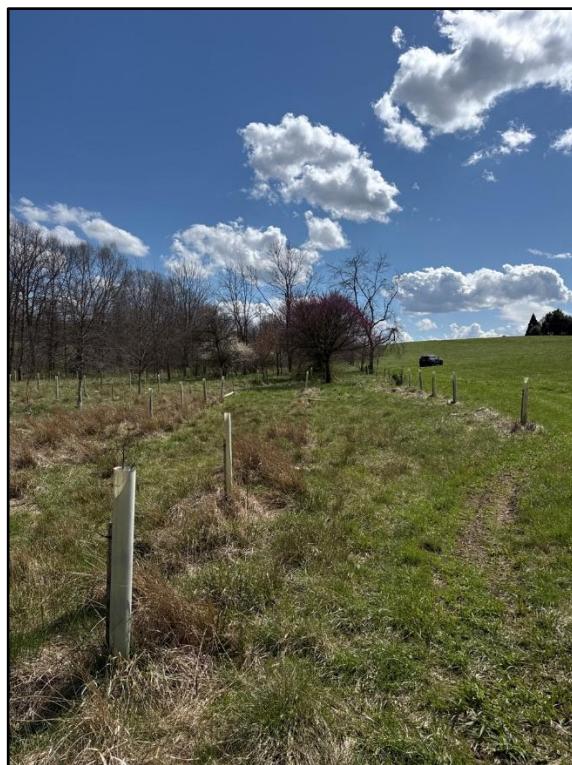
Photo 4: Overview photo facing south.

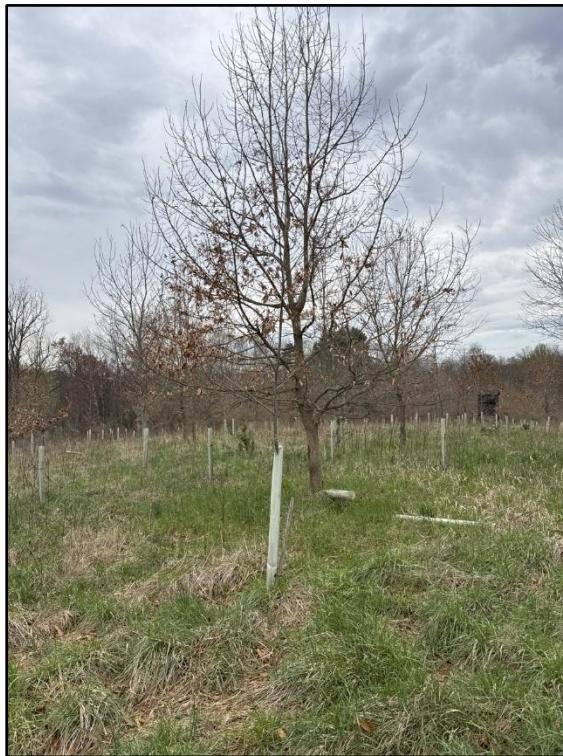
Photo 2: Overview photo facing southwest.

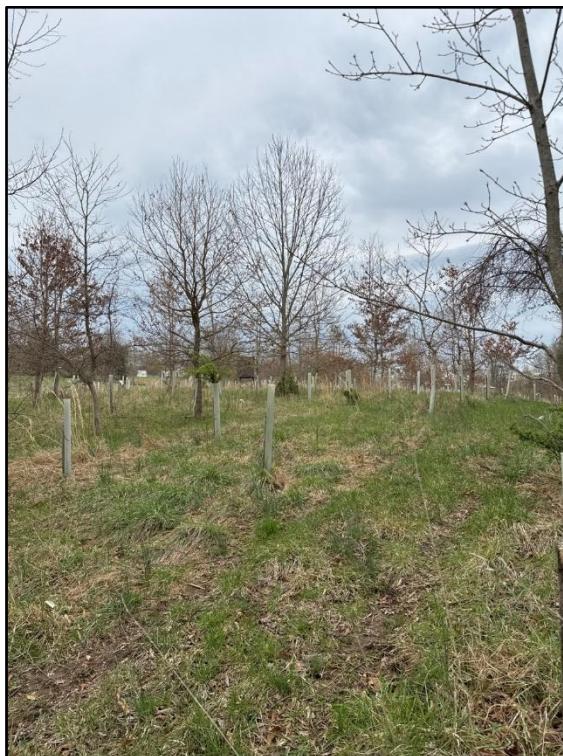
Photo 6: Overview photo facing east.

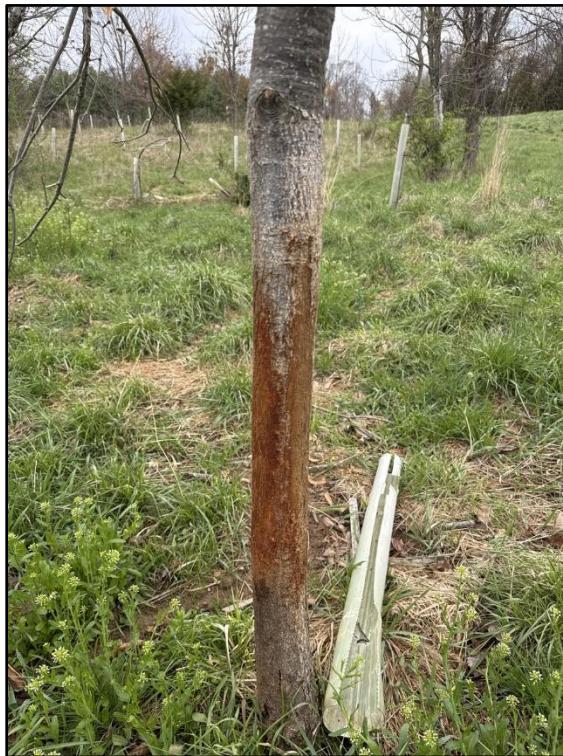
Special Concern Photo 2: Deer buck rub.

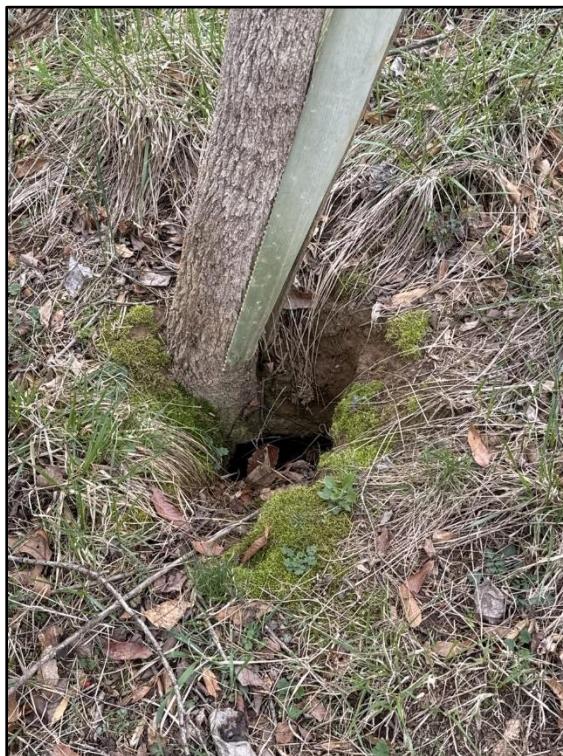
Special Concern Photo 3: Groundhog hole.

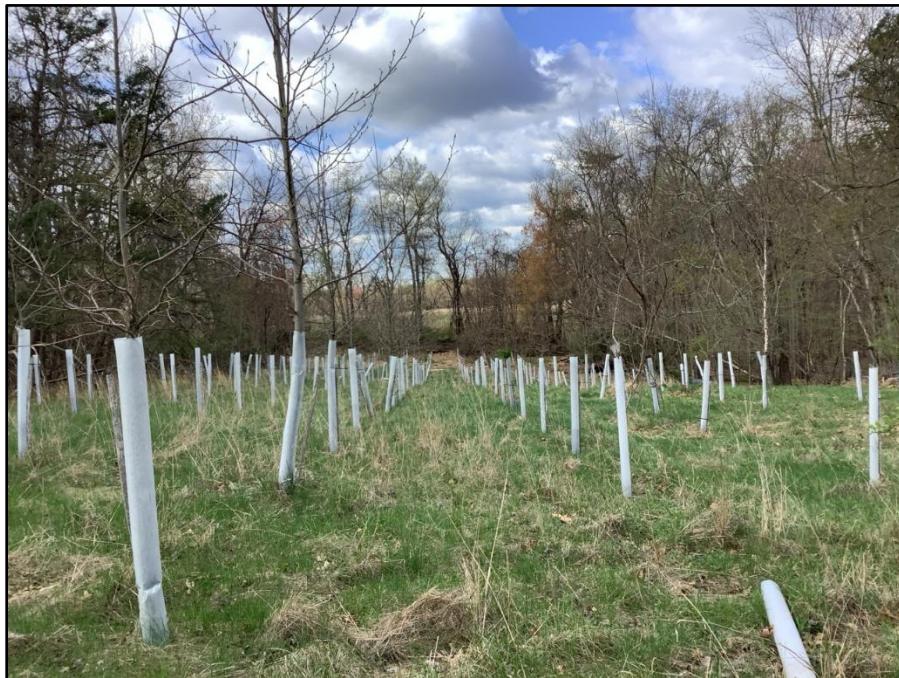
Photo 1: Overview photo facing south.

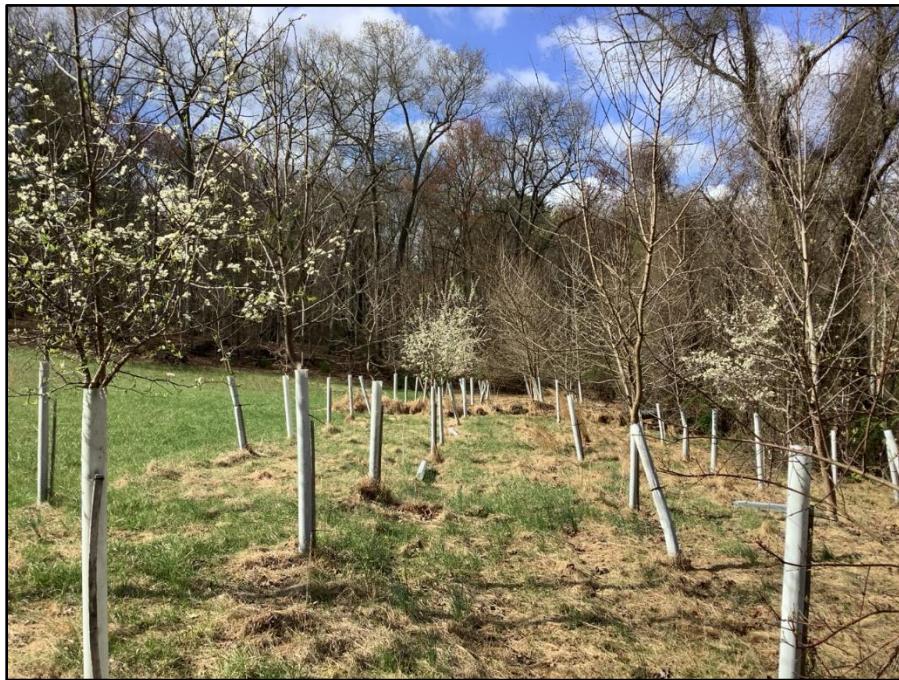
Photo 1: Overview photo facing south.

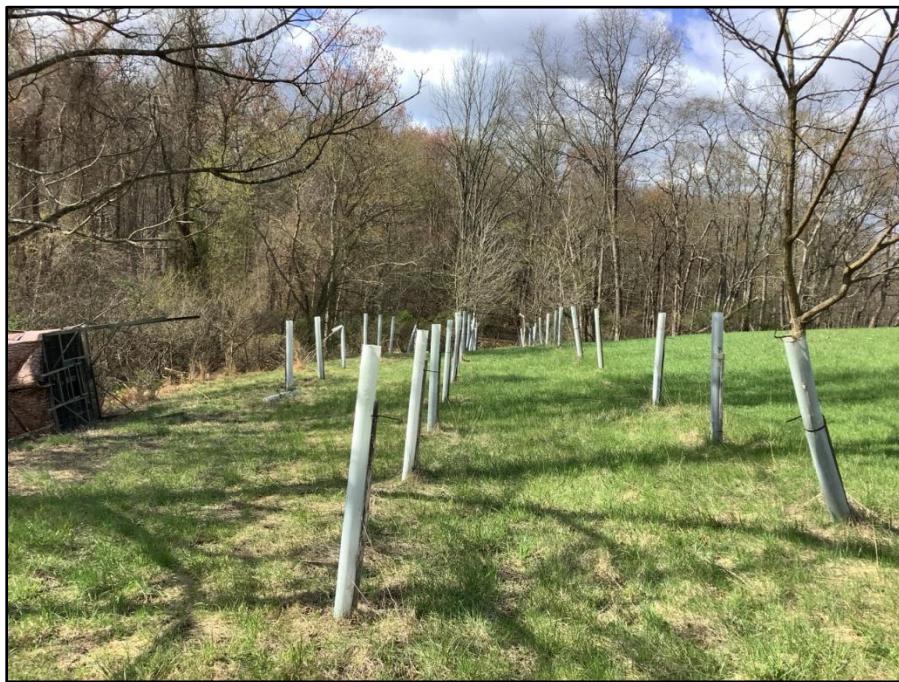
Photo 3: Overview photo facing west.

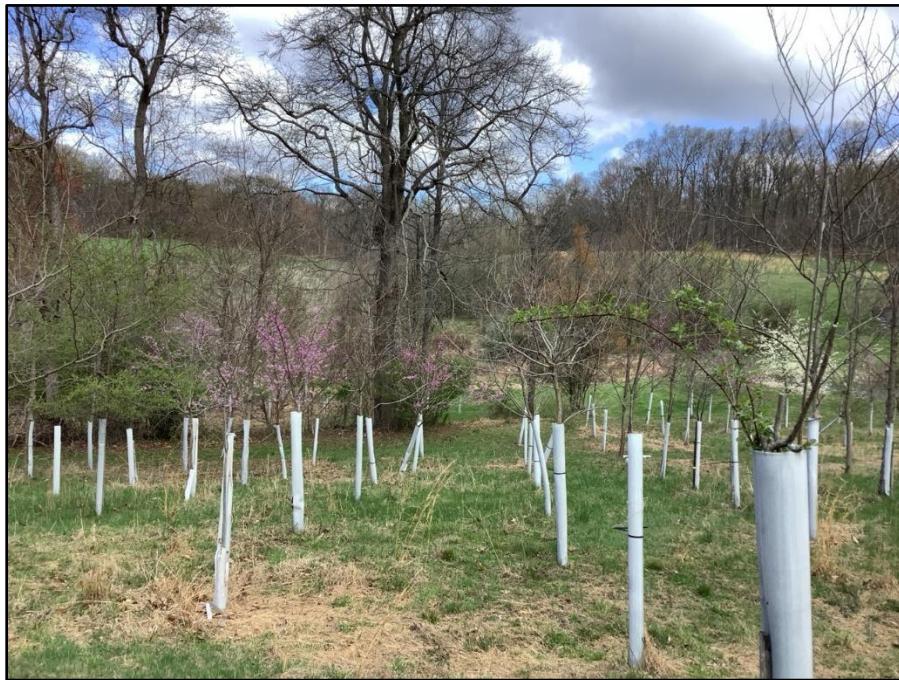
Plot Photo 2: Overview photo facing north.

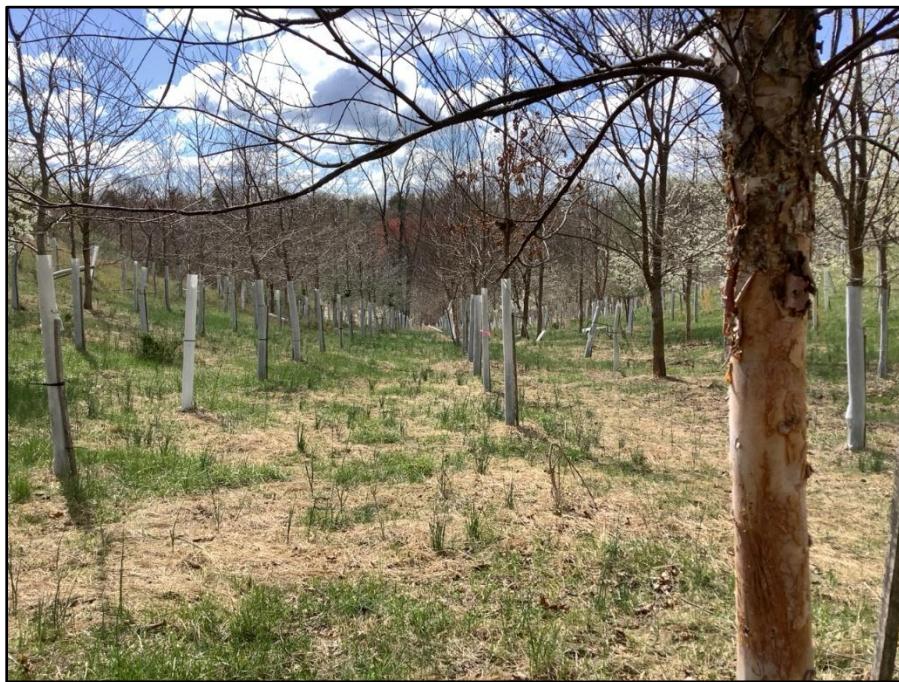
Plot Point Photo 10: Overview photo facing south.

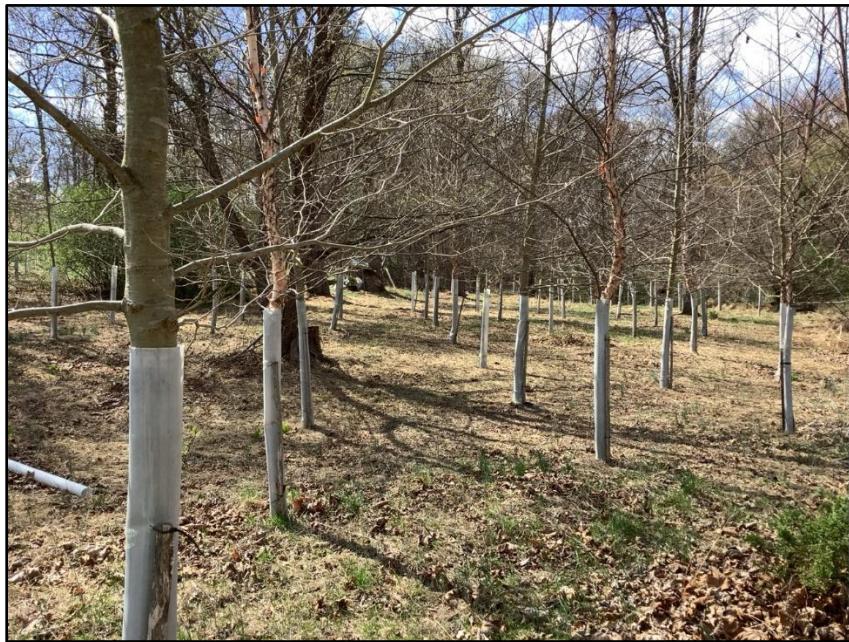
Plot Point Photo 4: Interior of site.

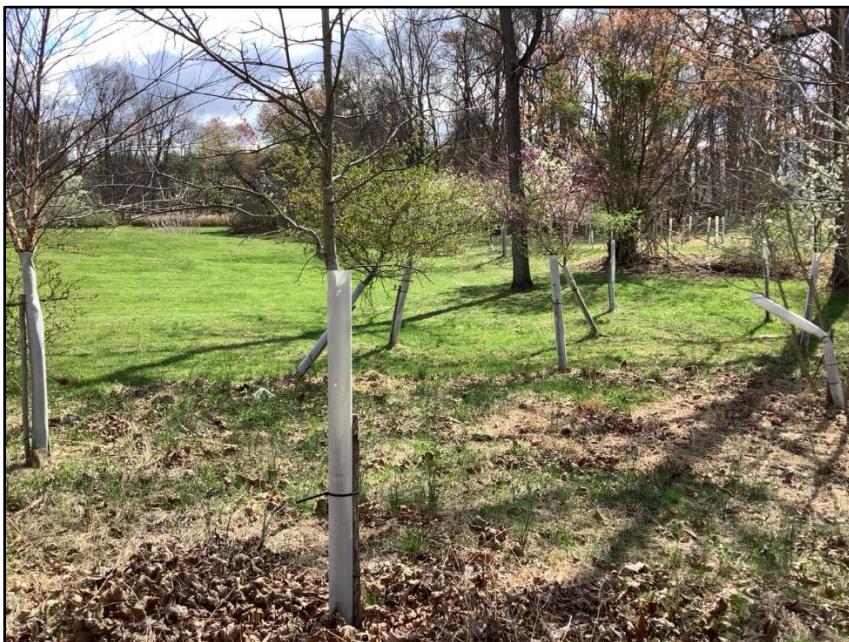
Plot Point Photo 5: Overview photo facing northeast.

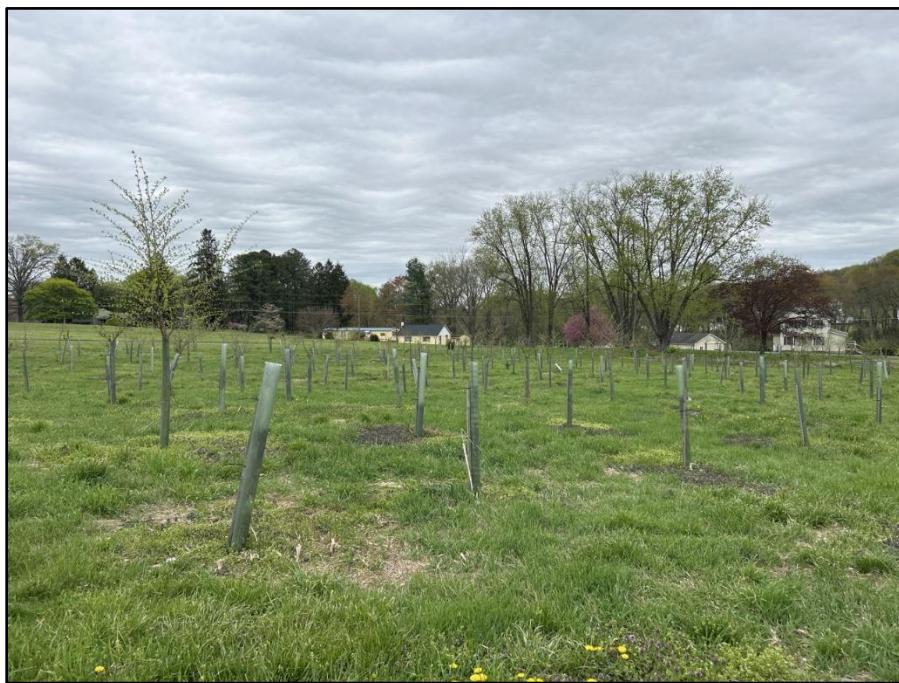
Photo 1: Overview photo facing east.

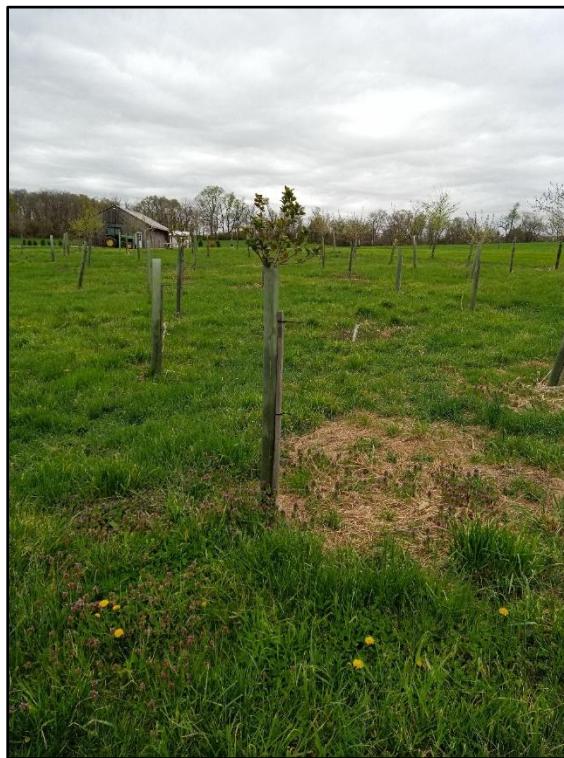
Plot Point Photo 4: Interior of site facing west.

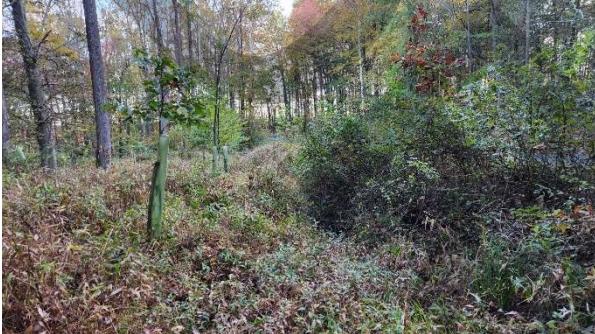
Upstream conditions. Stable with vegetation in channel.

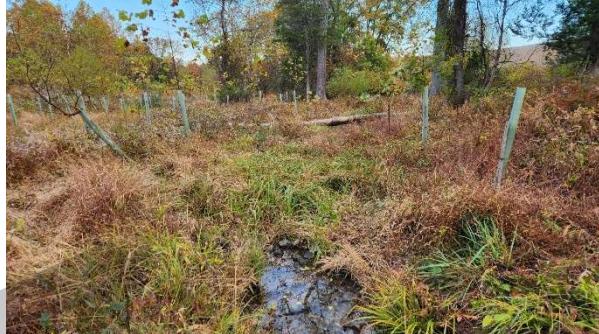
General stream conditions.

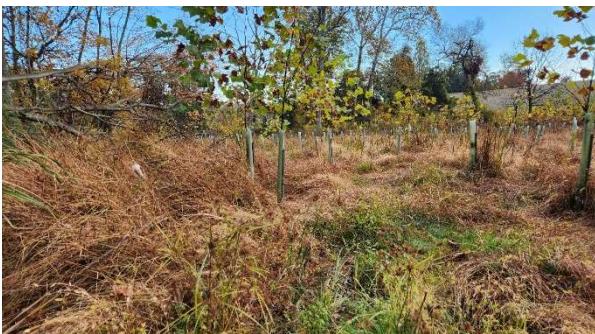
Tributary conditions.

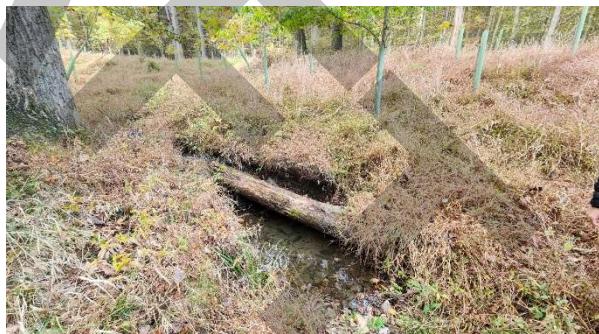
Scour on left bank of log vane. Flow undercutting log; rotting. Stream is stable.

- Targeted invasive species treatment may be considered to prevent further spread of *Phragmites*.
- Tree plantings appear to have mixed success. Consider replacement or inspection of plantings.
- Remove tree shelters and staking that is no longer needed.
- Monitor structure failures but no action needed at this time.
