Appendix E2 - Stormwater Restoration (Restoration Inspections)

MEMORANDUM

Date: December 3, 2024
To: Danielle Hankins – Harford County Department of Public Works
From: Heaven Aziz – RK&K
CC: Andrew Bodt – Harford County Department of Public Works
Kate Gordon – RK&K
Re: Harford County Fall 2024 Gunpowder Valley Conservancy Tree Planting Site Inspections

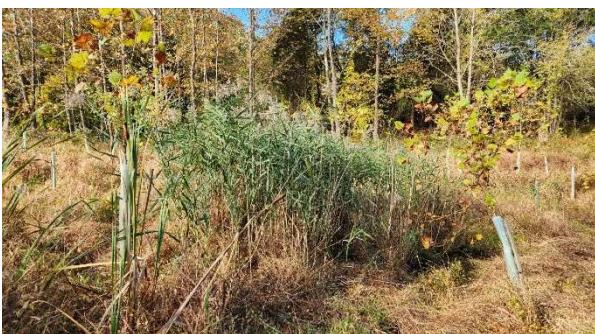
Example of phragmites patch. About 5 similar patches scattered across project.

- Targeted invasive species treatment may be considered to prevent further spread of *Phragmites*.
- Tree plantings appear to have mixed success. Consider replacement or inspection of plantings.
- Remove tree shelters and staking that is no longer needed.
- Monitor structure failures but no action needed at this time.

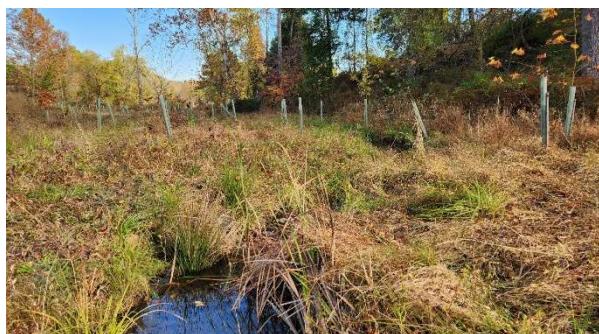
Downstream reach conditions.

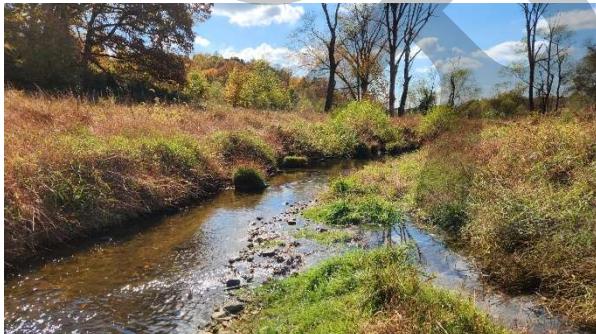
Upstream conditions; some evidence of minor channel enlargement, sparse woody establishment

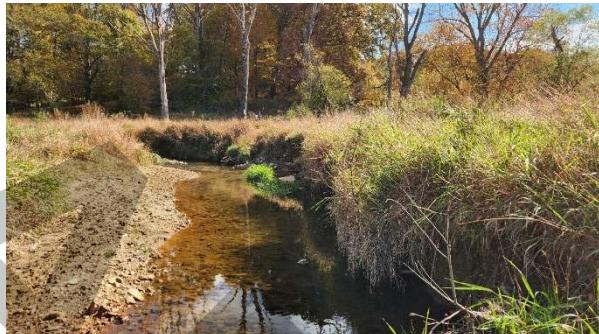
Example of upstream deposition and erosion at bend

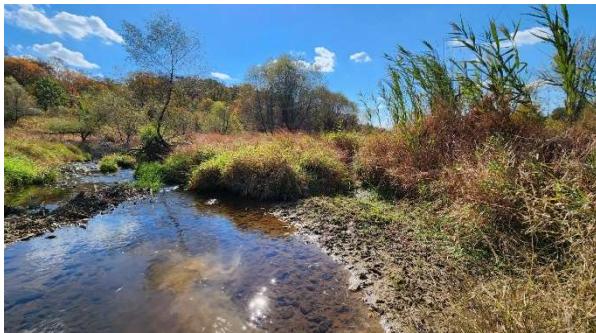
Erosion into old channel alignment; risk of alternative flow path to oxbow

- Willow live stakes could help protect areas of concern, particularly by downstream oxbows. Successful live stakes were observed in many locations.
- Localized bank protection may be considered for severely eroded areas to prevent further degradation.

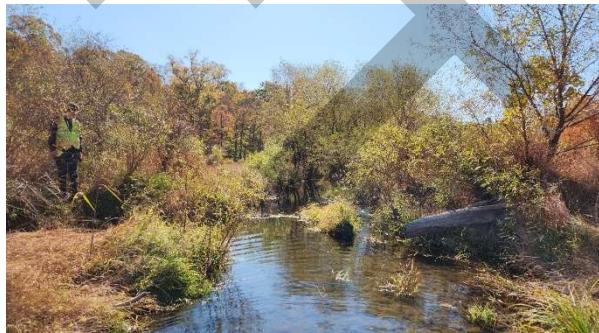
Mid-stream conditions; area of good willow establishment

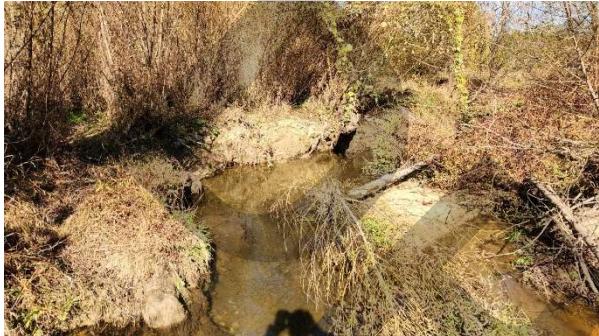
- Some bends have high vertical banks with no protection.
- Beaver activity (at least 3 active dams) in middle of restoration has caused change in erosion and flow patterns; currently stable while the beavers are active but may be problematic if the beaver abandon the dams.

Messy conditions due to upstream beaver dams

- Continue to monitor beaver dams and other areas of concern.
- Consider additional tree plantings in floodplain. Wire cages are recommended for beaver/deer protection.

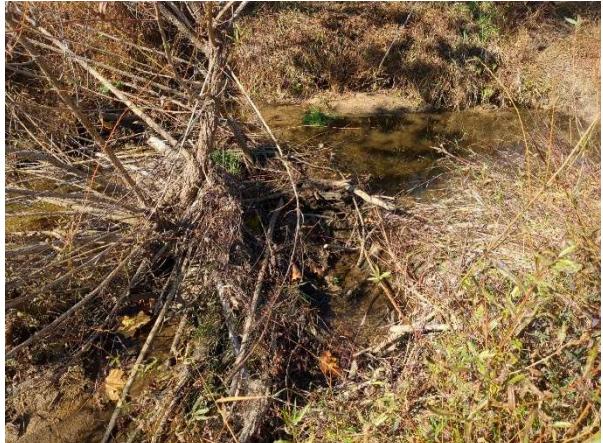
Downstream-most beaver dam. Two more immediately upstream.

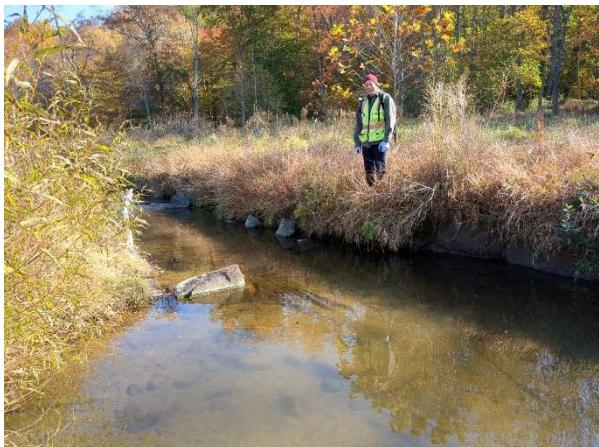
Suspected blown out log structure; causing erosion on left bank

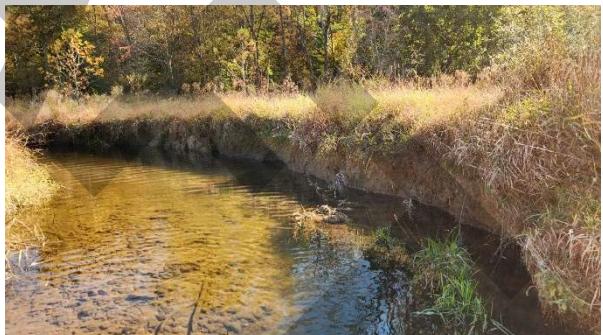
Severe erosion on outside meander

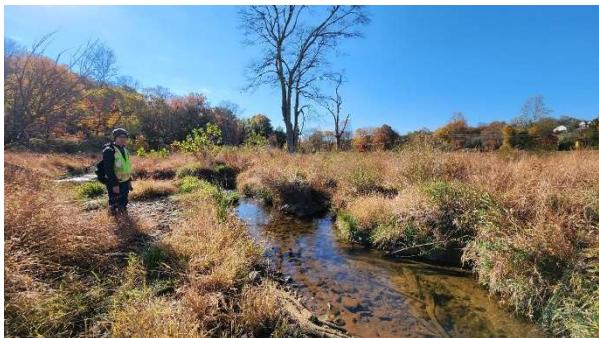
Bank erosion and collapse near oxbow

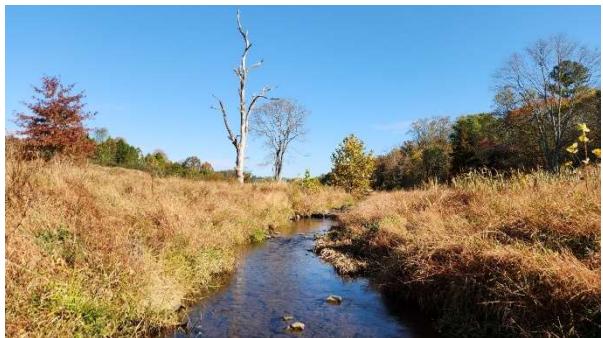
General downstream conditions

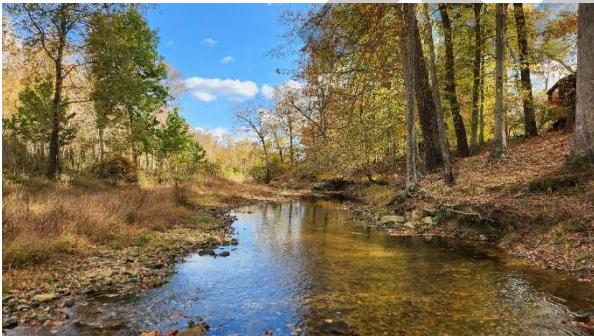
From the upstream end looking downstream; reach is stable; right bank is eroded but was not restored.

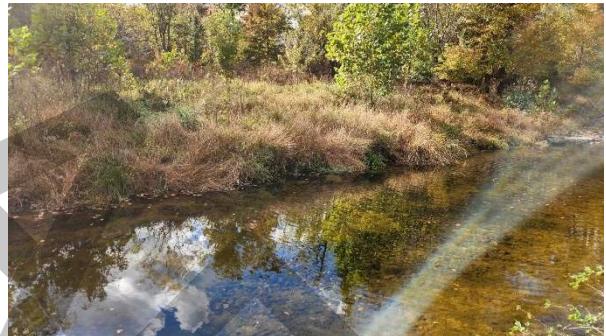
Example of typical erosion; minor erosion about 1-2 feet high obscured by overhanging vegetation. Monitor.

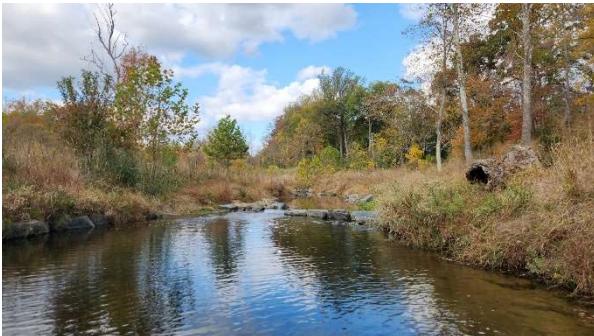
Representative stream conditions and structure example.

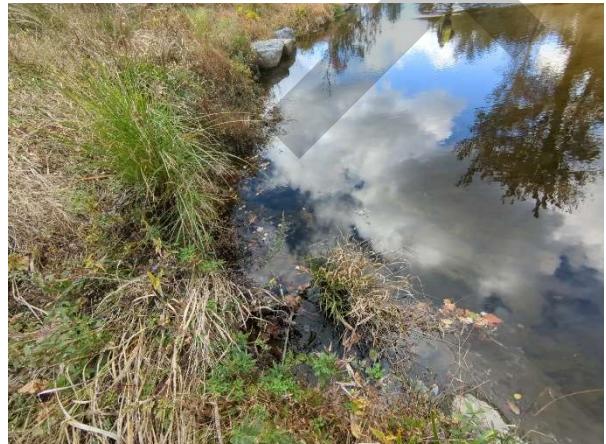
Boulder protection has fallen into stream and bank is eroding at the bend. Near the middle of the restored reach.

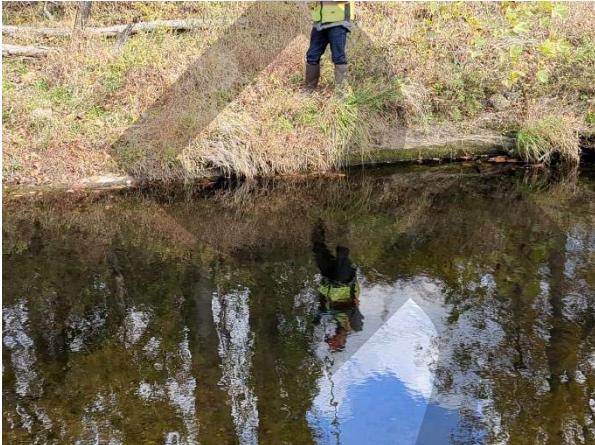
Deep pool under log structure. Currently stable but monitor for possible undercutting.

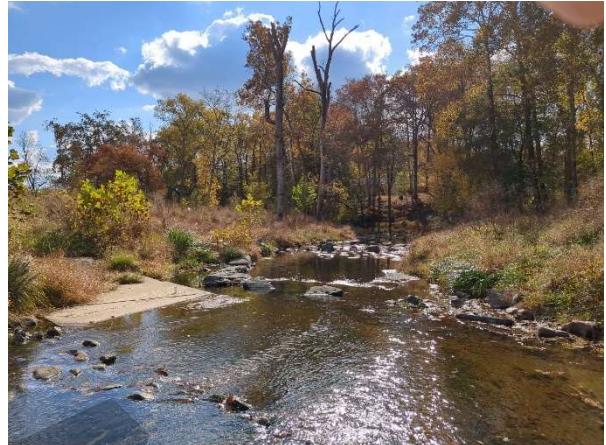
Typical downstream conditions. Stable and well vegetated.

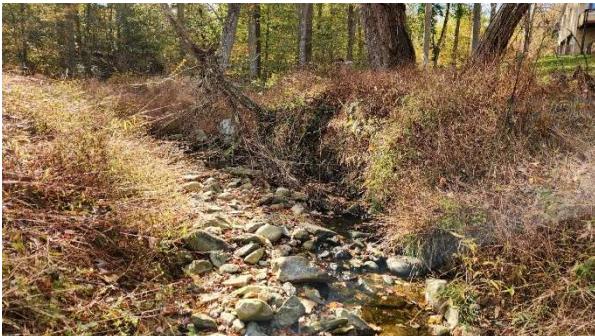
Tributary 4 - severe erosion on left bank near end of restoration. Banks are severely eroded.

- Consider removal or stabilization of Tributary 4 (downstream-most tributary on the left bank for credit calculations. Currently, not passing.
- Treatment of isolated phragmites stands may be considered.
- Monitor erosional areas and structure failures.

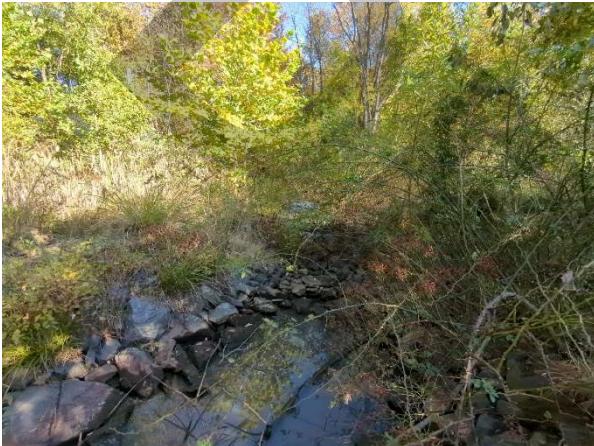
From upstream reach, looking downstream.

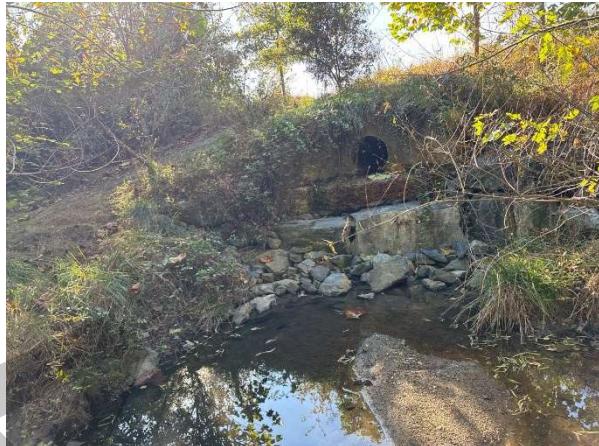
Outfall conditions. No issues.

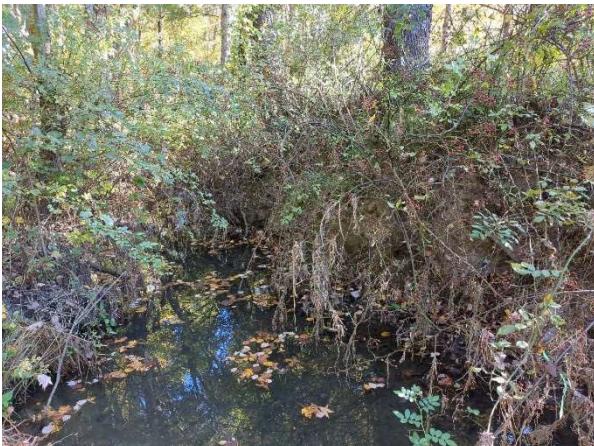
Eroded bank near upstream confluence.

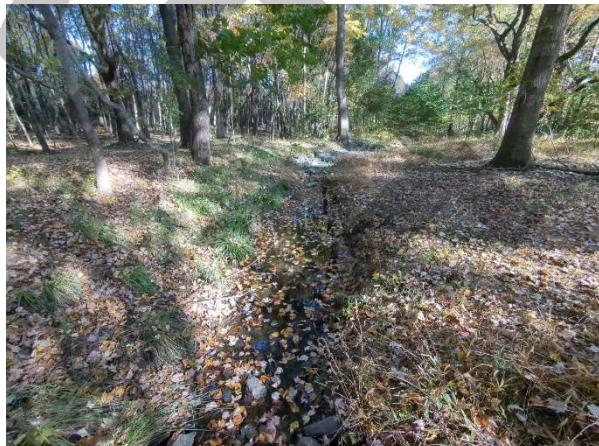
Minor erosion and possible stream enlargement. Monitor, but no issue.

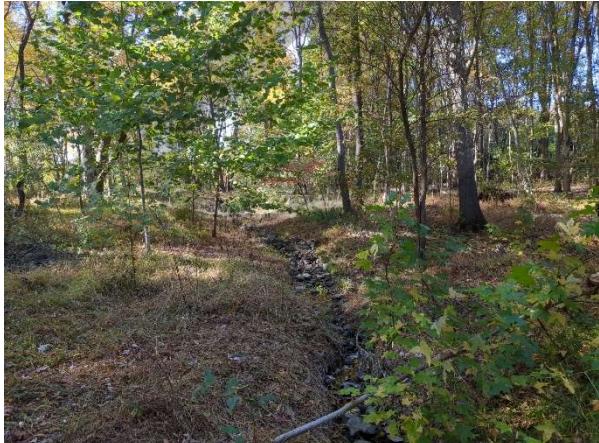
Typical stream conditions from middle of restoration.

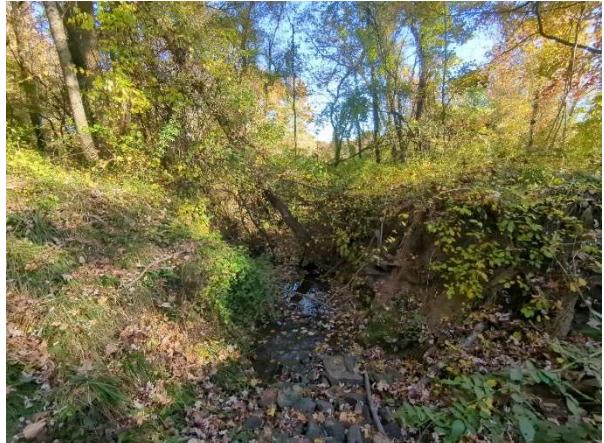
End of restoration. Stable to last riffle. Incised channel outside of restored area.

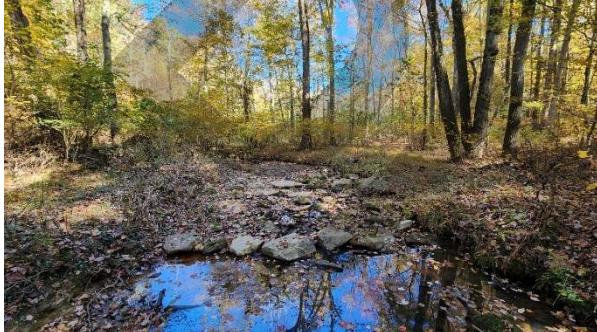
Start of restoration.

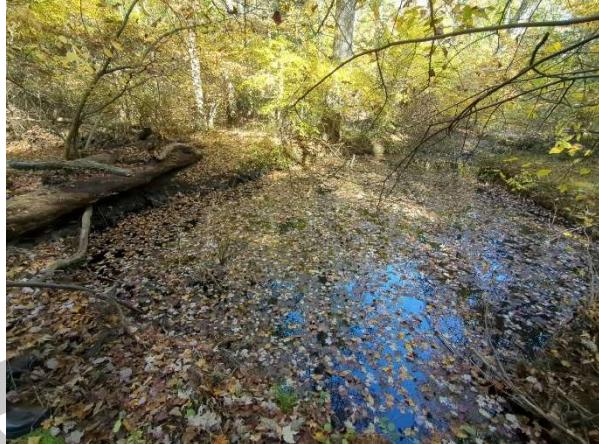
Example of channel meander and widening, erosion of right bank on left of picture.

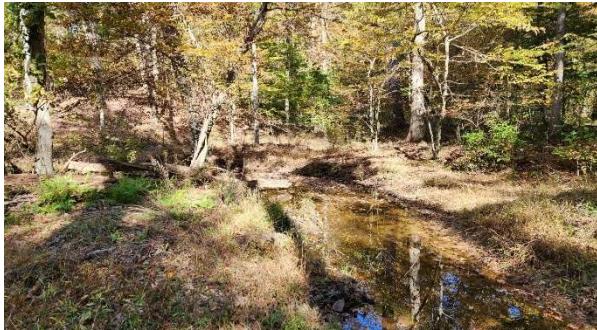
Example mid-stream conditions, minor widening and erosion.

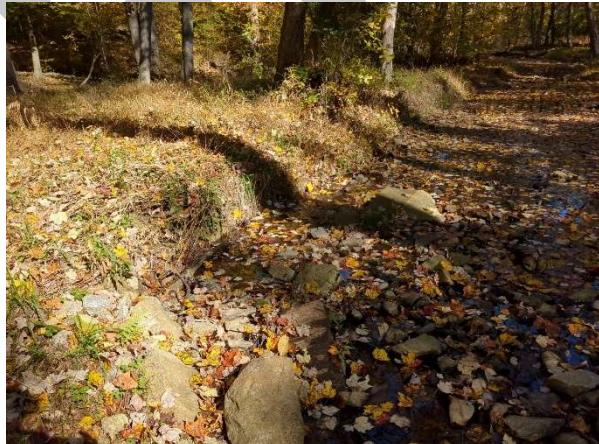
Flanking around riffle structure and subsequent erosion.

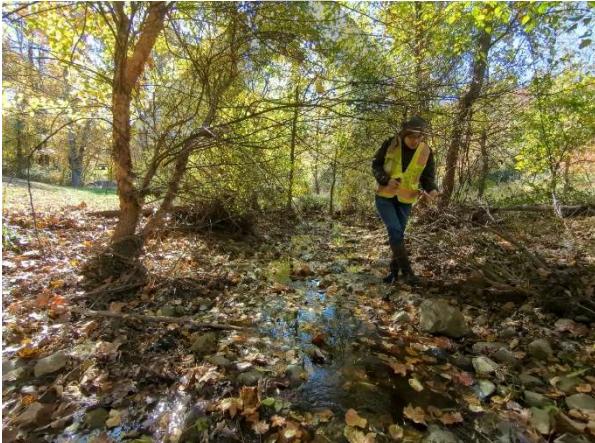
General upstream conditions.

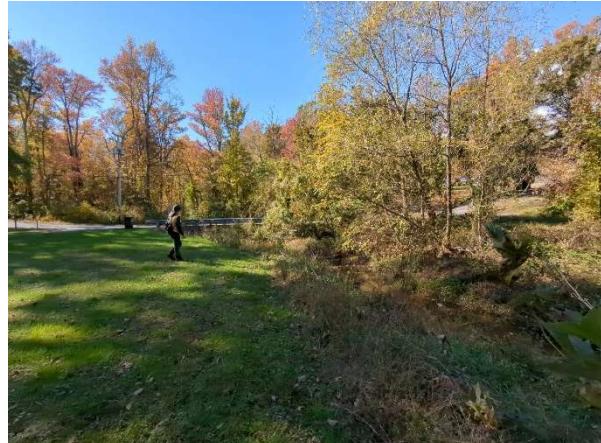
Mowing in riparian zone in upstream segment.

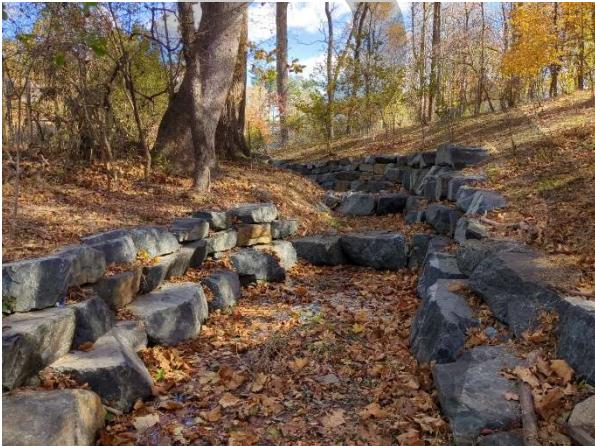
Typical step pool structures on northern reach. Maintained vegetation along banks.

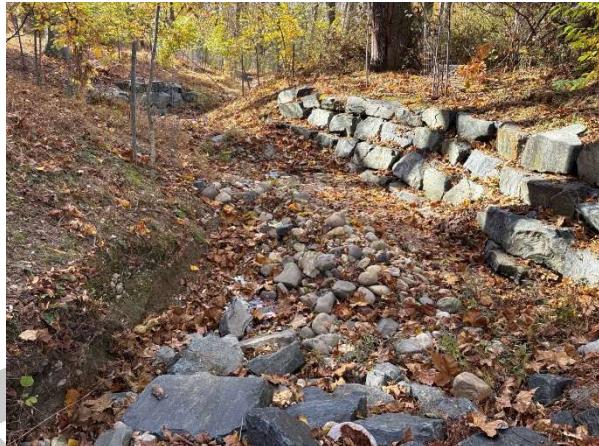
Erosion on left bank (middle of northern stream) due to deposition of cobble instream. Material can be redistributed to prevent continued scour.

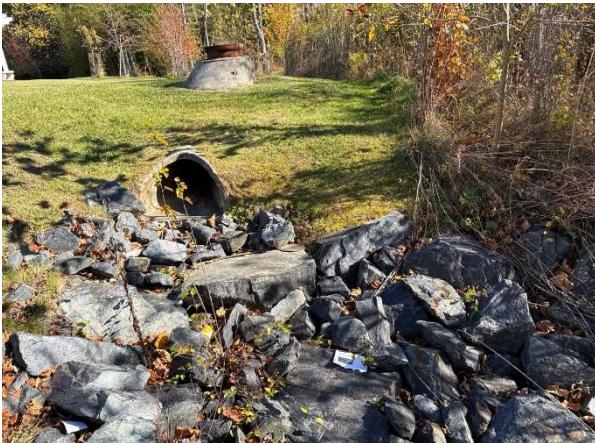
Outfall channel on southern stream is stable.

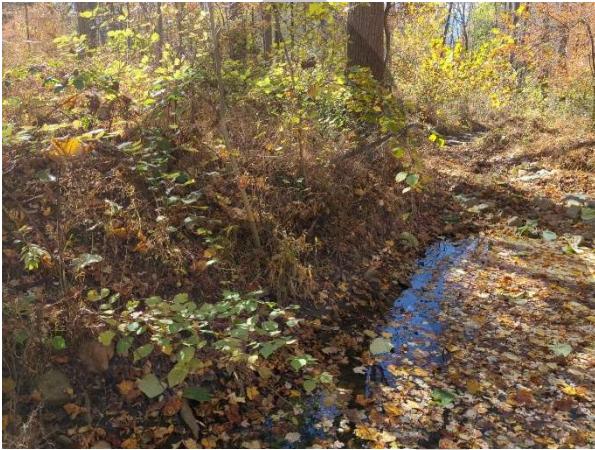
Example of typical erosion seen in the southern, downstream section. Vertical scour common at the bends but generally well-vegetated.

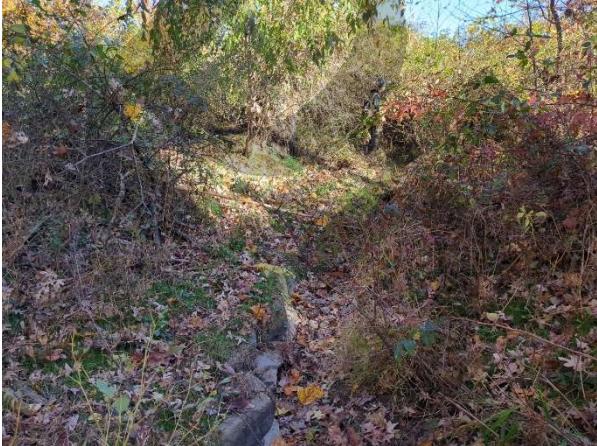
Example of general stream conditions.

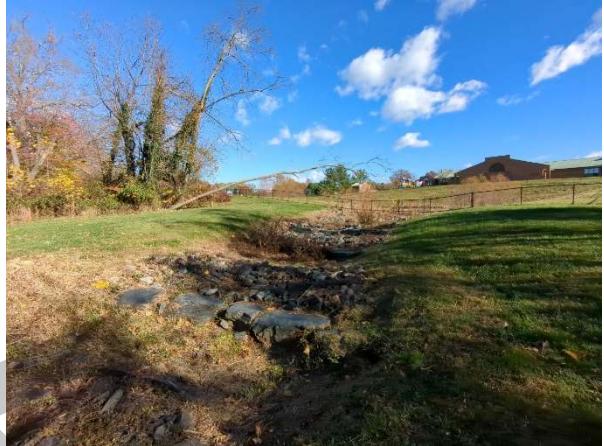
Step pools leading from pond to stream; stable.

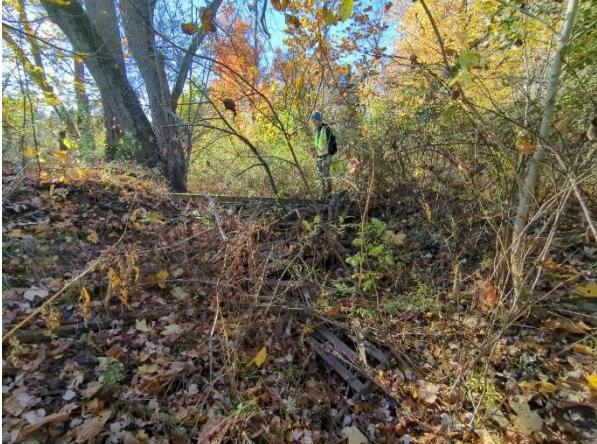
Makeshift bridge/pileup

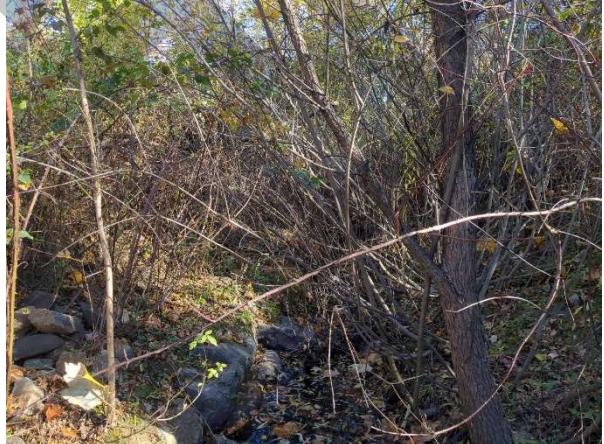
Downstream conditions. Woody growth in channel and banks.

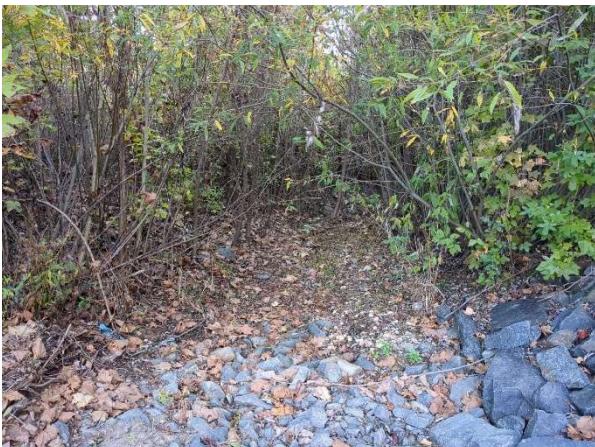
Upstream conditions below the stormwater pond; thick woody establishment

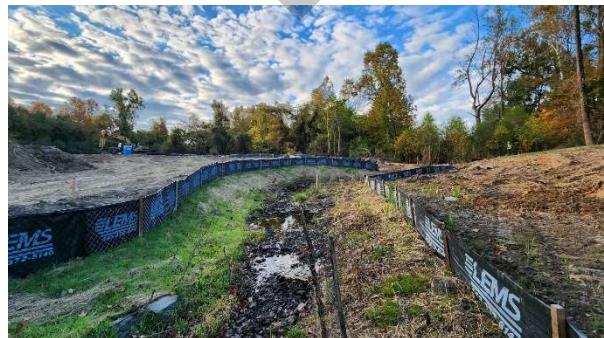
Riparian clearing and construction for proposed road; monitor for impacts after construction is complete

- Monitor development of the construction area and potential impacts on stream and riparian health.
- Consider removal of 200 ft of downstream from credit considerations due to failing conditions.
- Investigate broken pipe on downstream end; appears to be an abandoned sewer pipeline.
- Repair work of the downstream end could be considered but would likely require significant intervention and damage to surrounding forest.
- Invasive species are prevalent throughout the stream and are likely difficult to extirpate; isolated patches of *Phragmites* and knotweed in wetland areas may be controllable by targeted treatments.

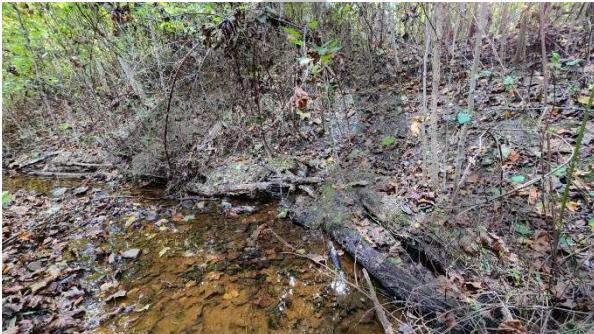
- Erosion begins roughly after the aerial sewer crossing.
- Bank supporting structures such as woody toes or coir fiber logs are decomposing or rotting and minor erosion was observed in these locations; however, root protection from vegetation is reinforcing banks.

Example of rotting woody toe and bank slumping; bank is well vegetated by volunteers.

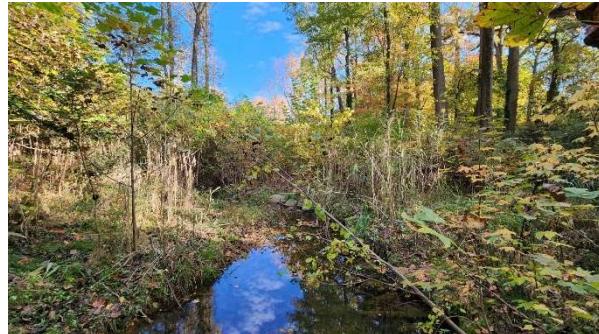
Wetland terrace with open canopy and associated *Phragmites* patches.

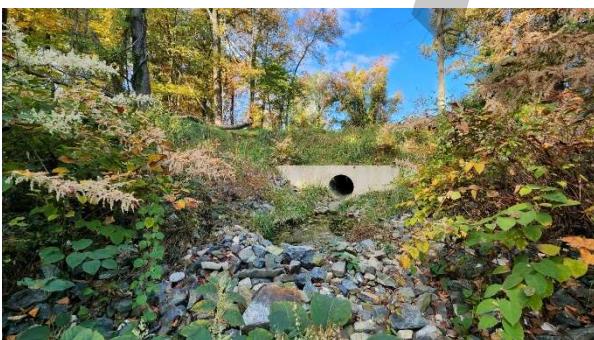
Step pool and outfall on left bank are stable but heavily invaded by NNI.

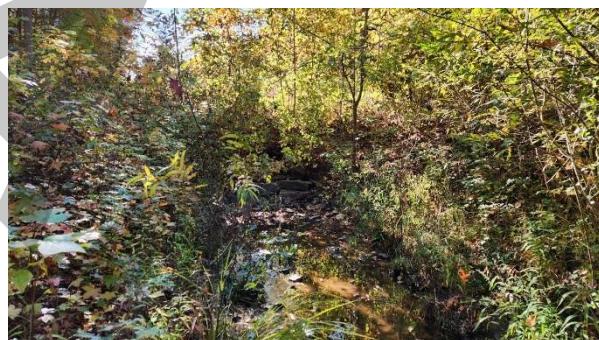
Right bank outfall channel is generally stable with minor erosion; some phragmites observed along banks.

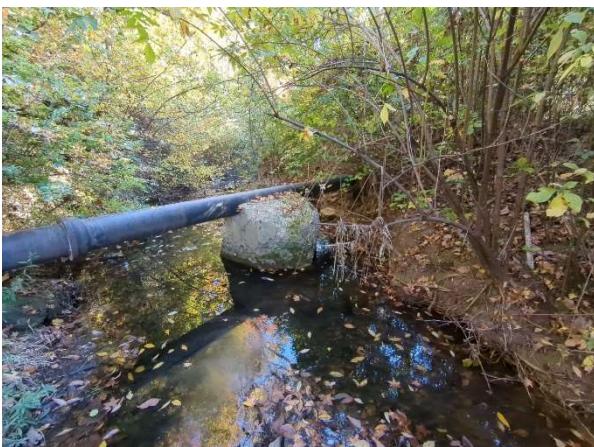
Beginning of erosion and scour near exposed aerial sewer crossing. Mostly on the right bank ~1-3 ft high.

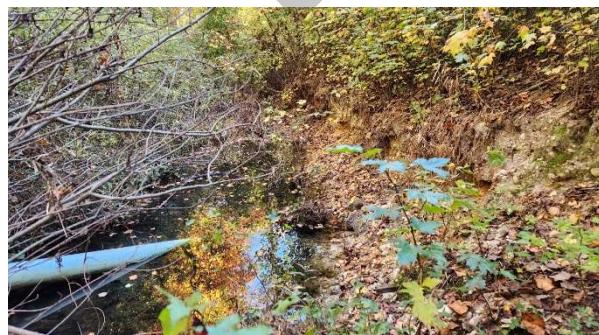
- Overall stable and passing, but significant deterioration was noted on the downstream end.
 - Total erosion ~450 ft (9.2%)
 - Pockets of minor erosion were observed throughout, but the last 200 ft of stream are failing and eroding despite indication of grading on as-built.

- An unknown, broken pipe was observed in the downstream end in the stream channel.

Example of severe erosion and slumping along right bank typical of the end of the restoration. An unknown broken pipe is observed in pieces along the reach.

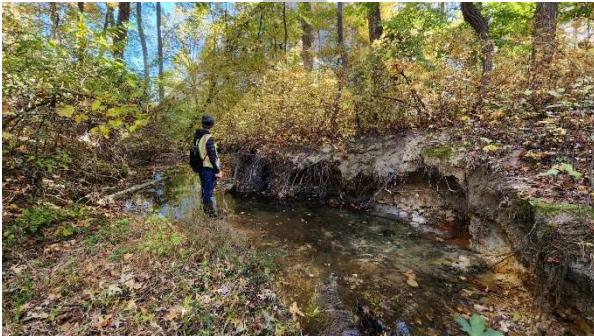
Example of downstream conditions. Failing banks 3-4 ft high.

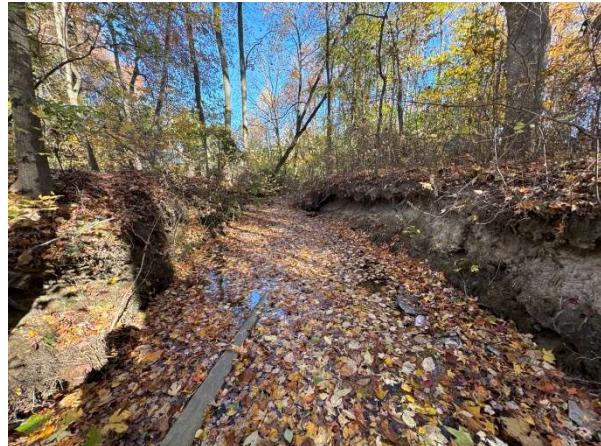
Another photo of downstream conditions with broken pipe in the foreground.

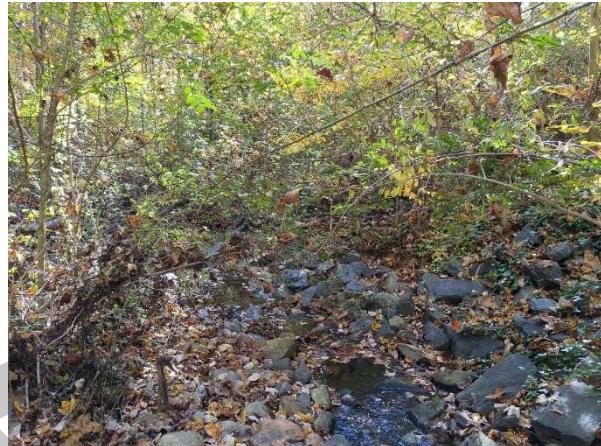
Midstream conditions; heavy invasive presence.

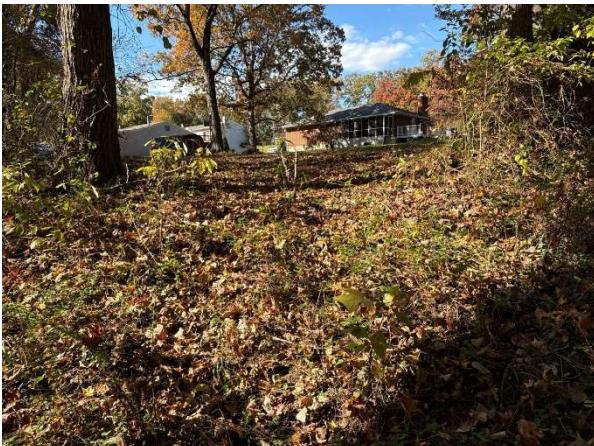
Example of mowing and clearing close to the stream.

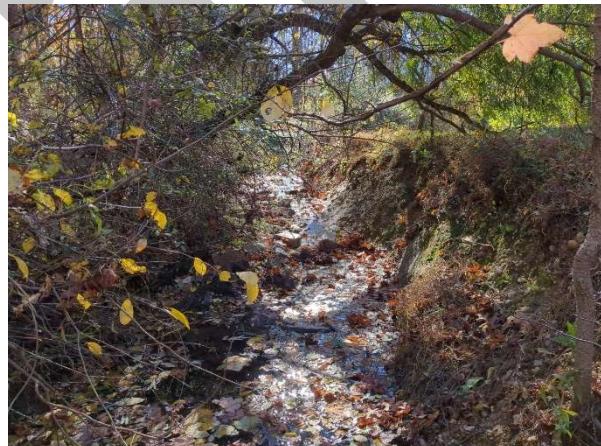
- Upstream conditions are stable, but downstream conditions show significant degradation.
 - Total erosion is about 345 ft (14% of total length)
 - Worst of erosion is between downstream driveway and footbridge.
- Upstream conditions are narrow and heavily vegetated with minor areas of erosion.
- Riparian zones were generally narrow throughout due to encroachment of mowing and private property. Encroachments appear to be well established and may represent the pre-restoration conditions.
- Downstream restoration, below the private driveway, has degraded over time despite evidence of previous localized repair work. This reach is not functioning.
- Limited woody vegetation establishment in downstream section.

Example of downstream conditions; despite grading on the right bank, it is currently raw and eroding.

- Consider removal of reach downstream of private driveway from credit considerations.
- Repair work in downstream section can be considered but would require significant effort.

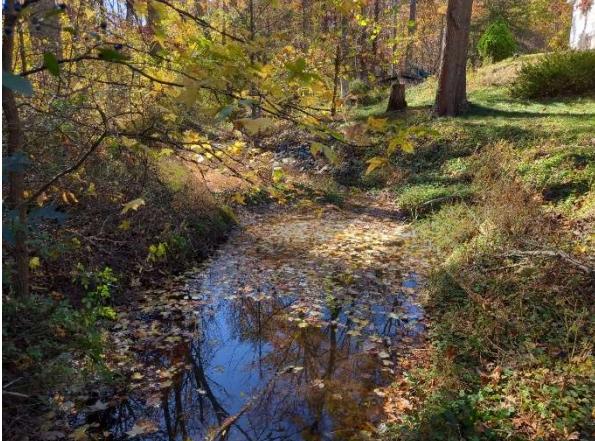
Conditions at the lower end of the reach downstream of footbridge; appears unrestored but is more stable; evidence of repair work and riprap in the distance.

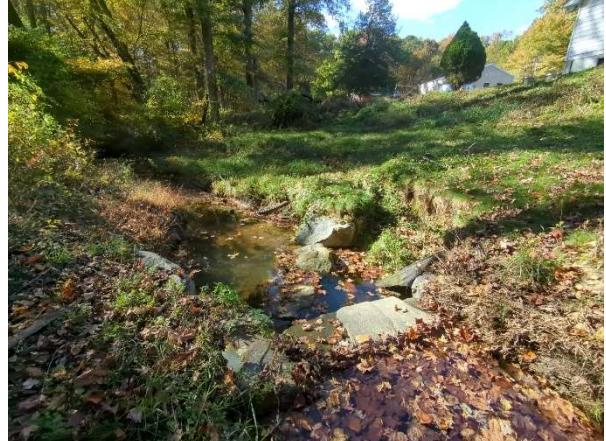
Failed structure at end of restoration but reinforced by new cross vane from past repairs.
